Marine Corps Base, Quantico Shoreline Protection Plan

Shoreline Studies Program
Virginia Institute of Marine Science
College of William & Mary
Gloucester Point, Virginia

March 2011

Final Report

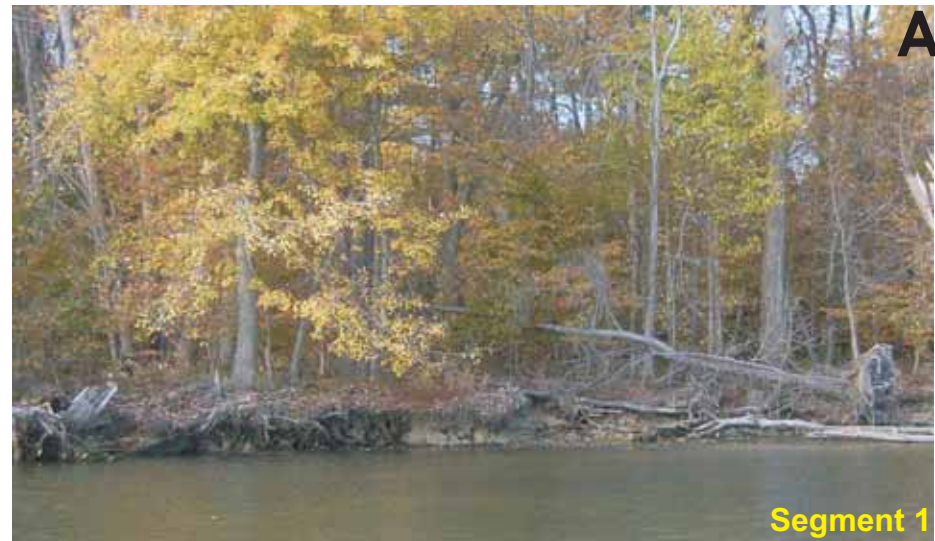
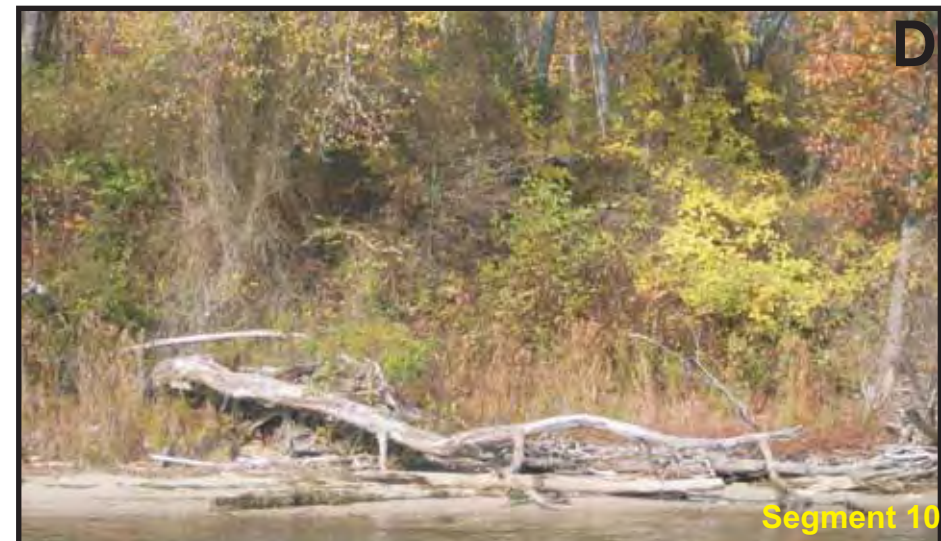
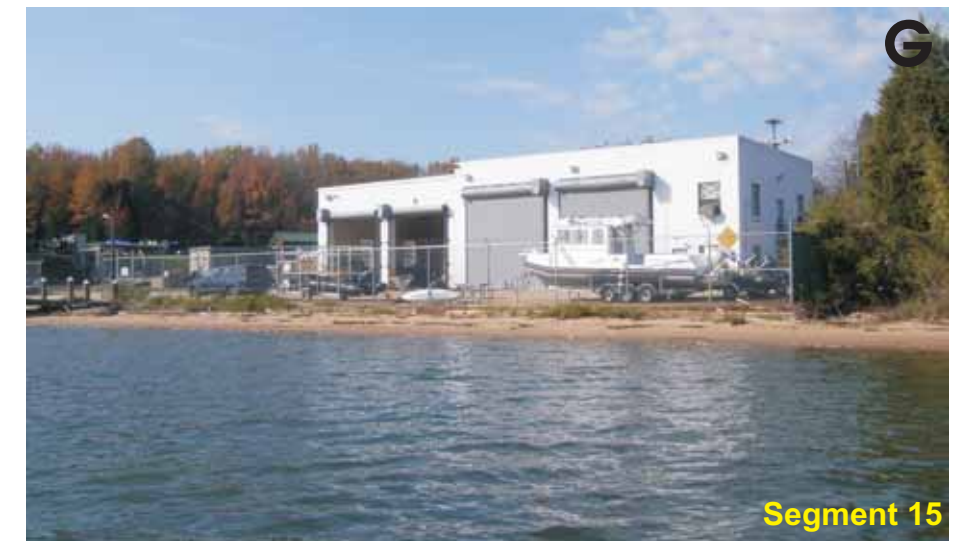
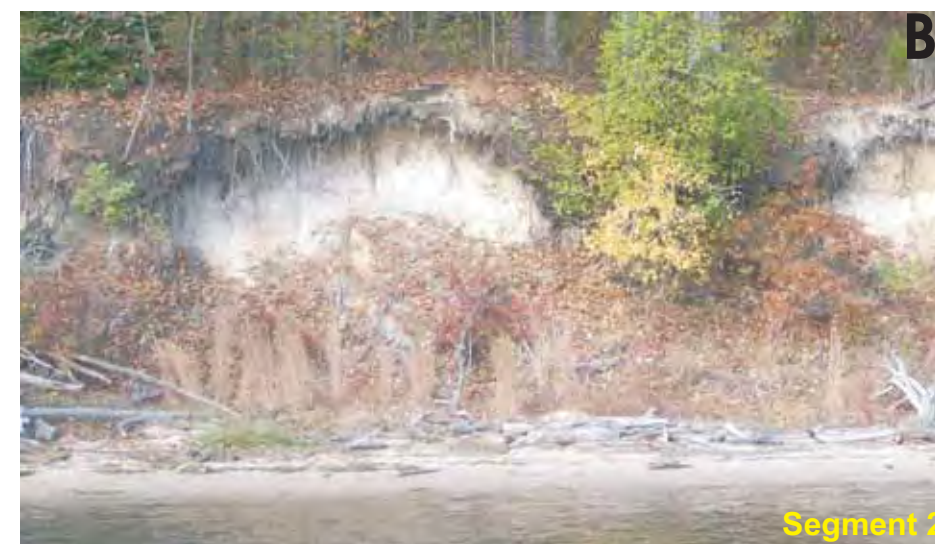
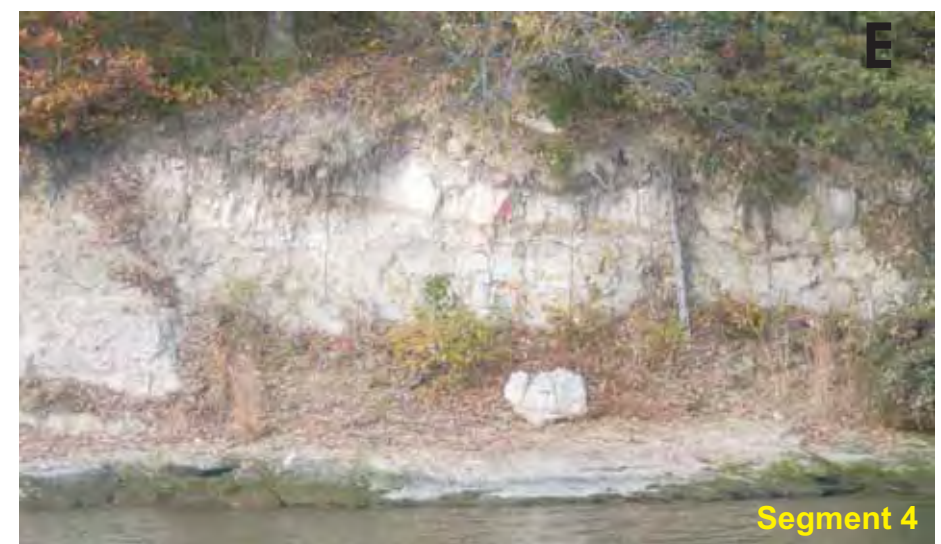
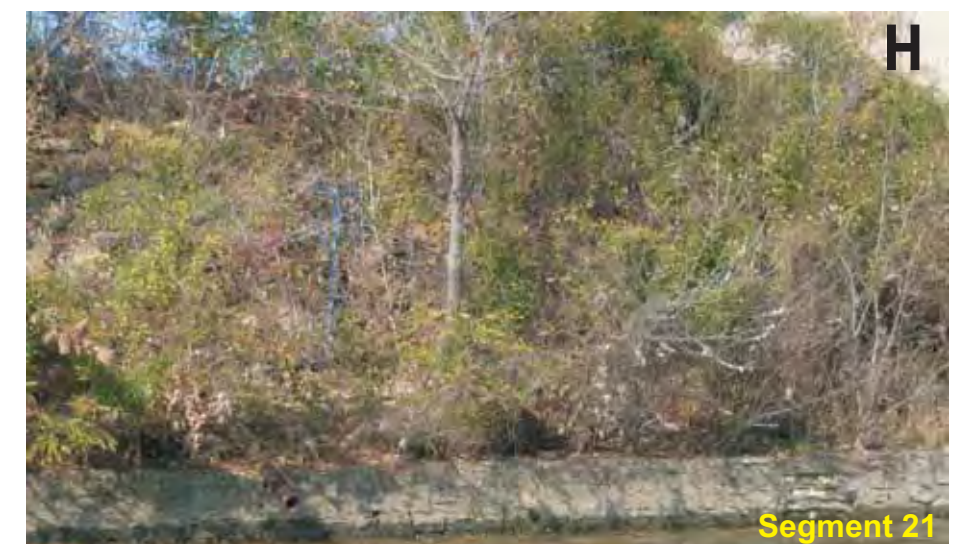
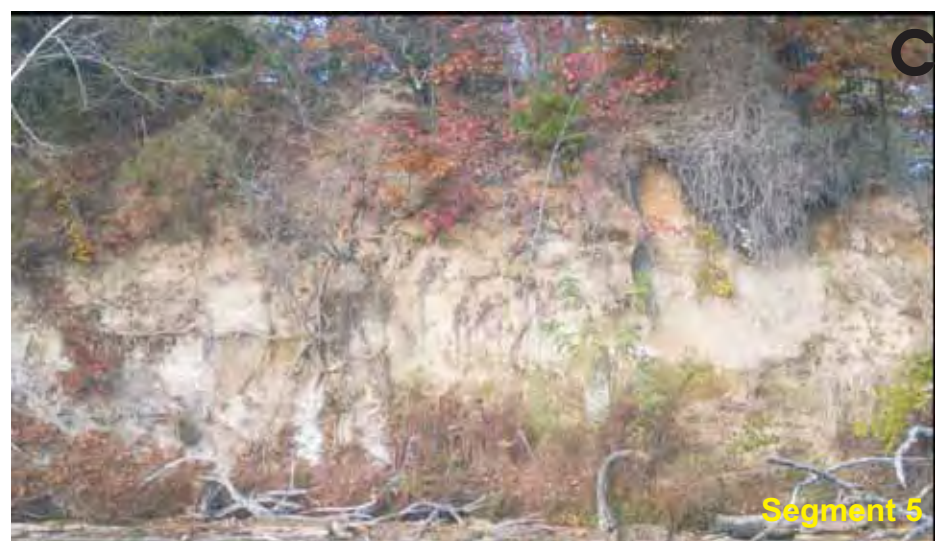
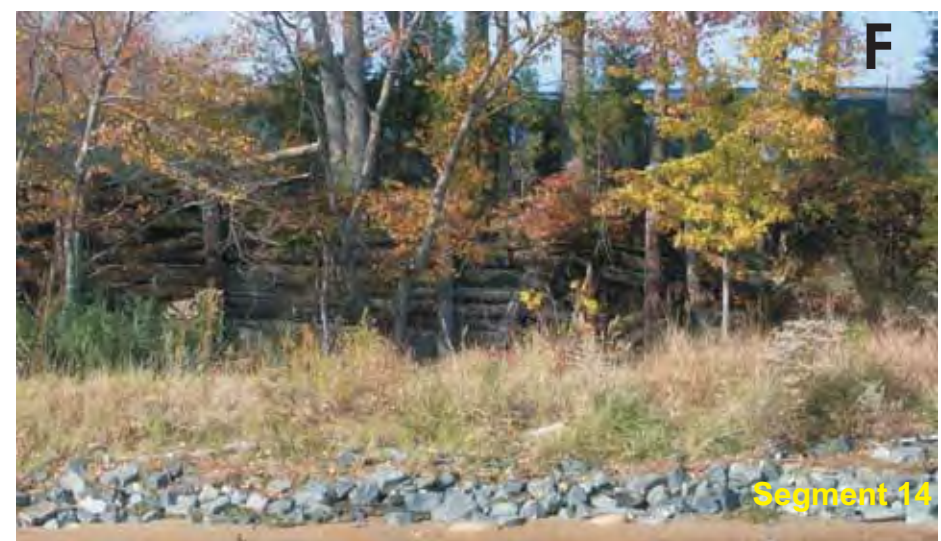
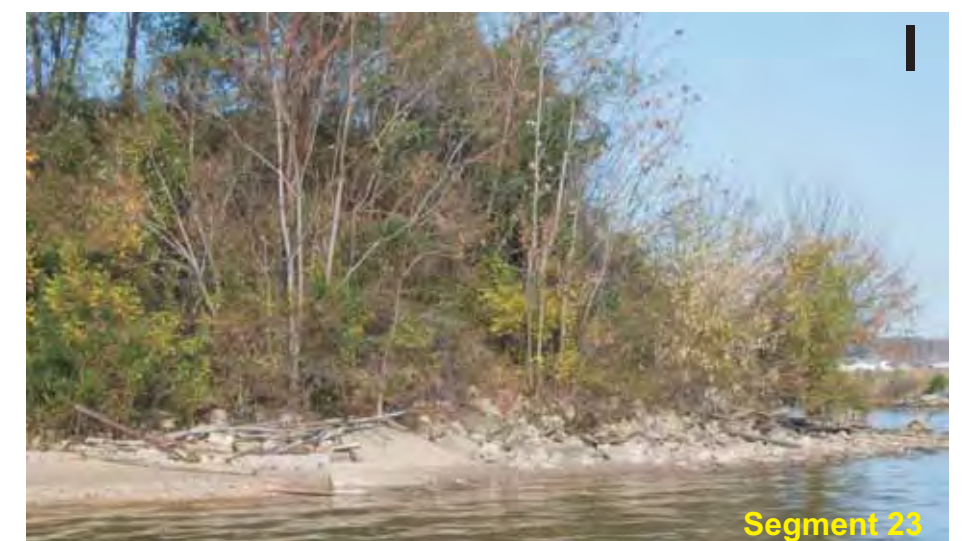
Figure 5-3. Photos taken along Quantico's shoreline in Reach 1. Photos taken on 5 Nov 2009 by VIMS personnel.

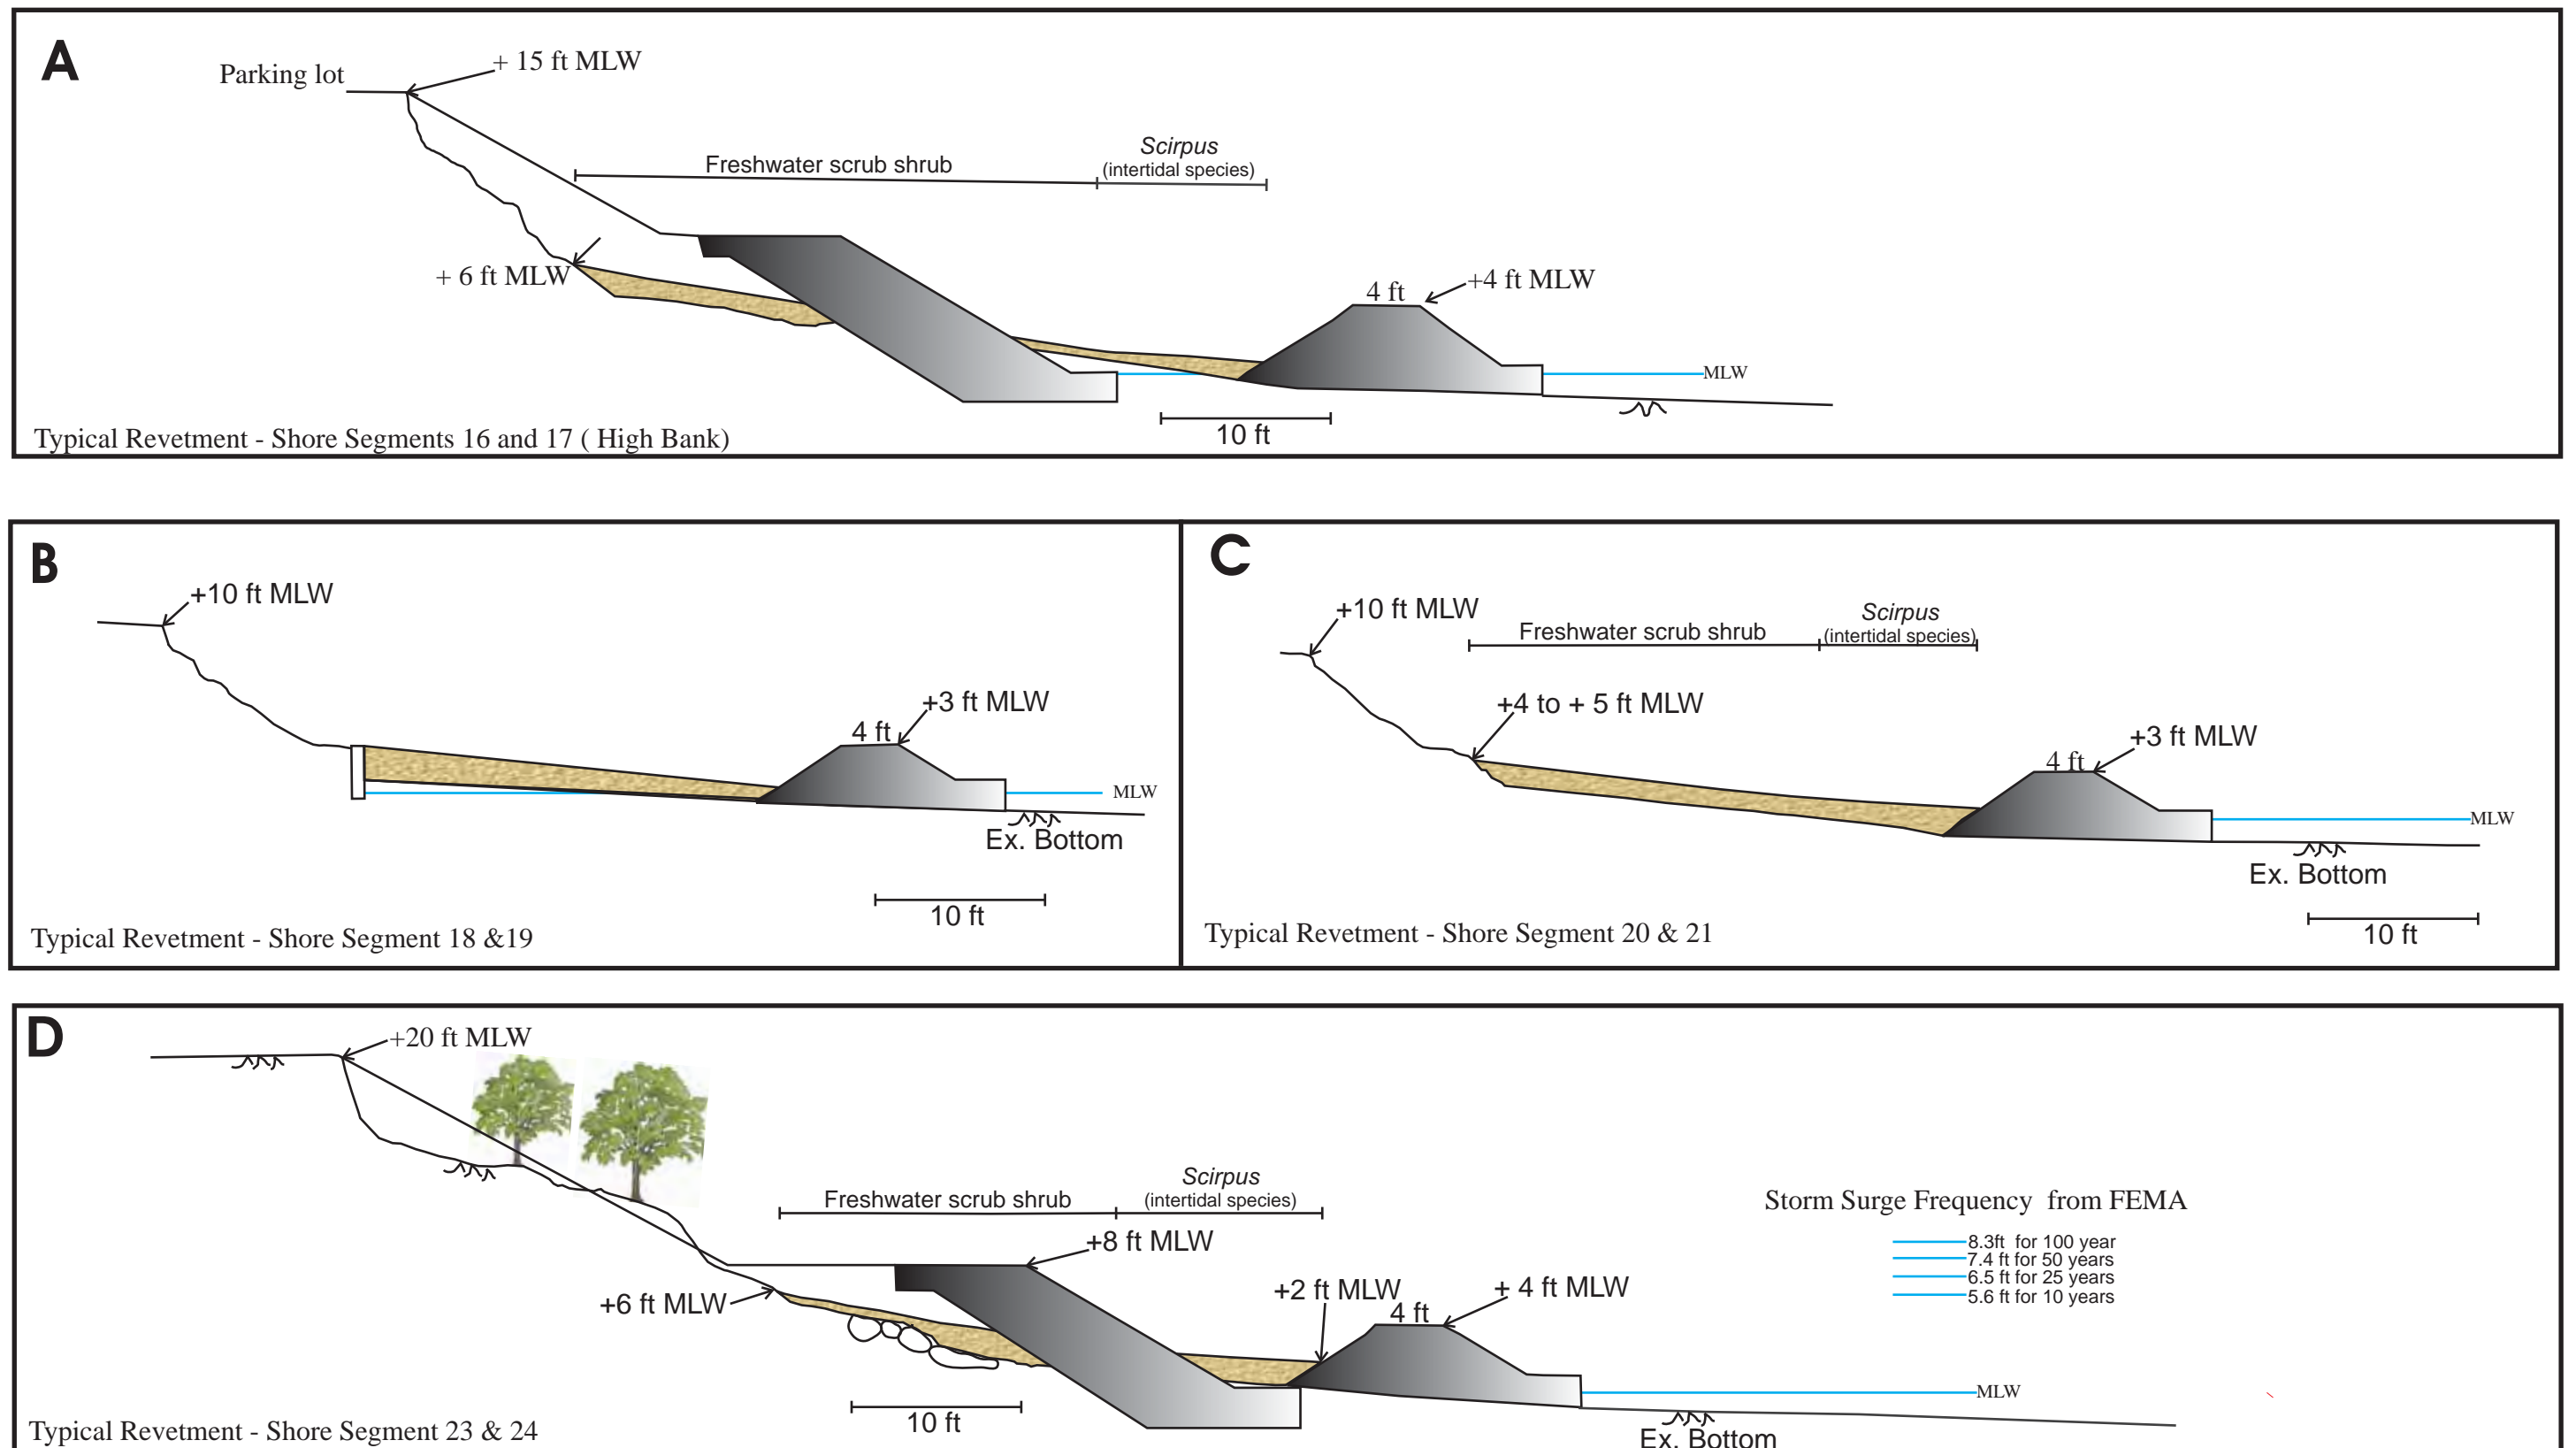
Figure 5-5. Shore management strategy cross-sections for Reach 1B.

proximity of the parking lots to the top of the bank, a sill would be appropriate and recommended for Segment 17. However, to insure bank protection on Segment 16 a revetment is the preferred strategy ([Figure 5-5A](#)).

The upland bank drops down to + 8 MLW beginning at Segment 18 where a sloping concrete wall occurs. Although in fair condition, the wall is old and signs of deterioration are evident along its base. "Do Nothing" is an option, but a low sill would soften the hard edge and provide scour protection the base. At Segment 19 the bank drops to about +5 ft MLW and the shore is protected with low stone and concrete walls which are old and could benefit from armoring the face with rock or a low sill system ([Figure 5-5B](#)).

The upland bank rises to about + 10 along Segment 20 where the base of bank is undercut and erosive. A sill is proposed ([Figure 5-5C](#)). In Segment 21, a low stone wall protects a stable upland bank face. Again the wall is old but still in fair conditions. "Do Nothing" is an option or the sill could be extended. Along shore Segment 22, a crib wall appears to be in good condition and is protecting the bank. Along shore Segment 23, the base of bank is transitional with a transitional to stable, but steep, top of bank. However, about midway alongshore, the upland bank, now about + 20 feet MLW, has a parking lot near the top of the bank. Here a sill or revetment is proposed ([Figure 5-5D](#)). A revetment might require excavating the bank slump, and a more detailed geotechnical analysis is recommended.

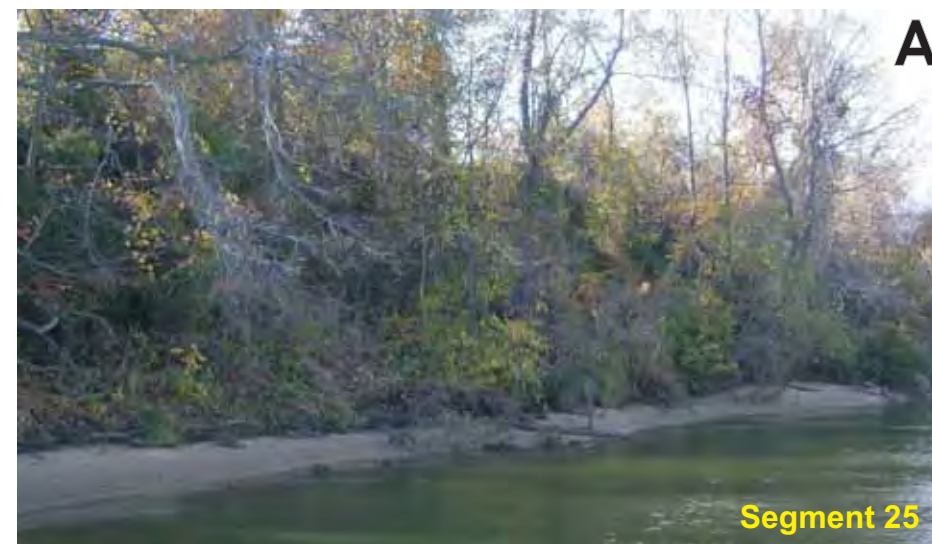
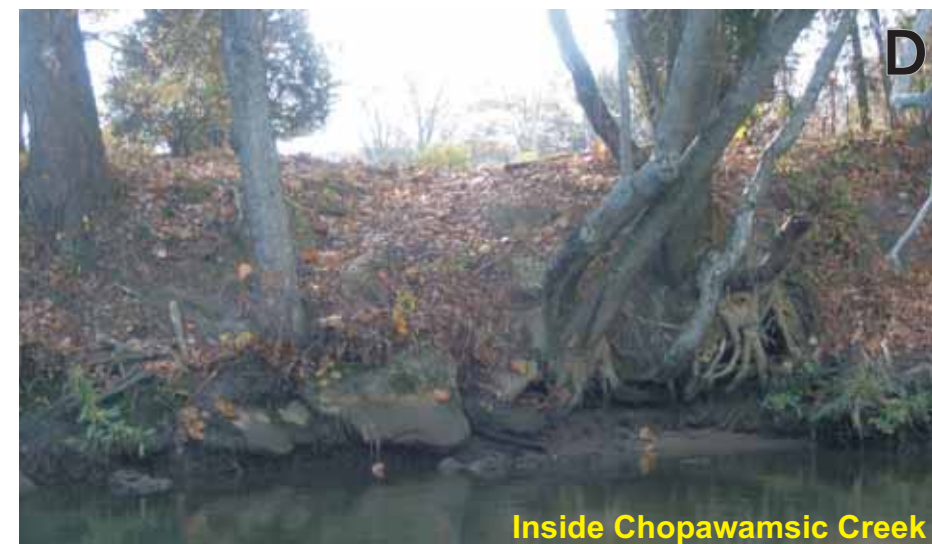
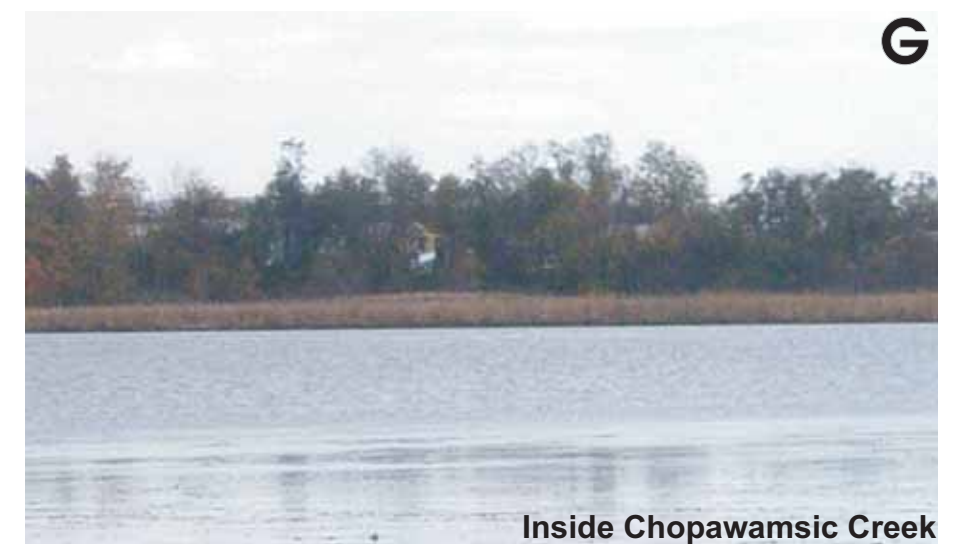
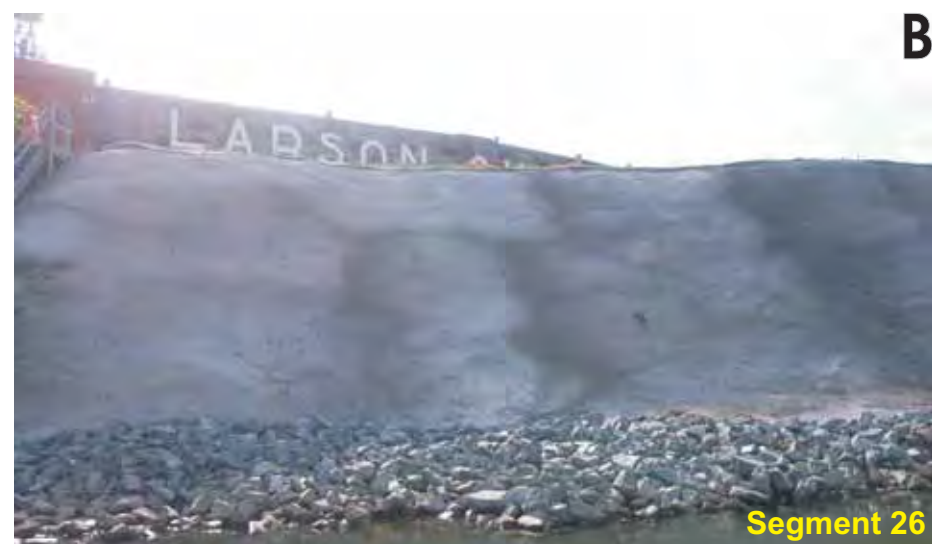
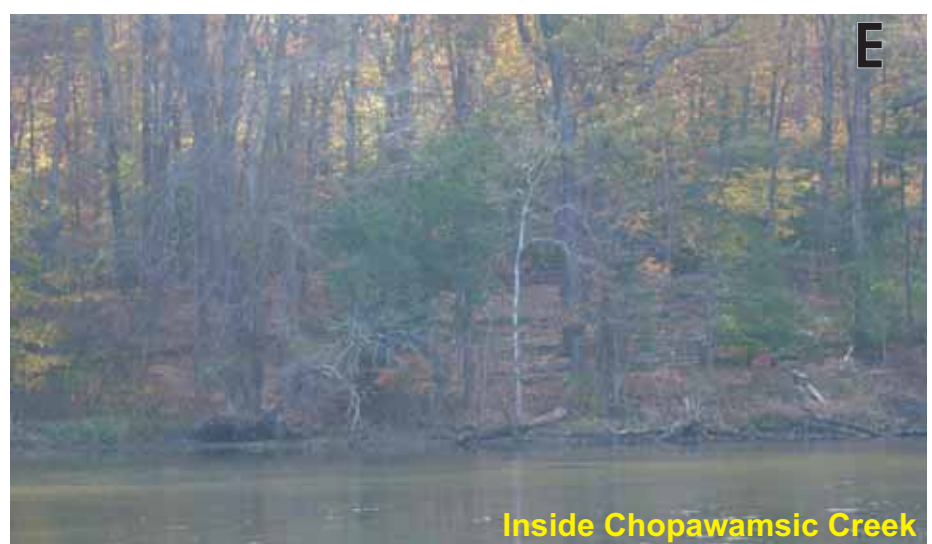
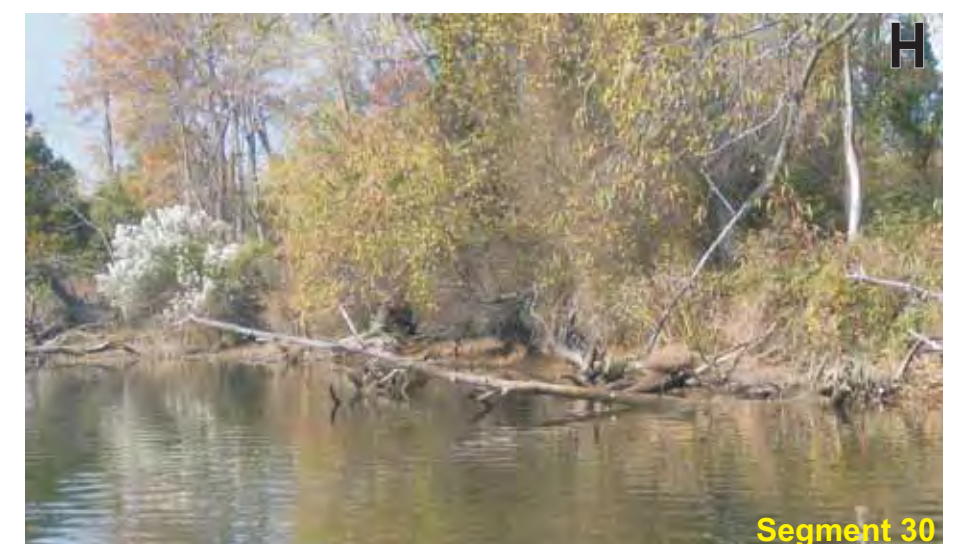
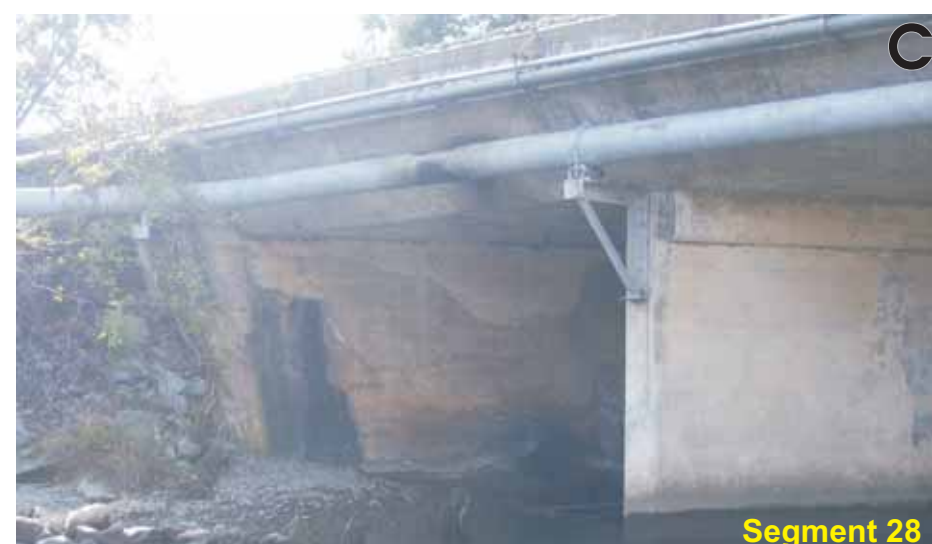
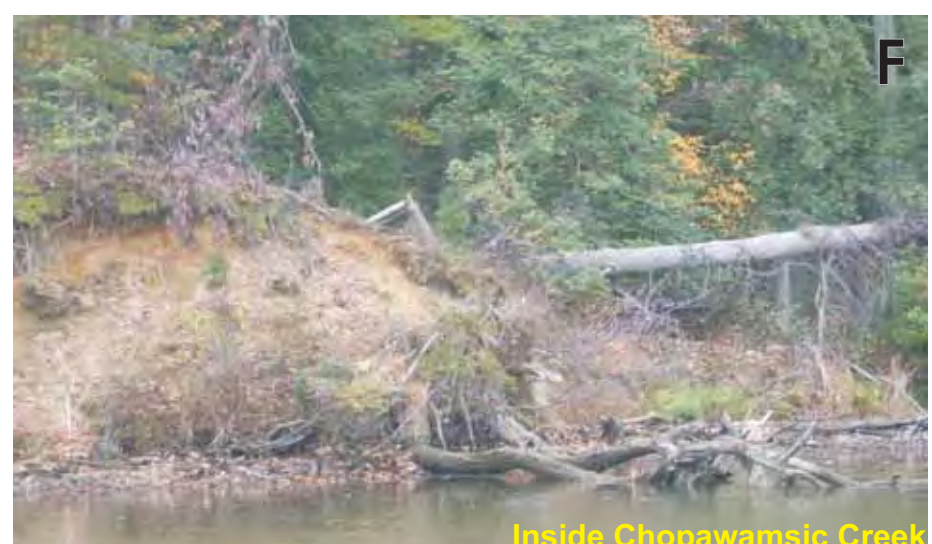
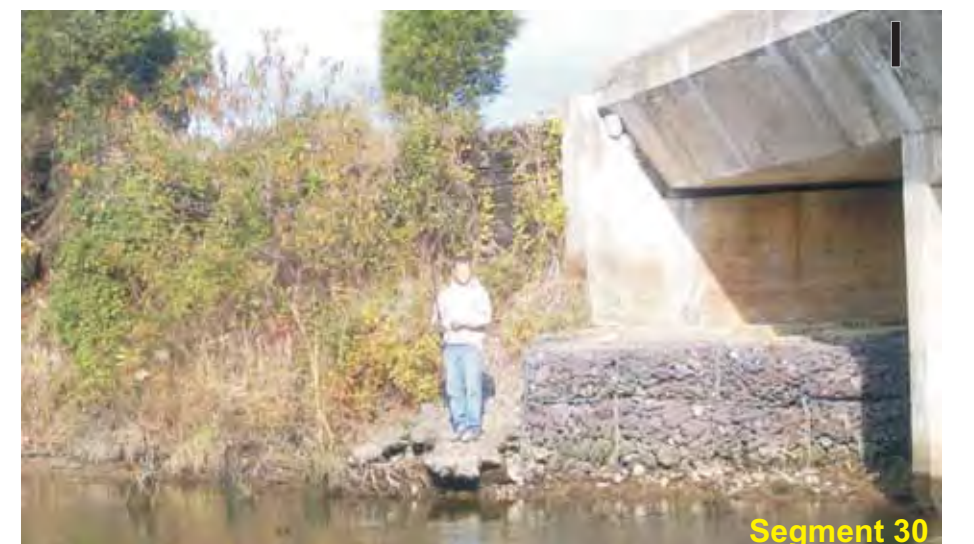
bridge abutment is bolstered by gabions (Figure 6-2I). For the remainder of Reach2C, Segment 31 has been armored with stone (Figure 6-2J) and part of Segment 32 has scattered broken concrete alongshore and intermittently eroding upland banks (Figure 6-2K).

Figure 6-2. Photos taken along Quantico's shoreline in Reach 2. Photos taken on 5 Nov 2009 by VIMS personnel.

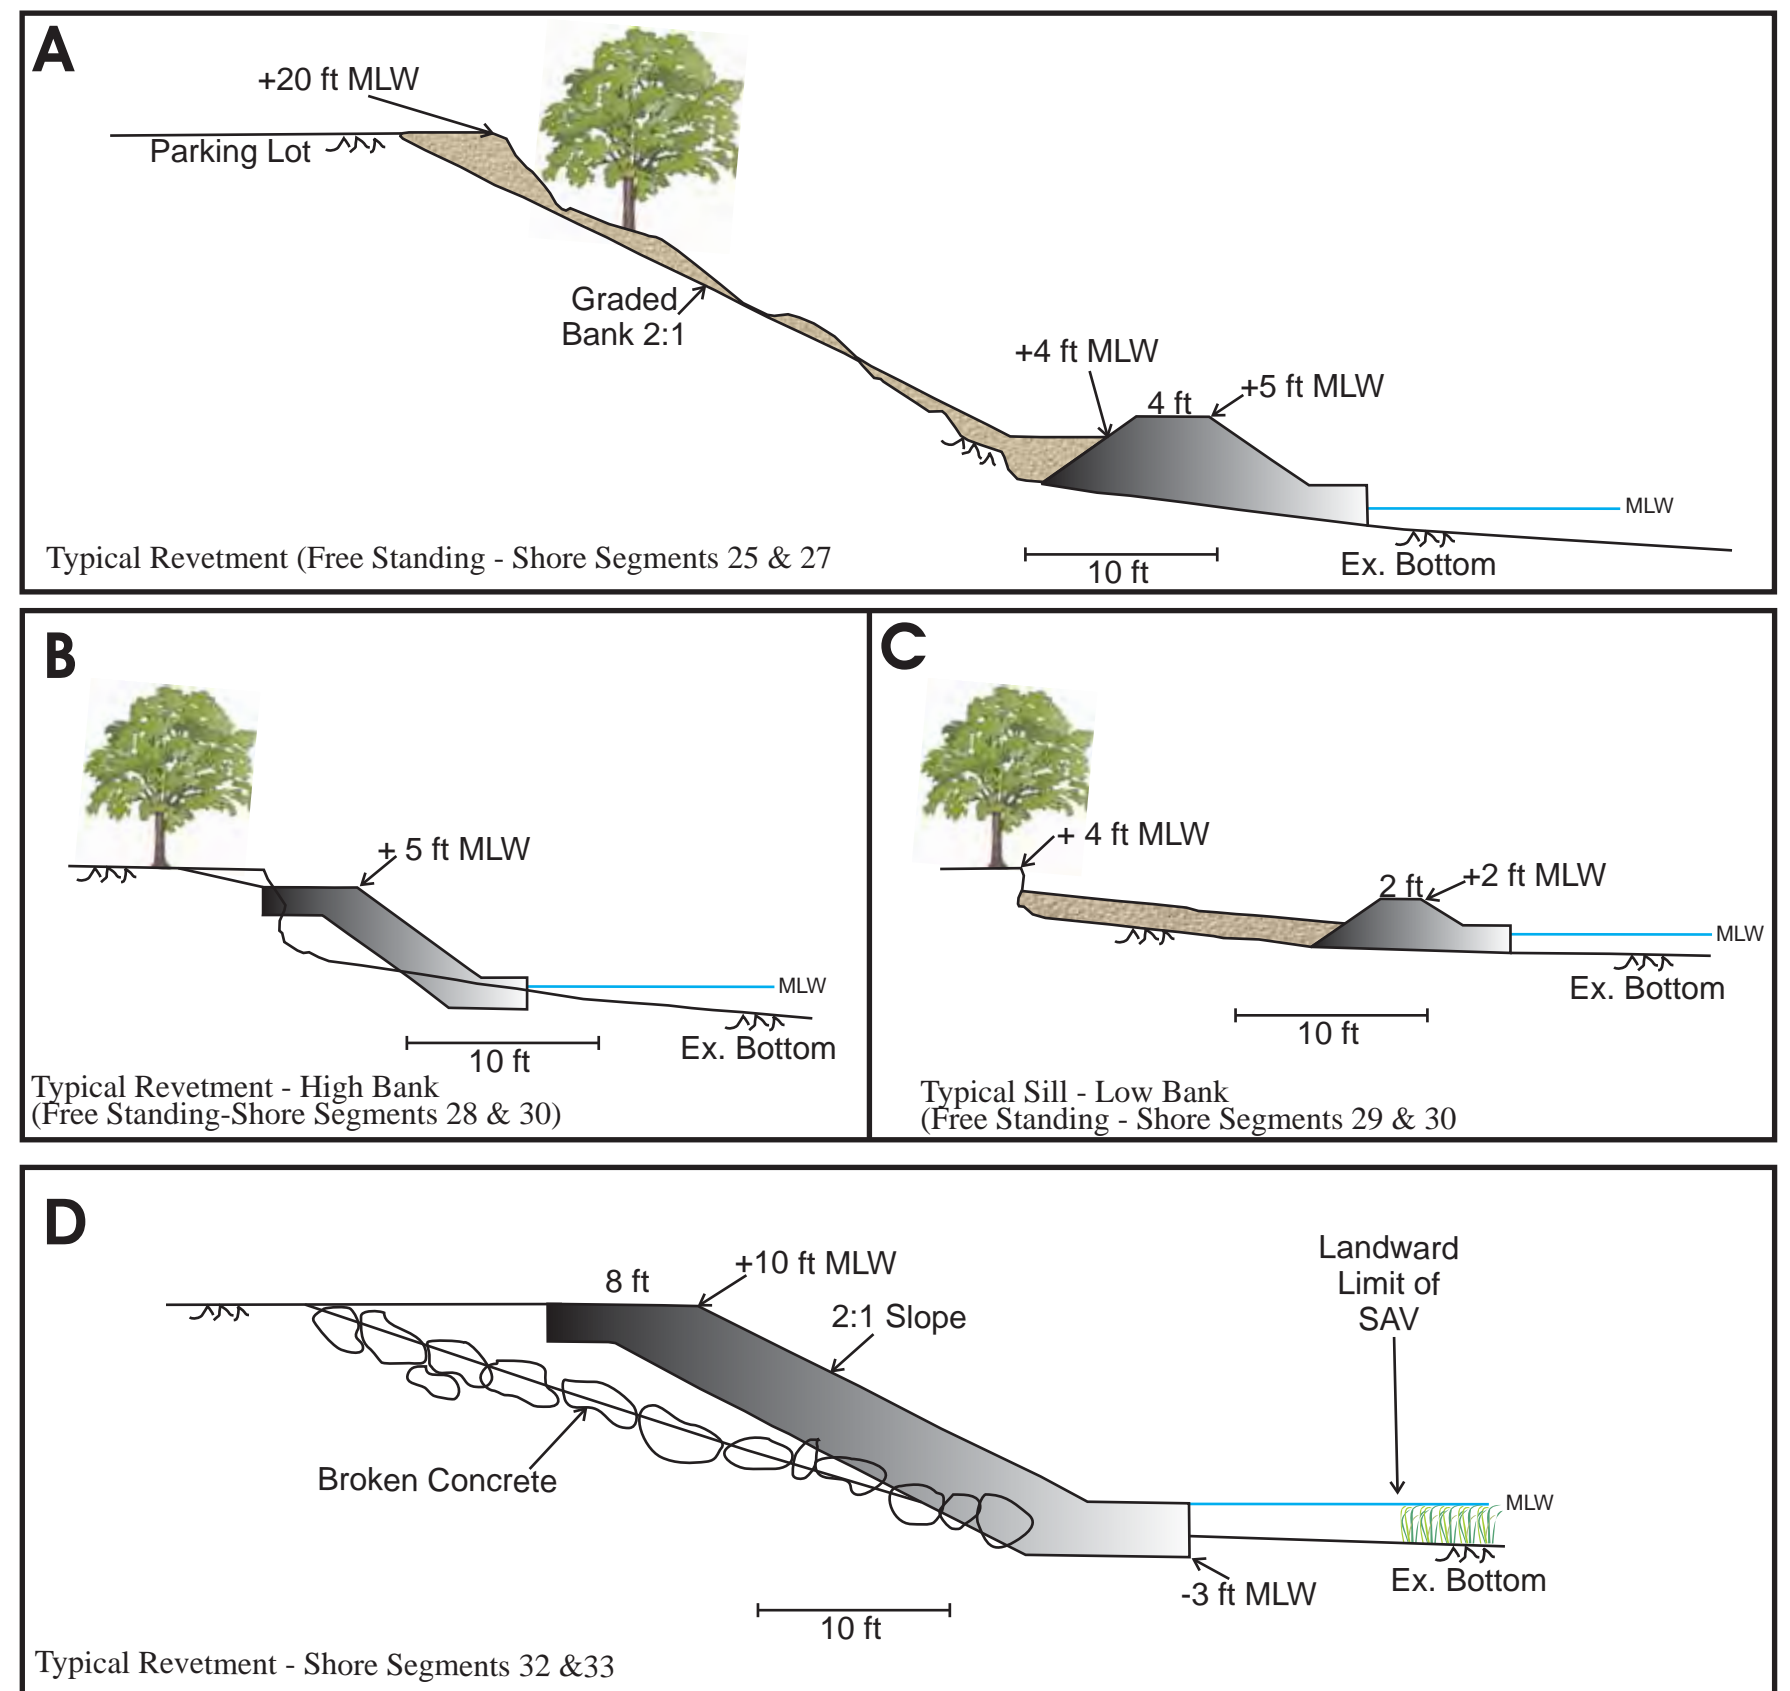
Figure 6-3. Cross-sections of typical structures for Reach 2.

For Reach 2C the low banks on the north shore would continue to erode at a slow rate if nothing is done. Alternatively, the lower banks could use a low sill (Figure 6-3C) and the higher banks with a revetment (Figure 6-3B). The riverward section of Reach 2C, Segment 31, has been protected with riprap both new (Figure 6-2J) and old (Figure 6-2I). At the beginning of Segment 32, old broken concrete is deteriorating and does not offer proper shore protection (Figure 6-2K) as evidenced by continued bank erosion. “Rearmoring” the bank with stone would provide for long term-shore protection (Figure 6-3D).

The long-term option for Segment 32 and 33 would be to rework the existing broken concrete and add armor stone as discussed in previous section (Figure 6-3D). This would provide predictable protection for the exposed airfield coast that would be designed to withstand a 100-year storm.

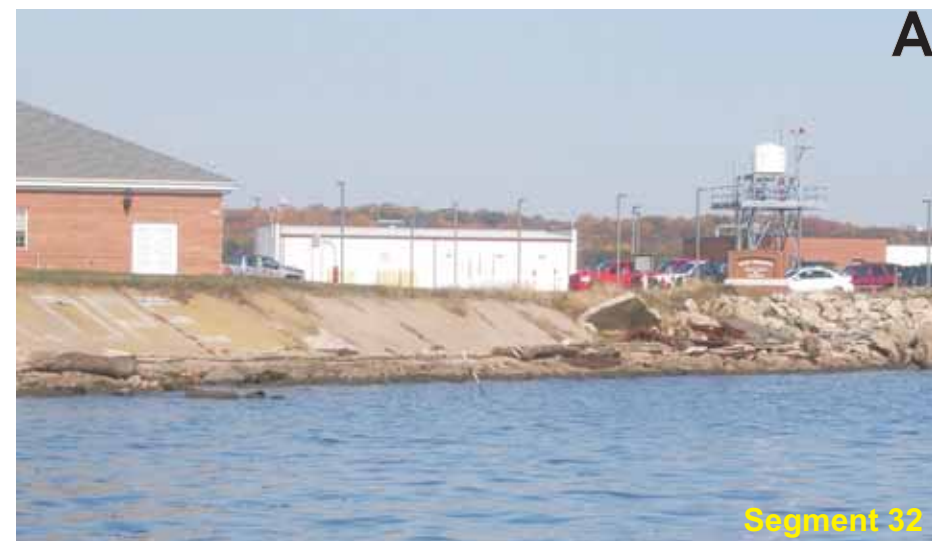
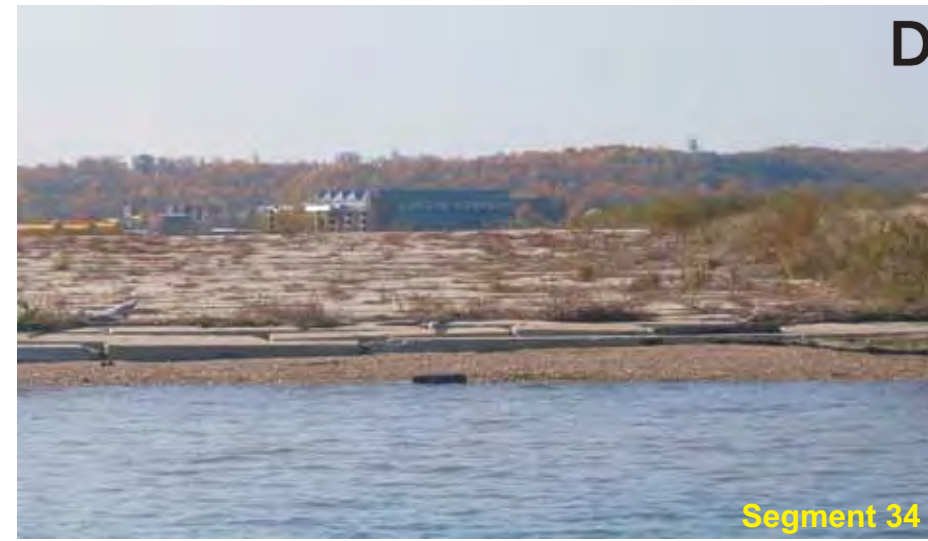
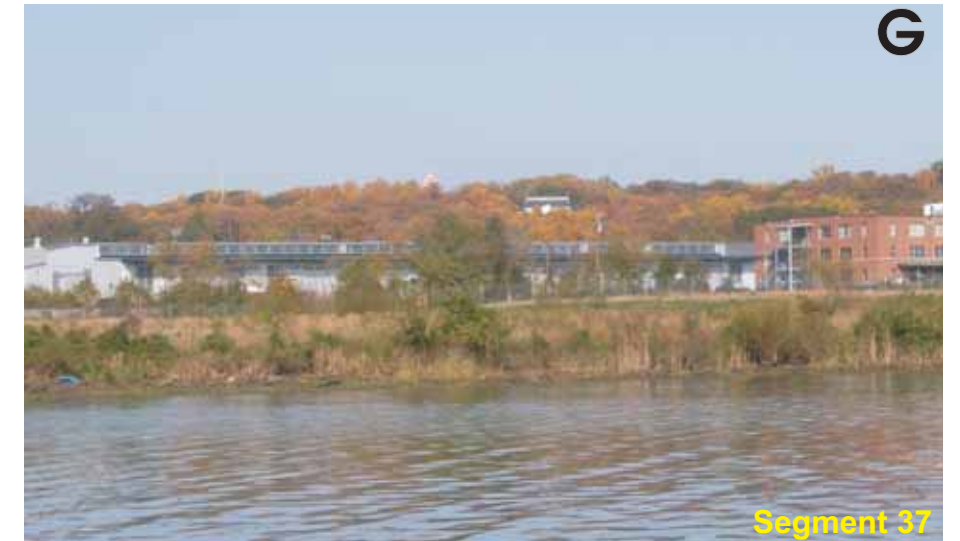
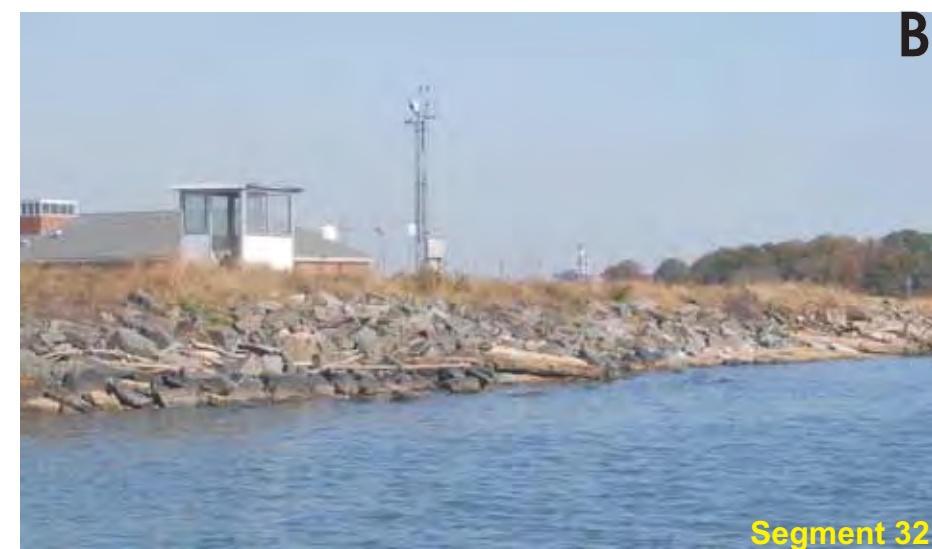
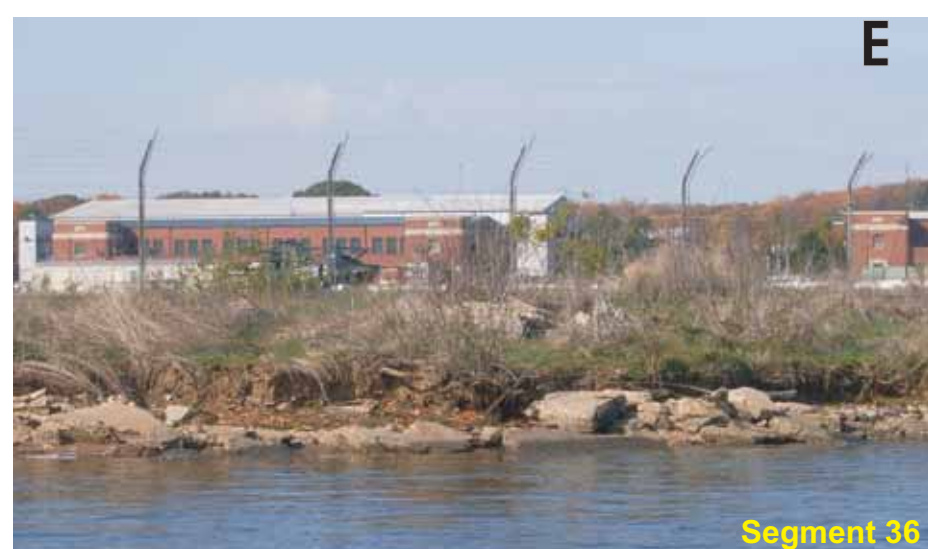
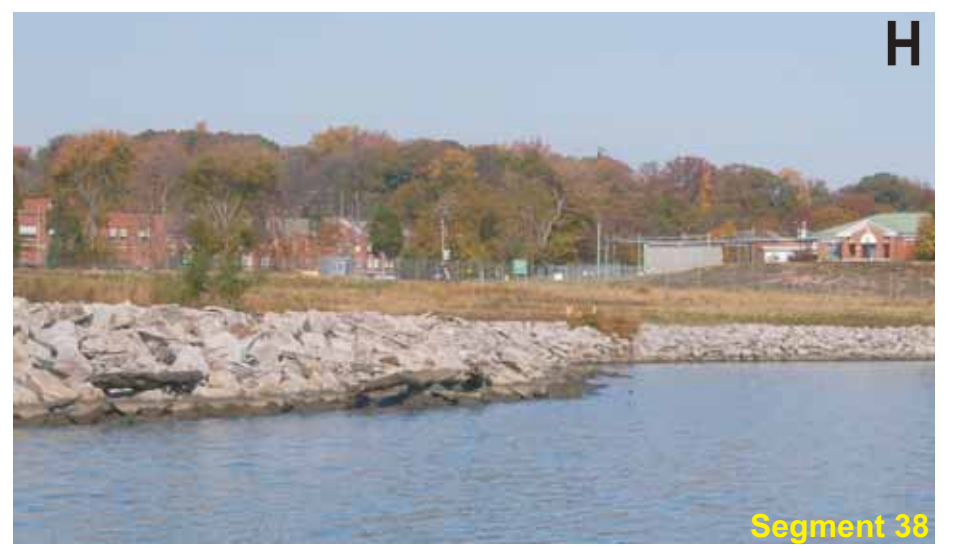
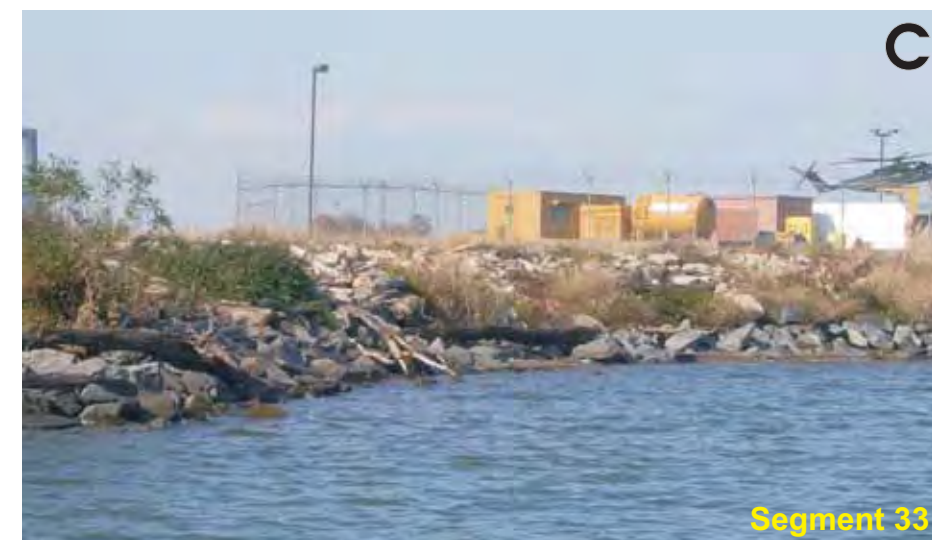
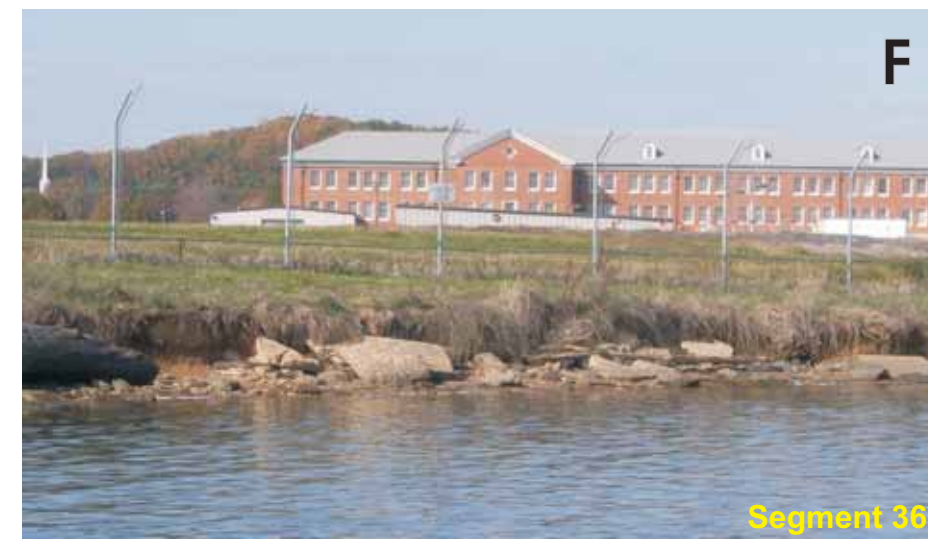
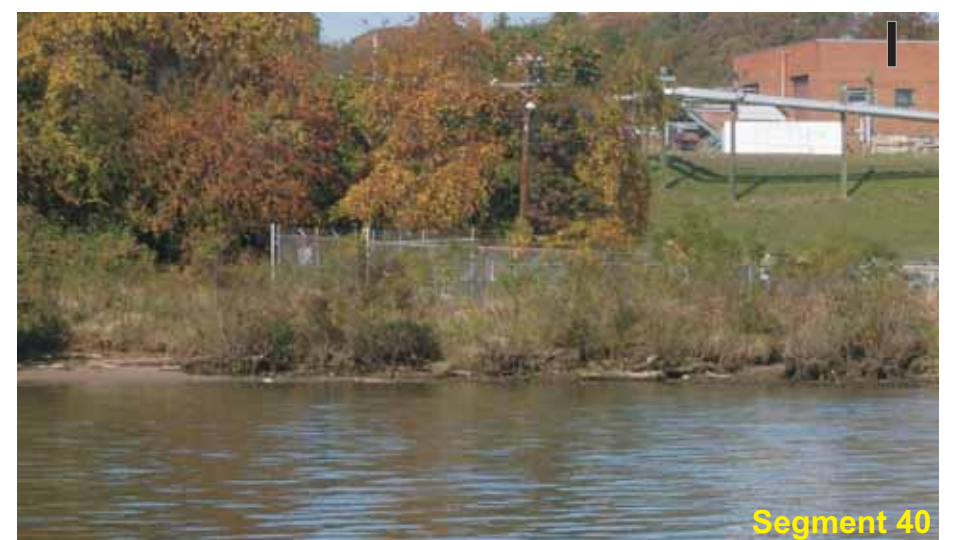
The Reach 3 shoreline has mostly been hardened or otherwise modified over time by filling. Reach 3A has been protected by various materials mostly broken concrete and rock. The bank height is fairly constant at about +10 ft MLW along most of Segment 32. A runway intersects the shore about half way along Segment 32 (Figure 7-3A). The broken concrete used along the upland bank is randomly-placed and occasionally intermixed with rock (Figure 7-3B) but functioning as shore protection nevertheless. However, it is not an engineered structure and there are many voids and inconsistencies.

At the boundary between Segment 32 and 33, the upland bank is characterized with mostly rock along the base, broken concrete along top with a grassy swath in between (Figure 7-3C). An LCAC landing ramp is the approximate boundary between Segments 33 and 34 and consists of a series of parallel concrete beams on grade (Figure 7-3D). The bank elevation drops to about +5 ft MLW to the end of Reach 3A, Segments 34, 35 and 36 where a broken concrete and unprotected erosional low banks (Figures 7-3E and 7-3F).

Reach 3B includes Segment 37, a low unprotected marshy shoreline that is eroding (Figure 7-3G) and Segment 38 which has been armored with a stone revetment (Figure 7-3H). Reach 3C is a low eroding marshy shoreline (Figure 7-3I) with a small stone wall (Figure 7-3J) on Segments 39 and 40. Segment 41 is very low with scattered pieces of broken concrete (Figure 7-3K). The bank rises to more than 10 feet on Segment 42 with a small beach and relatively wide backshore (Figure 7-3L). More broken concrete occurs along the base of the upland banks in Segments 43 and 44. The bank face is relatively stable with vegetation but steep with leaning trees, evidence of slow bank creep (Figure 7-3M).

Reach 3D begins with a concrete/stone wall on Segment 45 (Figure 7-3O) which continues for about 2,400 feet. The wall is in fair to good condition (Figure 7-3P) along most of its length. There is a Base landmark, the Wisdom Tree, which is perched on the bank (Figure 7-3N). Numerous weep holes help relieve hydrostatic pressure from upland runoff and groundwater. The wall ends and Segment 46 where a very low bank (Figure 7-3Q) and small embayment begins. Broken concrete along the shore continues across Segment 47 (Figure 7-3R) to the marina. The marina shore is protected by a bulkhead, and the docks are protected from wave action by a concrete wall (Figure 7-3S) on the south and large dock on the north, Segment 48 (Figure 7-3T). The marina marks the end of Reach 3.

Figure 7-3. Photos taken along Quantico's shoreline in Reach 3. Photos taken on 5 Nov 2009 by VIMS personnel.
