Marine Corps Base, Quantico Shoreline Protection Plan

Shoreline Studies Program
Virginia Institute of Marine Science
College of William & Mary
Gloucester Point, Virginia

March 2011

Final Report

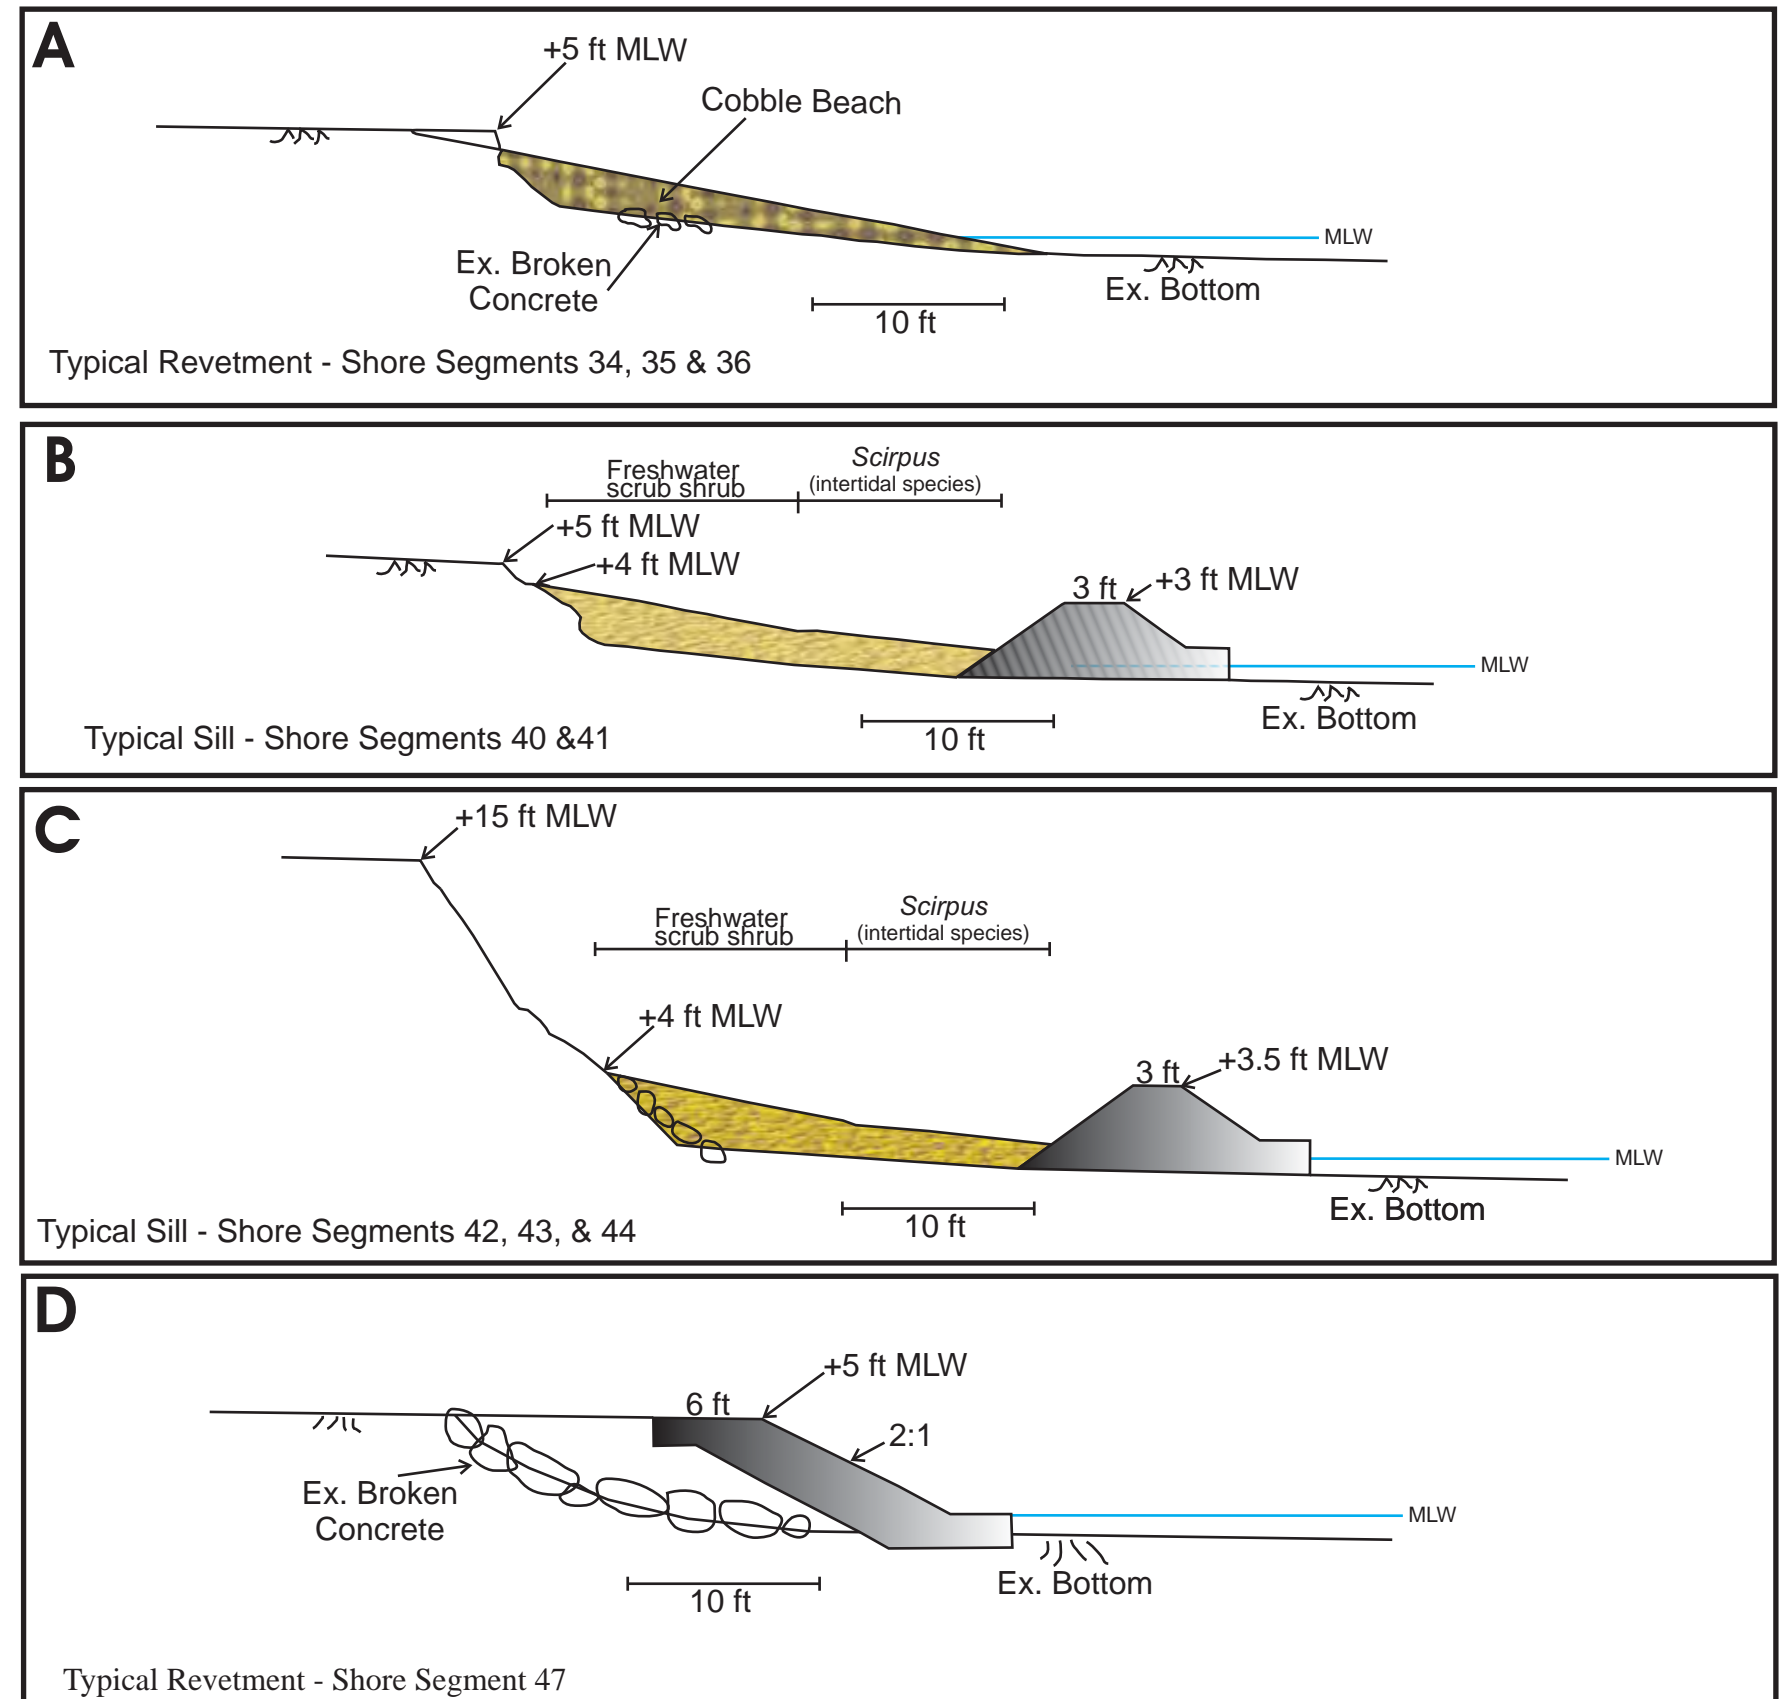
Figure 7-4. Typical cross-sections for recommended structures in Reach 3.

As the shoreline turns into “Chopawamsic Bay,” the bank becomes lower and there is much less broken concrete. Continued slow erosion of the upland can be expected. A coarse cobble beach could be created to protect the low eroding upland bank rather than hardening the shore with a stone revetment. This is proposed for Segments 34, 35 and 36 (Figure 7-4A).

A “Do Nothing” approach would not result in any significant shoreline retreat along Reach 3C because of the intermittent presence of broken concrete. However, this shore provides the opportunity to build “Living Shoreline” marsh sills. This is recommended for Segments 40 and 41 which have a low bank (Figure 7-4B) and Segments 42, 43 and 44 which have high banks (Figure 7-4C).

A spur and some sand fill along the upriver end of Reach 3D will help maintain the small embayment on Segment 46. The remaining coast, Segment 47, could be left alone as broken concrete occurs along the shore or it could be armored for long-term integrity (Figure 7-4D).

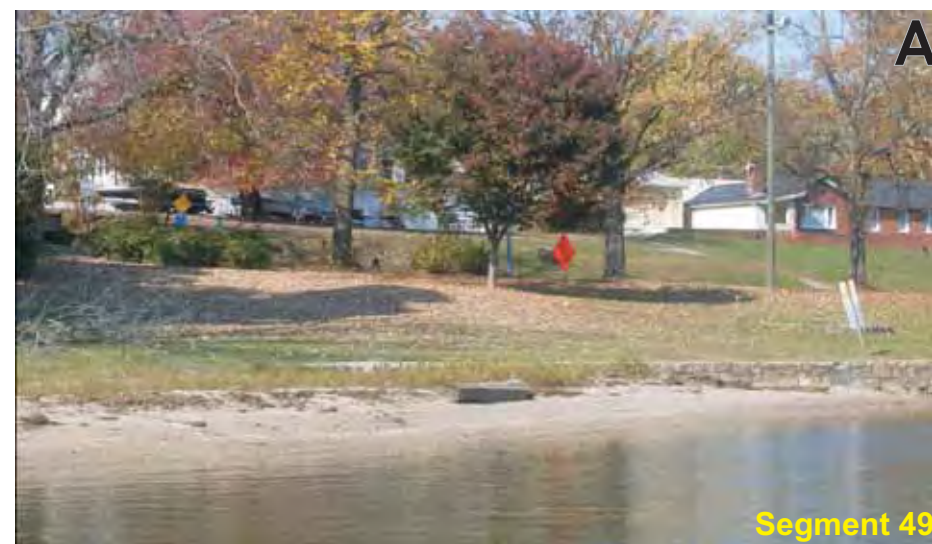
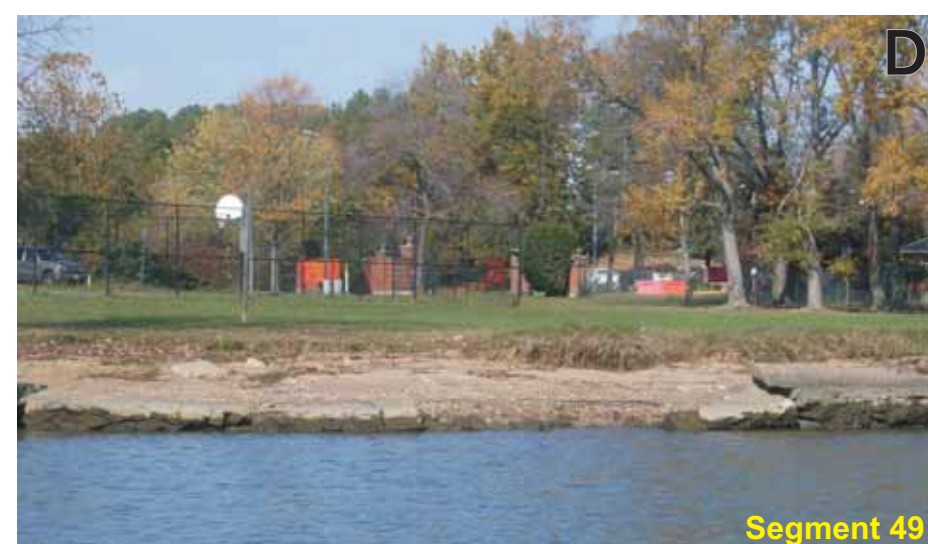
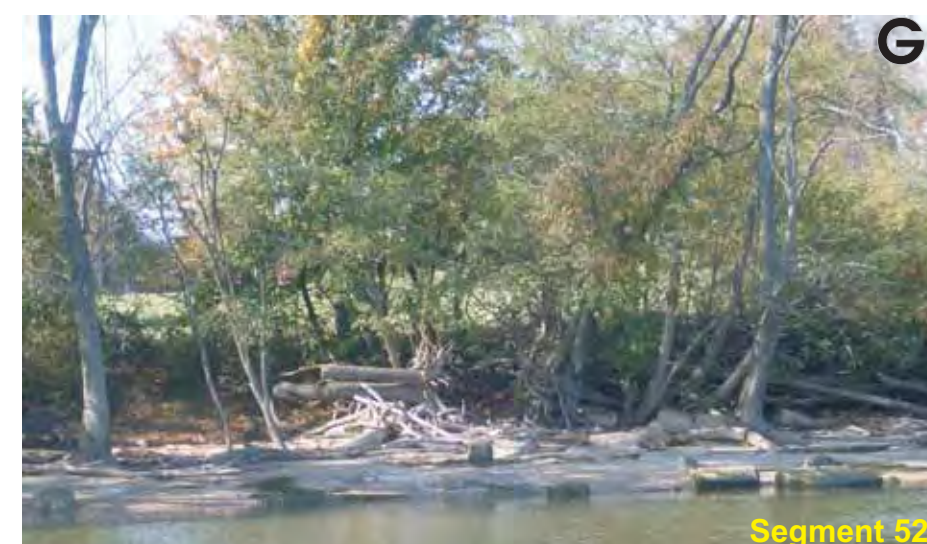
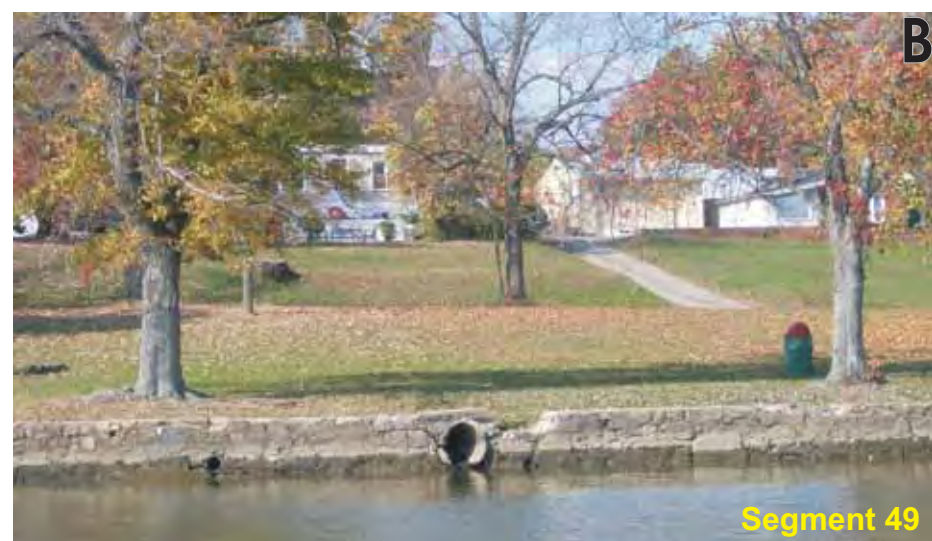
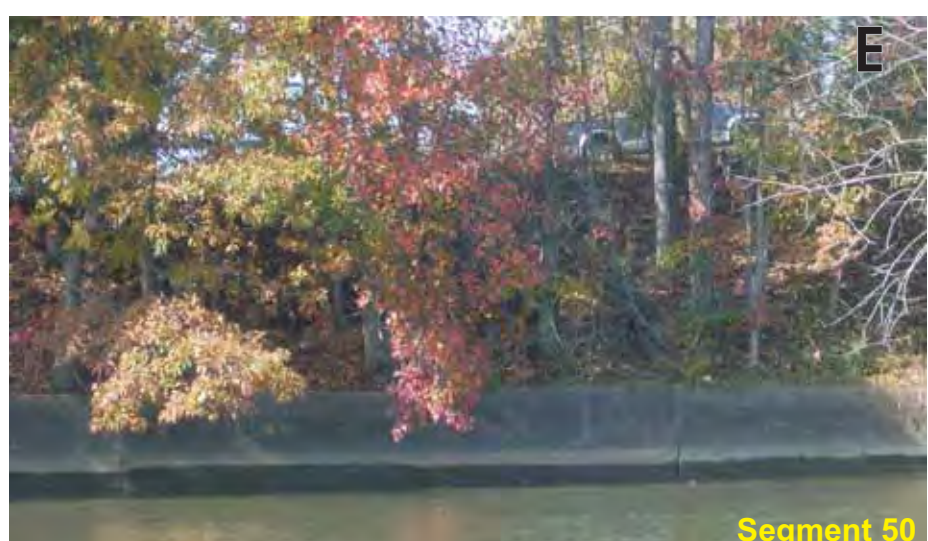
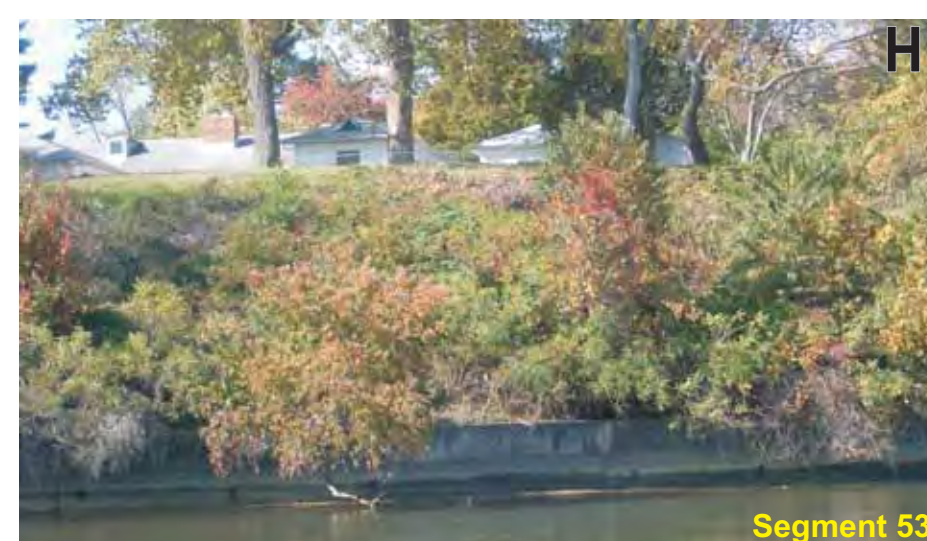
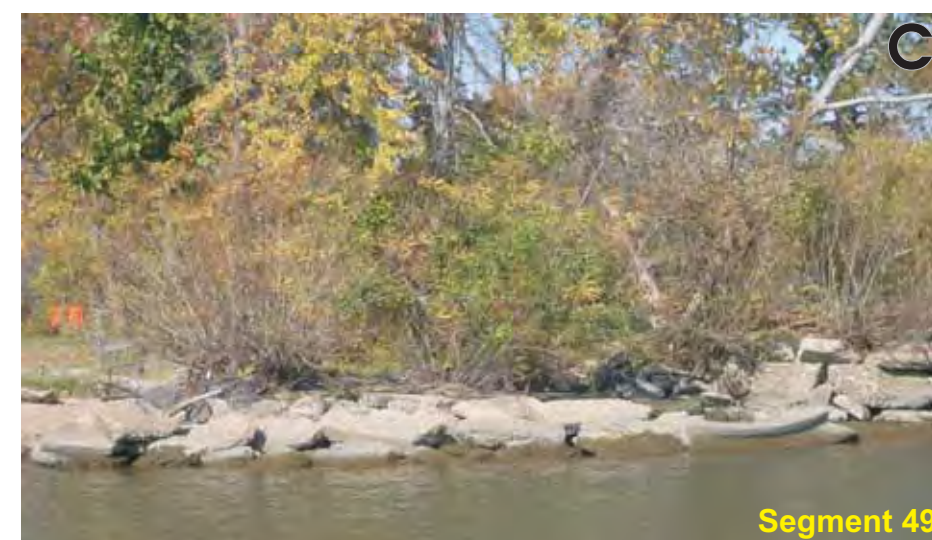
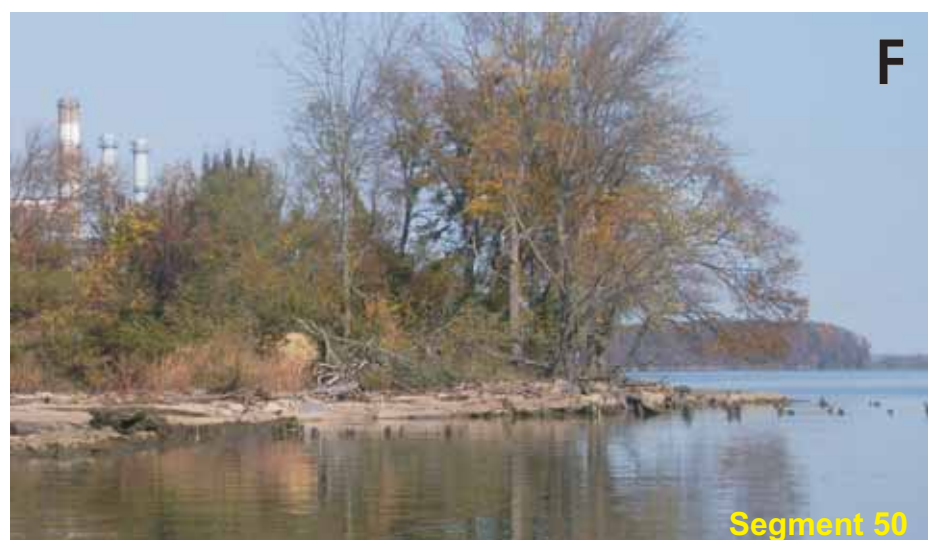
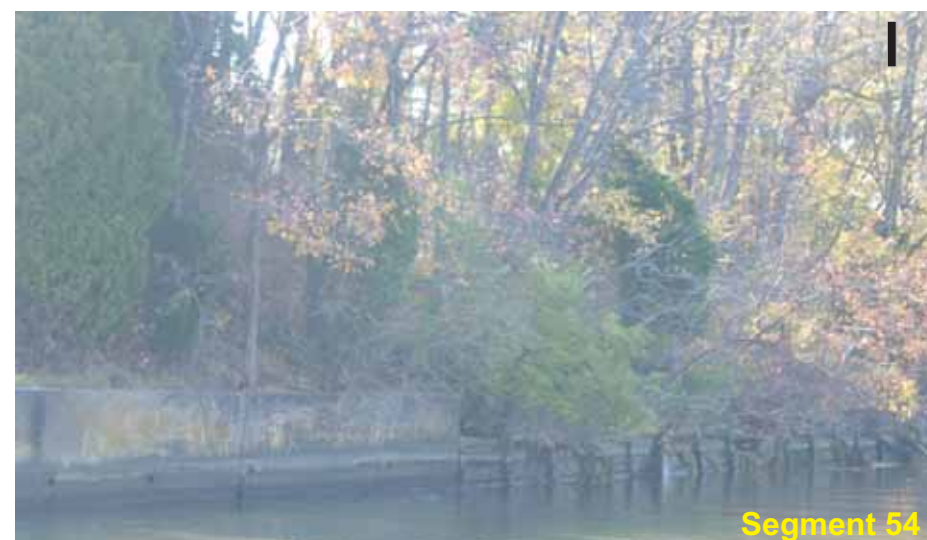
Figure 8-2. Photos taken along Quantico's shoreline in Reach 1. Photos taken on 5 Nov 2009 by VIMS personnel.

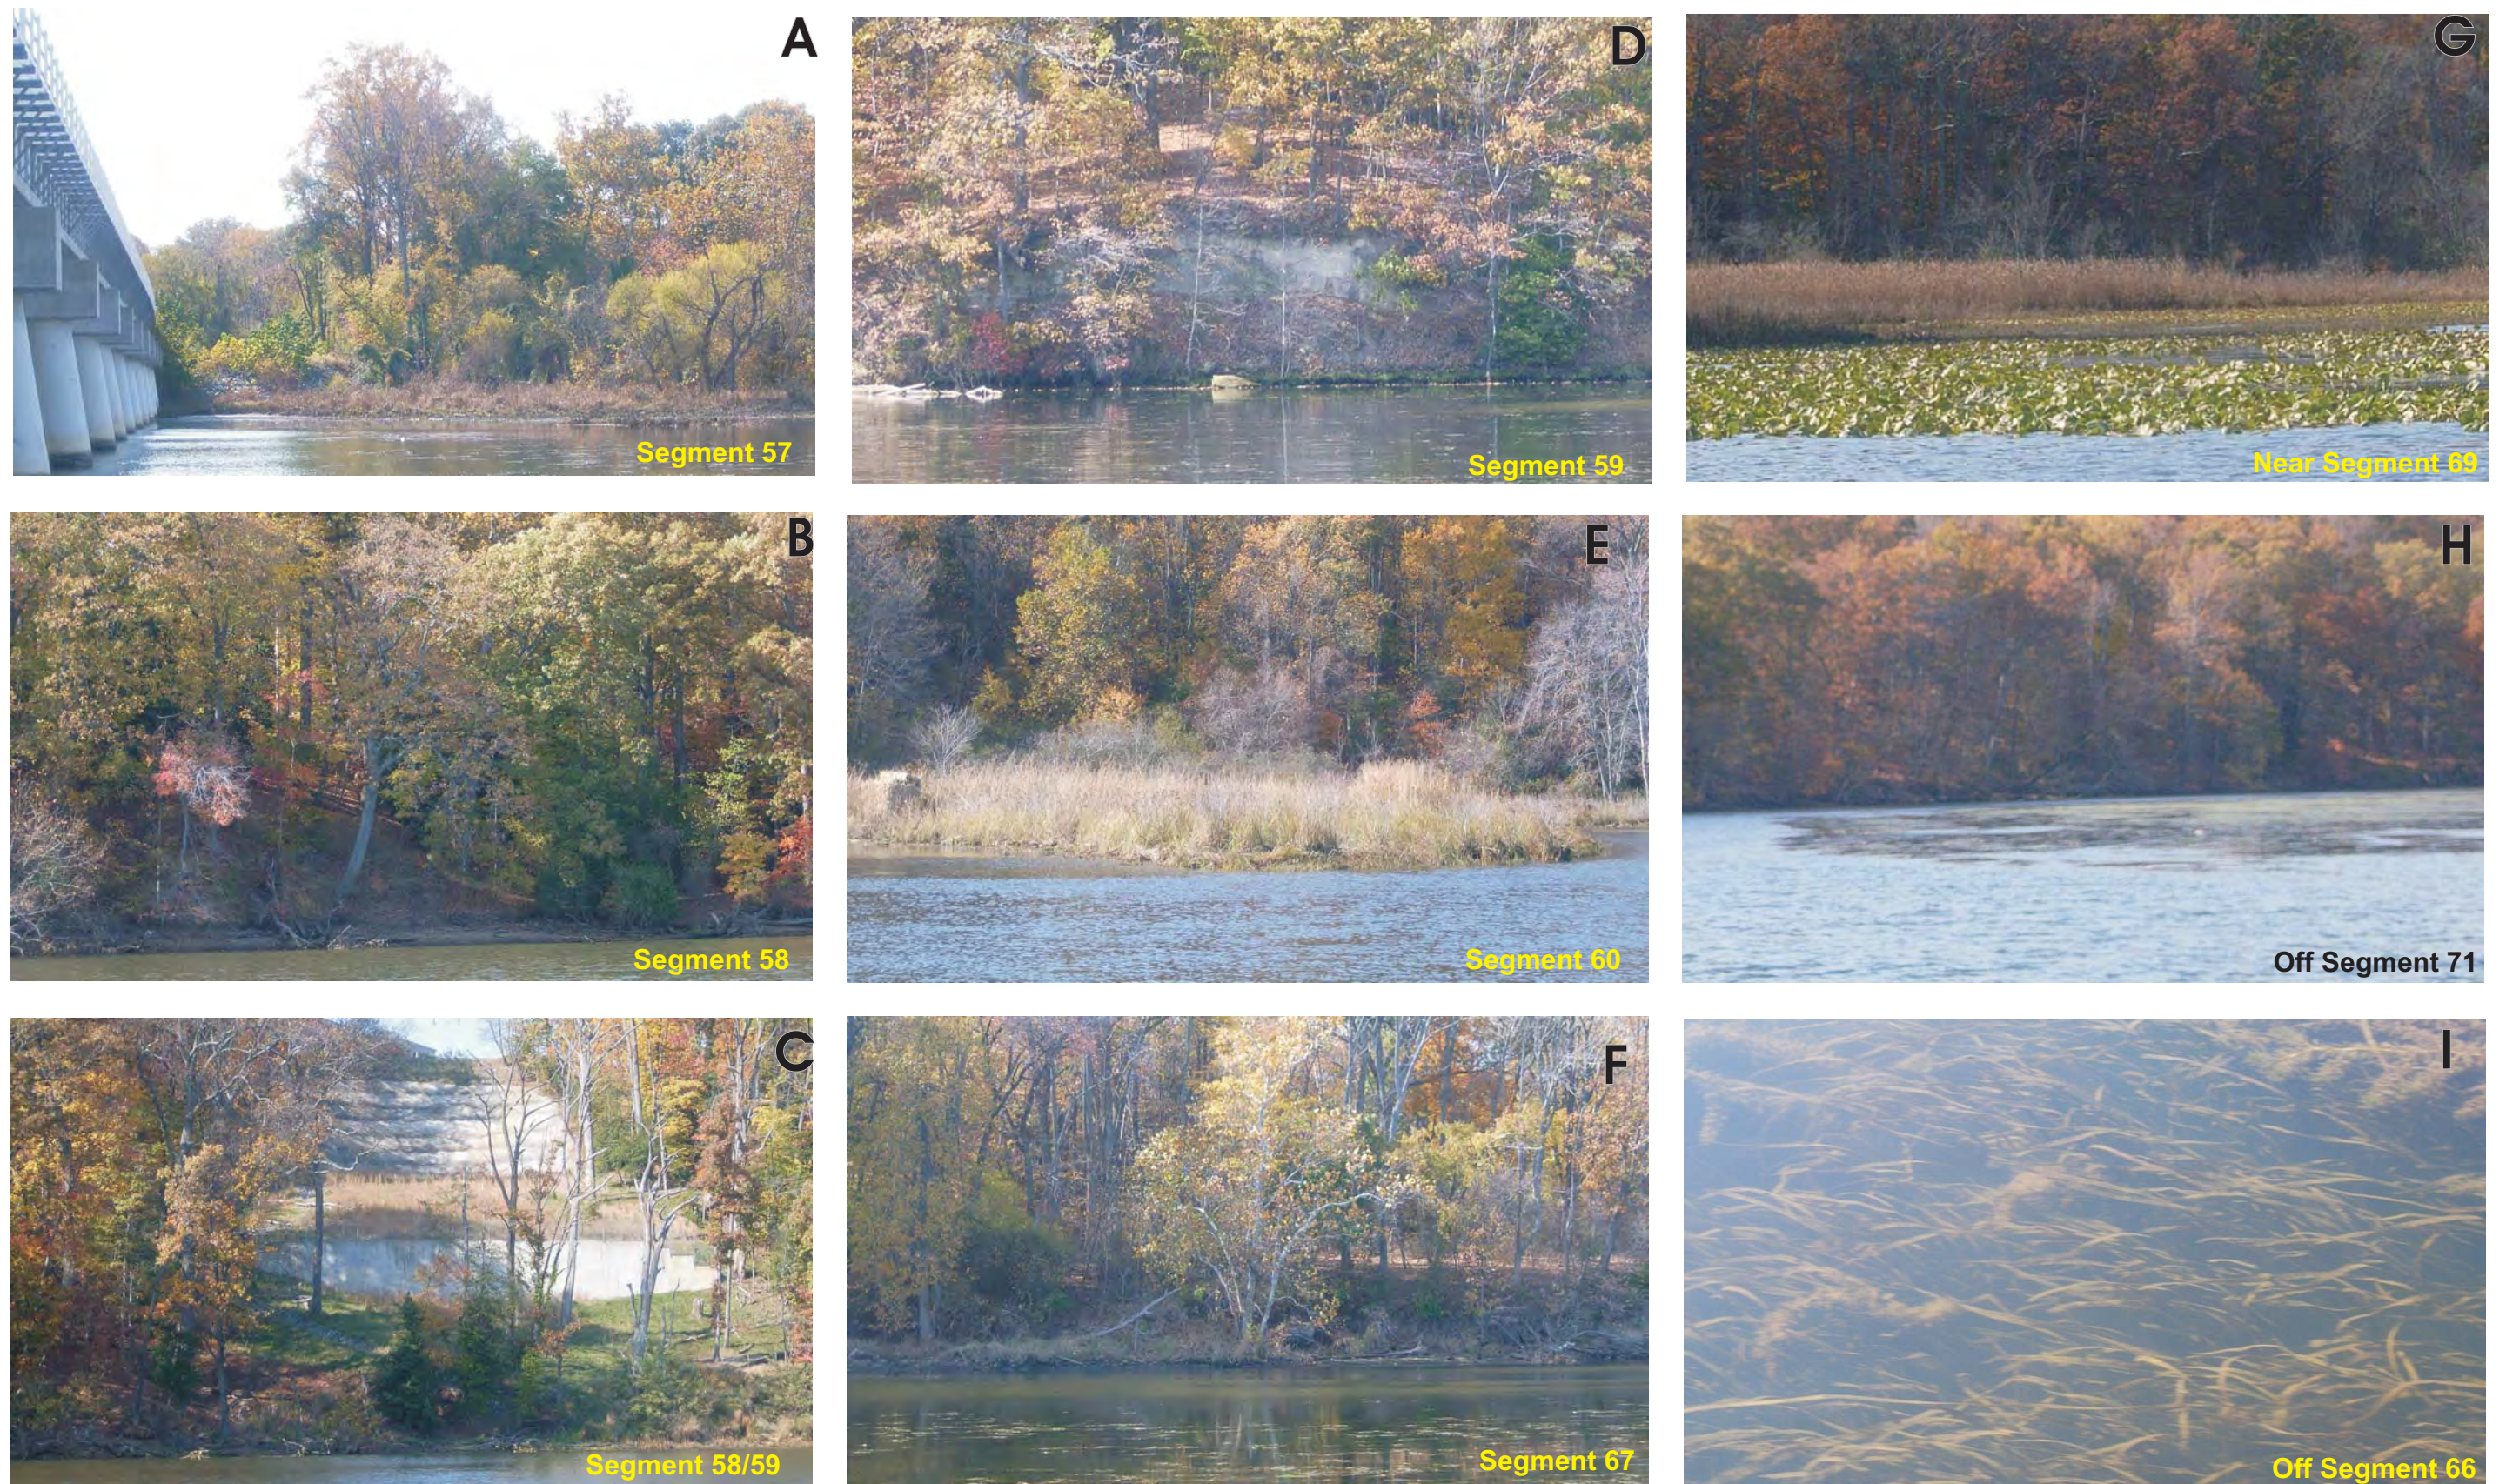
Figure 9-3. Photos taken along Quantico's shoreline in Reach 5. Photos taken on 5 Nov 2009 by VIMS personnel.
