A survey of the effectiveness of existing marsh toe protection structures in Virginia

A Survey of the Effectiveness of Existing Marsh Toe Protection Structures in Virginia

Final Report to the Keith Campbell Foundation for the Environment, Inc.

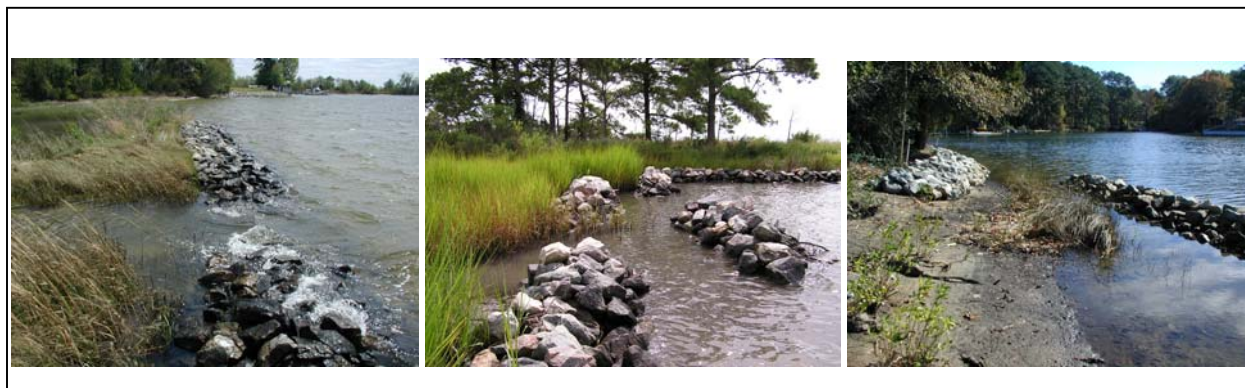
Figure 3. Three different types of tidal openings are illustrated, including a straight gap (left), offset gaps at a pocket marsh (center), and an end opening instead of tying into the upland bank or other erosion control structure (right).

Tidal openings were specifically included in the design of 15 out of 36 projects (Figure 3). These breaks in the revetments are important for reducing the interruption of tidal exchange, which provides nekton access to the marsh and regulates water temperatures in the marsh. Tidal openings were either straight or off-set and overlapping to prevent diffracted wave action and erosion scour at the opening. These openings were strategically placed along the length of long, continuous structures, at the tidal openings to ponds and pocket marshes or at the ends of the structures.

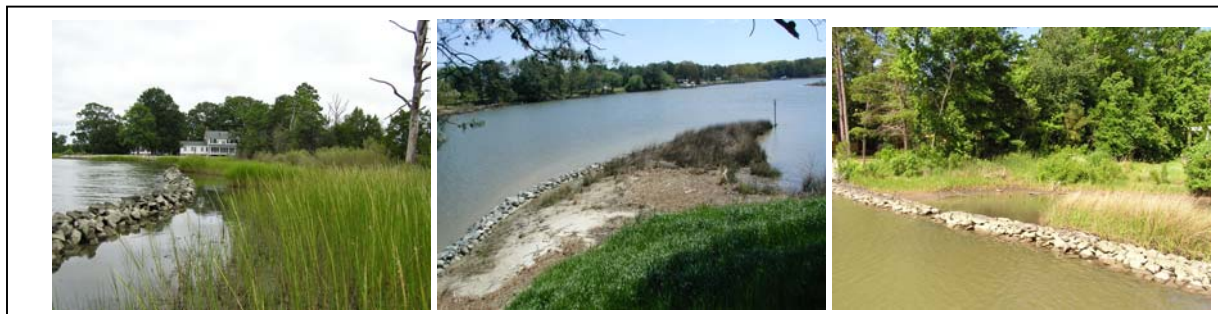
Figure 4. Three different geomorphic types of tidal salt marshes were the targets for erosion protection, including fringing (left), spit (center) and pocket marshes with open tidal ponds (right).

Three different geomorphic types of tidal marshes were targeted by these projects, including fringing marshes (N=18), spit marshes (N=12) and pocket marshes with tidal ponds (N=4) (Figure 4). Fringing marshes were the most common marsh type and most of these were long, continuous features greater than 100 linear feet. There was also one project located in a small tidal channel that connected a larger inland marsh with a major tributary. Only one project involved the complete creation of a tidal marsh where it did not naturally occur (Poplar Grove, MA06).

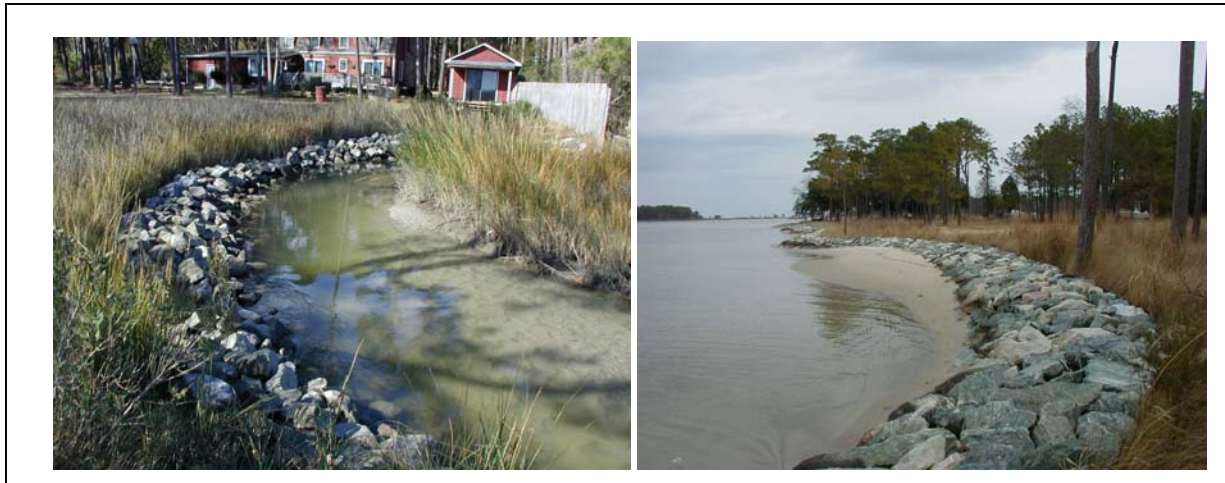
Figure 5. Unnecessary and inappropriate applications of marsh revetments are illustrated with these examples. The project on the left was located in a tidal channel and is excessive and unnecessary for erosion control (MA03). The project on the right was designed to perform like an upland revetment (LA07).

There were 2 cases where the marsh protection structure was considered unnecessary or inappropriate (Figure 5). If a particular shoreline erosion situation can be addressed with either no action or a non-structural solution, then a marsh revetment would be considered unnecessary. One project was considered to be unnecessary for erosion control purposes (MA03). In this case, there was no pre-existing marsh or upland erosion condition due to the protected, very low energy setting in a small tidal channel.
