## **Captain Sinclair's Recreational Area Shoreline Management Plan**

February 2016

*Prepared for*  
*Middle Peninsula Planning District Commission*  
*And*  
*National Fish and Wildlife Foundation*

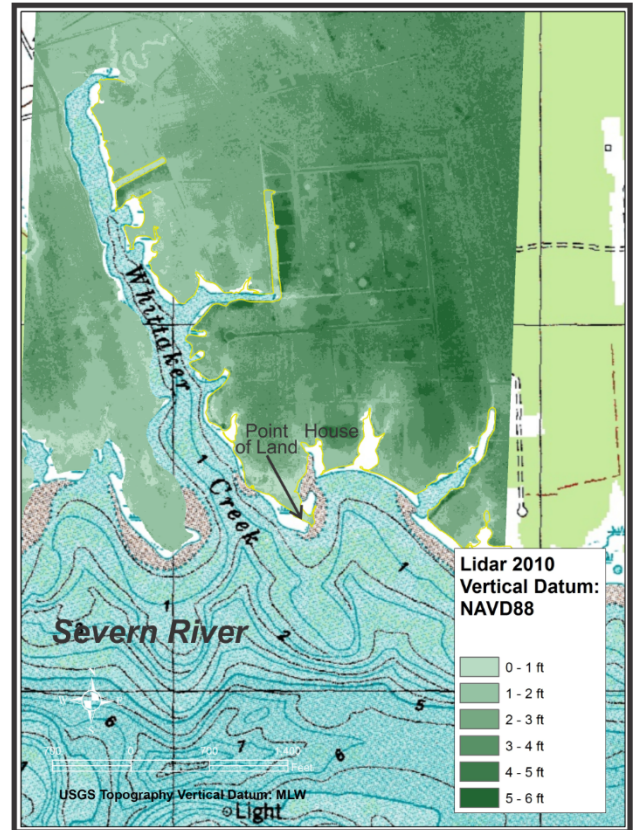
Figure 2. Virginia Base Mapping Program's LiDAR digital elevation model data from 2010 overlaid on a U.S.

CSRA has shoreline on the Severn River and Whittaker Creek. The upland region is very low and easily flooded during severe storm events (Figure 2). The maximum upland height is about 6 feet North American Vertical Datum 88 (NAVD88) and consists of Holocene deposits. The lowest area is marsh at the point of land where Whittaker Creek joins the Severn River. Most of the marsh was only 0 to 1 foot NAVD88 in 2010. The nearshore is very shallow with the five foot mean low water (MLW) contour about 1,900 feet offshore. Offshore of the point of land at the confluence of Whittaker Creek and the Severn River, the 1 foot contour is over 1,000 feet offshore meaning the nearshore is very shallow.

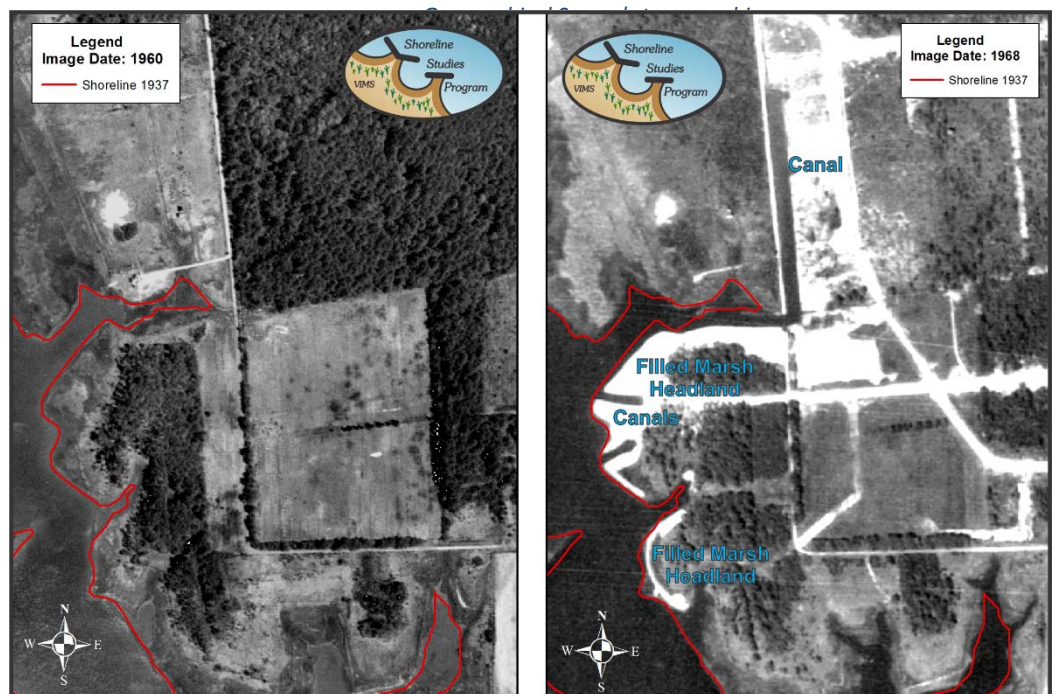
Figure 3. Shoreline Studies Program rectified aerial mosaics from 1960 and 1968 showing the dredging of canals at the site and subsequent placement on the upland.

In 1960, the CSRA shoreline was tidal marsh fronting the low wooded upland along Whittaker Creek and farm (Figure 3). Sometime between 1960 and 1968 extensive excavation and filling was done around much of the property. The shoreline along Whittaker Creek was most impacted with the excavation of the long canal where the present day boat ramp resides. Also two marsh headlands were filled, and two short canals were created (Figure 3). Today these filled areas have re-vegetated with upland species including shrubs, cedars, and pines. A small tidal pond was formed on the land side of southerndeposited sand. It connects to Whittaker Creek by a narrow meandering tidal inlet. The two small canals on Whittaker Creek have filled in at their mouths and act like small tidal ponds (Figure 4). The southern filled marsh headland is now an eroding upland bank, and the site of two duck blinds.

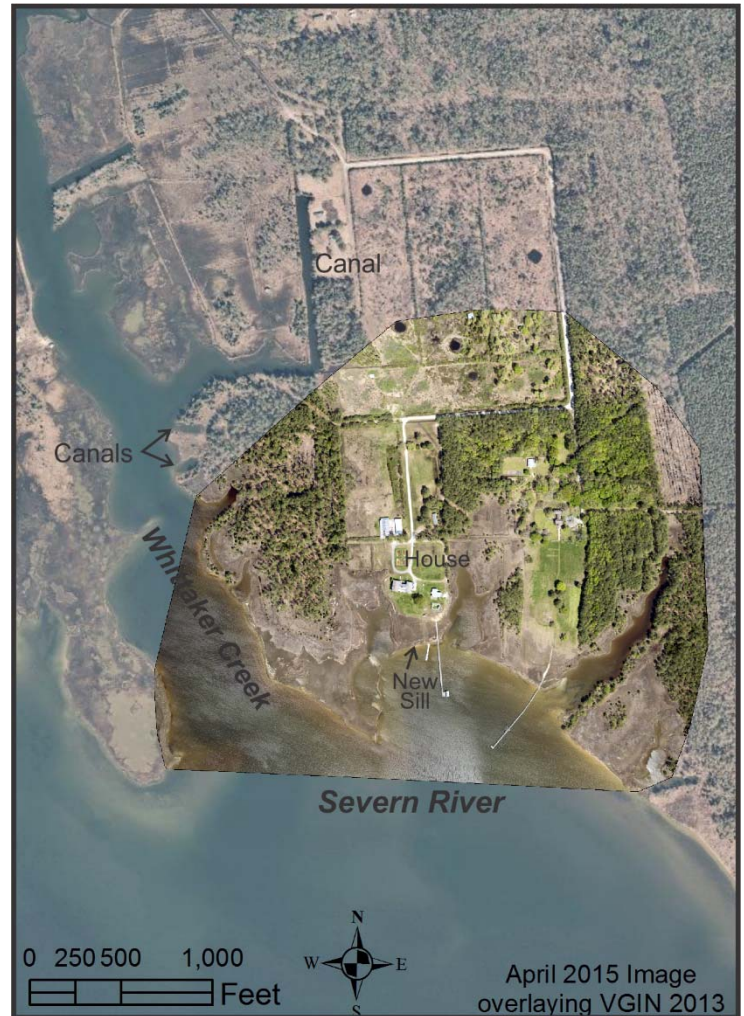
Figure 4. Present shore conditions as depicted by Shoreline Studies Program's April 2015 rectified aerial photo mosaic overlaid on a Virginia Base Mapping Program 2013 image.

Farther south along the rest of Whittaker Creek and into Severn River, the broad marsh peninsula has experienced higher erosion rates than other areas of the property due to its long fetch exposures to the southwest, south, and southeast of 2 miles, 0.8 miles, and 1.6 miles, respectively. Turning northward along the shoreline, a small tidal creek was once protected by a marsh spit but is now completely open (Figure 4).

The point of land at the confluence of Whittaker Creek and the Severn River has had the highest erosion rate. Approximately 210 feet of marsh has eroded along the southwest facing side of the point (Appendix A). Erosion on the eastern side of the point has broken through a marsh spit that fronted the small tidal creek (Figure 5). In addition to wind/wave erosion, infrared photography in 2013 appears to show areas of non-channelized inundation within the marsh (Figure 5).

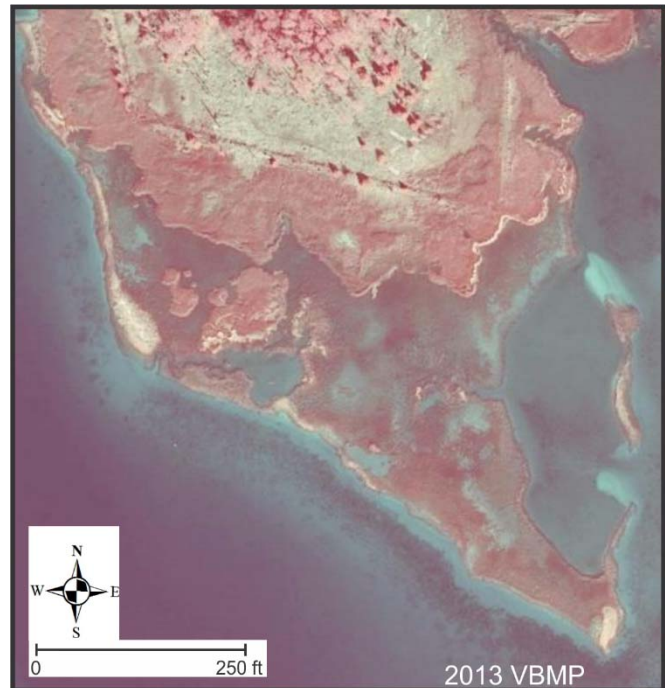
Figure 5. Virginia Base Mapping Program's 2013 infrared aerial photo mosaic showing inundation of the marsh at CSRA.

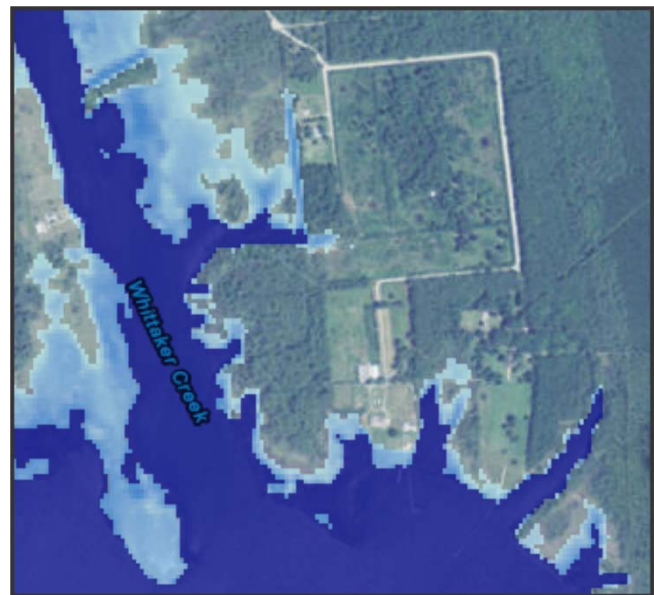
Figure 6. NOAA's sea-level rise and coastal flooding impact viewer showing areas (in blue) affected by a projected 1 foot inundation at CSRA.

Sea-Level rise was calculated to be 3.81 mm/year (NOAA Tides and Currents, 2016). At this rate, by 2050, 0.4 ft of sea level rise will occur. NOAA's Sea Level Rise and Coastal Flooding Impacts (NOAA, 2016) interactive mapping tool showed the extent of 1 foot of sea level rise on Captain Sinclair (Figure 6). Generally, the low marshes are the areas that will be impacted most by sea-level rise at CSRA. However, the upland is low enough that the marsh may be able to migrate landward with sea level.

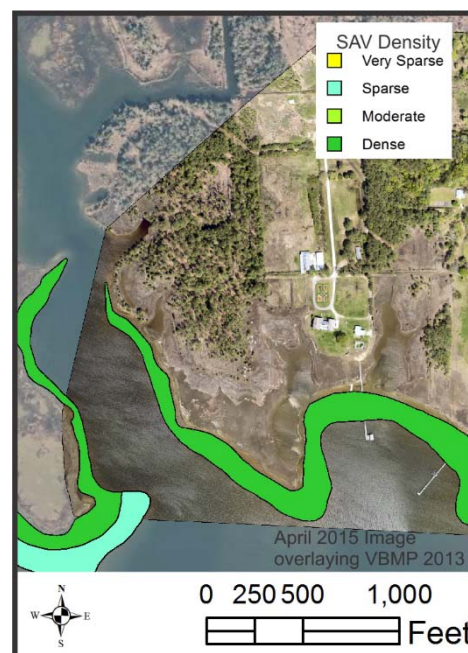
Figure 7. Submerged aquatic vegetation density mapping from the VIMS SAV program for 2014.

Submerged aquatic vegetation (SAV) is dense along the nearshore of CSRA (Figure 7) as determined by the Virginia Institute of Marine Science's Submerged Aquatic Vegetation program. Because the SAV is close to the shoreline, any shoreline management recommendations for this property must take it into consideration. A great deal of oysters are distributed throughout the marsh around the property.

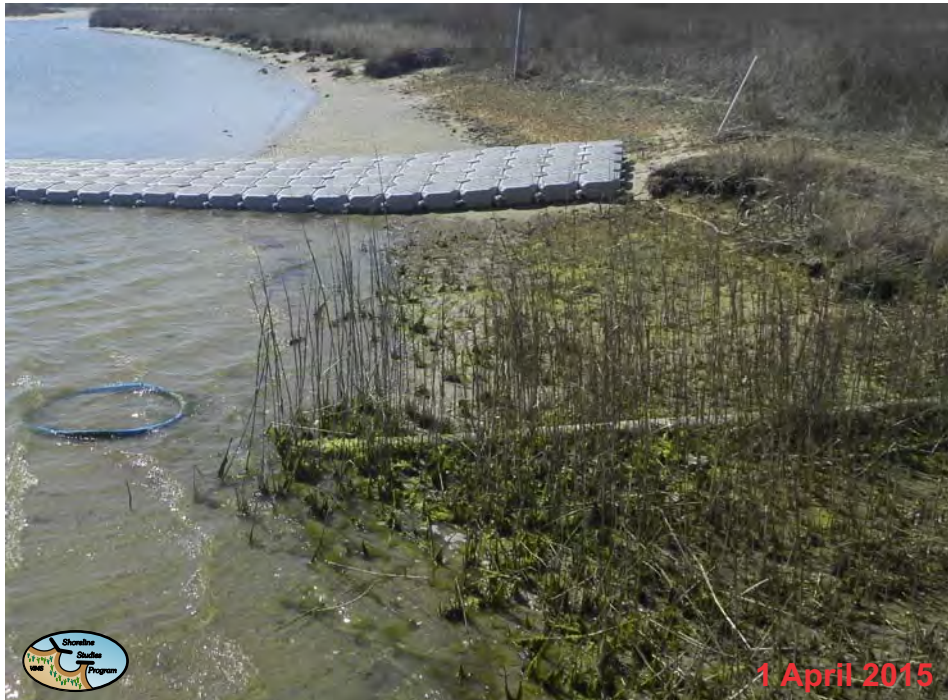
Shoreline before living shoreline construction. *Spartina alterniflora* exposed along the eroding shoreline.

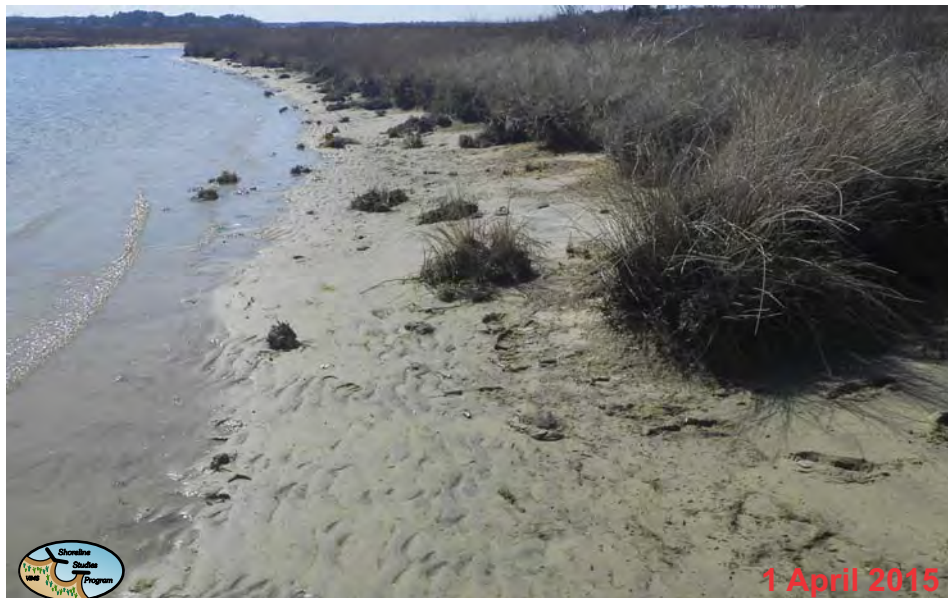
Shoreline before living shoreline construction. Marsh scarp along the main shoreline.

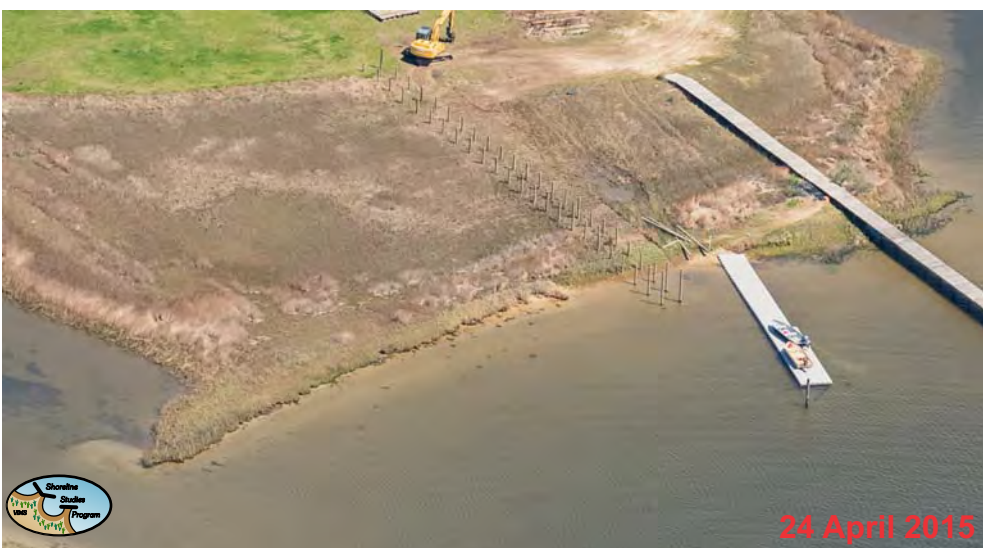
Shoreline before living shoreline construction. The new pier has since been completed. 24 April 2015

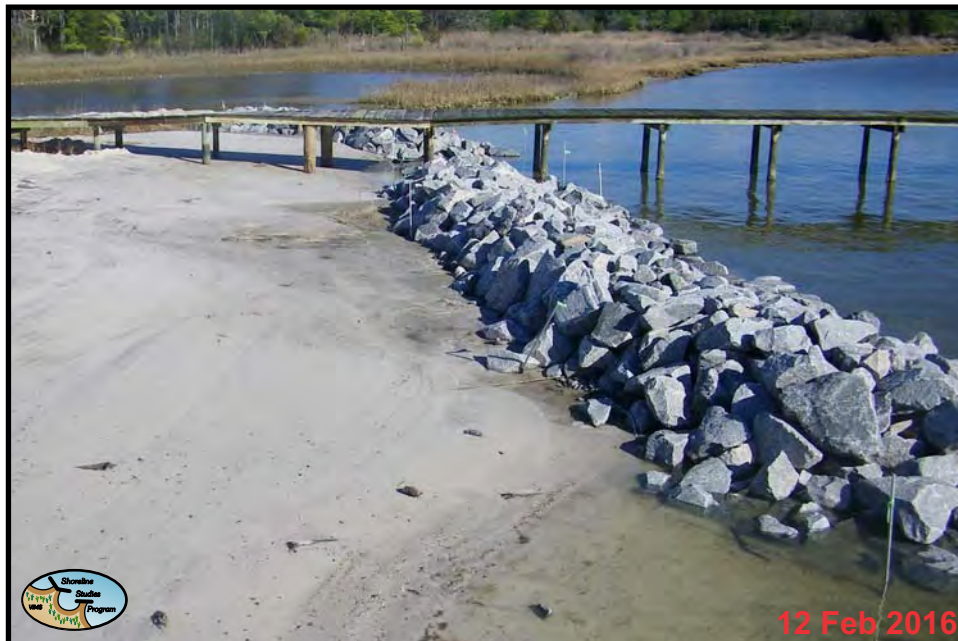
Post-Construction:  
Sill 2

Note: Sand will not  
be planted until  
after April 15 to  
ensure survival.

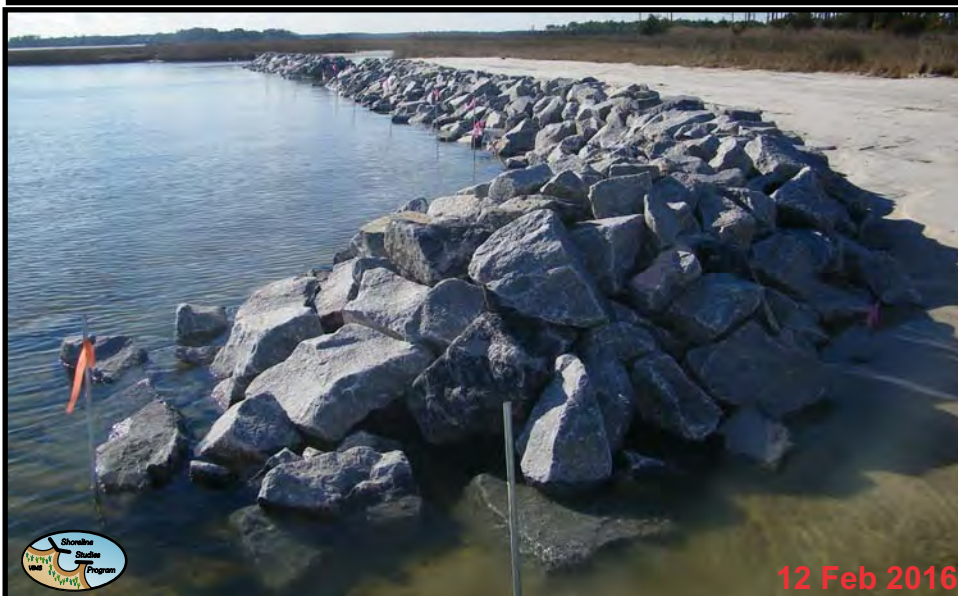
Post-Construction:  
Sill 3

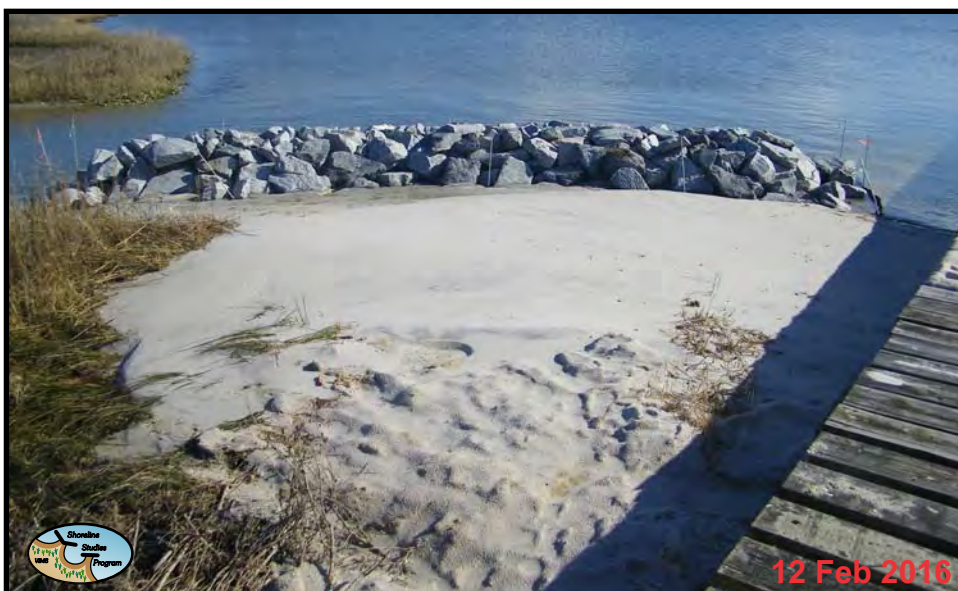
Post-Construction:  
Sill 1

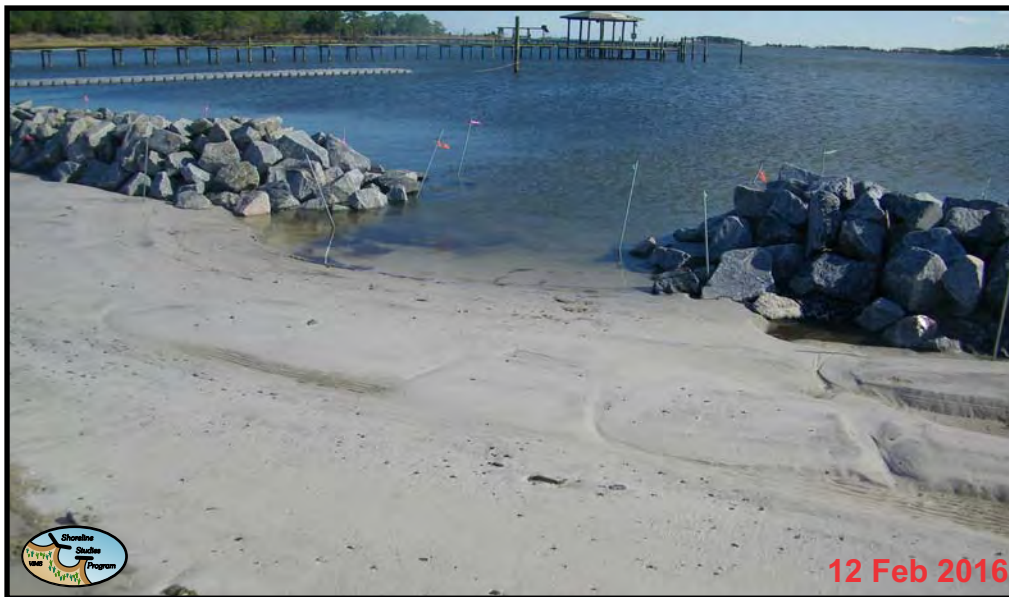
Post-Construction:  
Window between  
sills 3 and 4

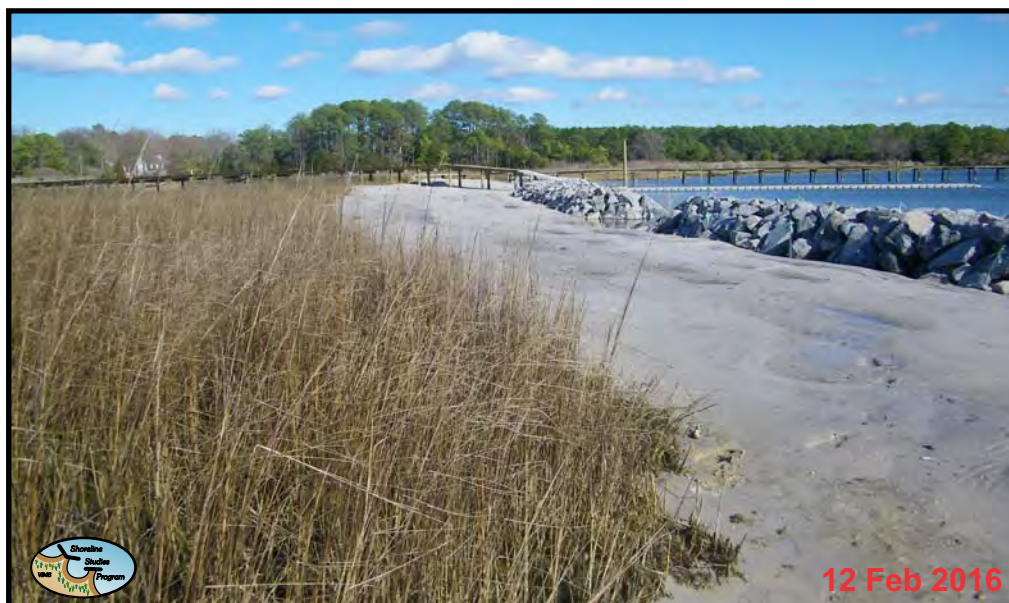
Post-Construction:  
Sand fill up to the  
top of existing  
marsh scarp.

The sand behind  
the structures will  
be planted with  
marsh grass after  
April 15.

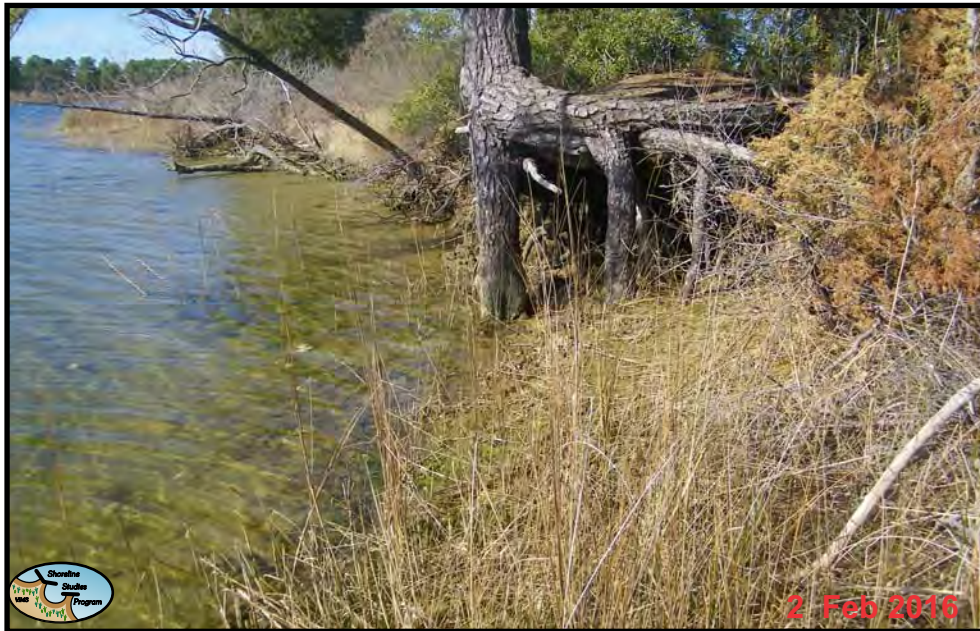
Whittaker Creek Living Shoreline project is in the permitting phase. Logs totalling 60 feet in length will be placed along the shoreline and anchored as per the design and cross-sections on the following pages.

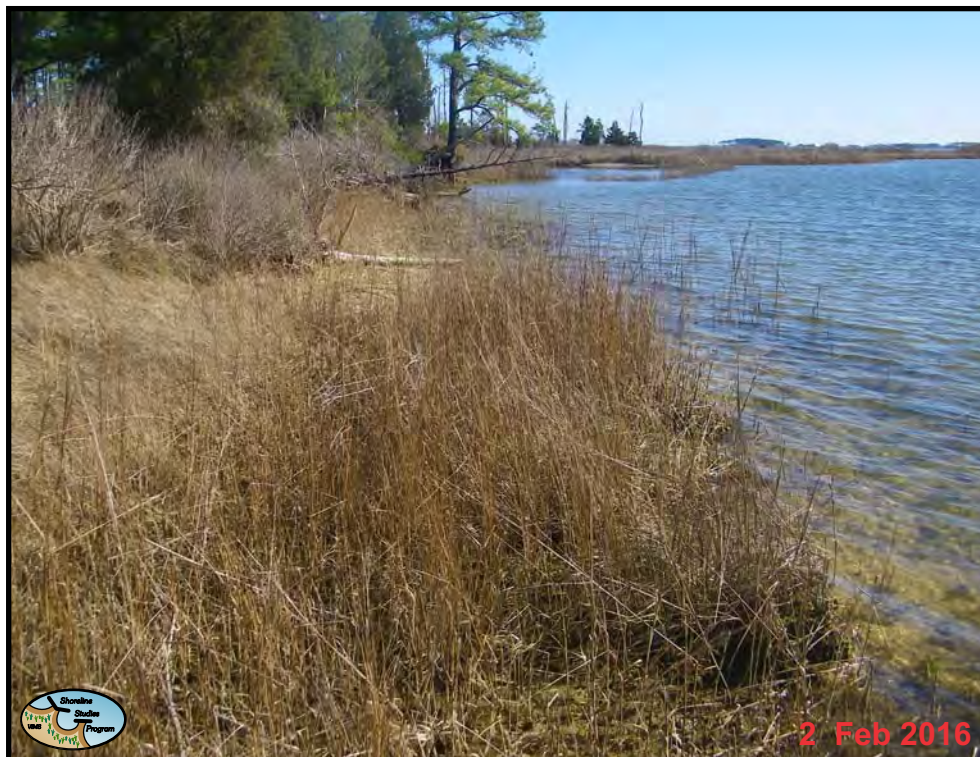
Whittaker Creek Living Shoreline project is in the permitting phase. Oyster bags totalling 60 feet in length will be placed along the eroding marsh scarp as per the design and cross-sections on the following pages.

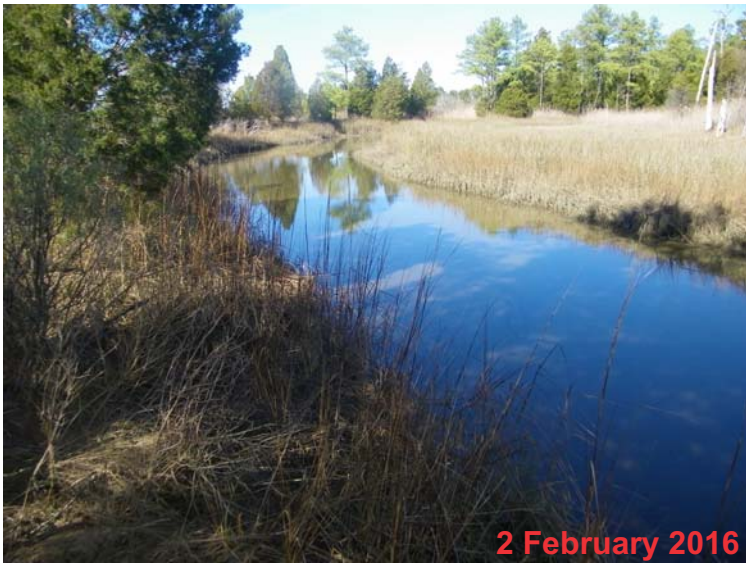
1 Tidal pond formed when material dredged from the canals was placed along the shoreline in the 1960s.

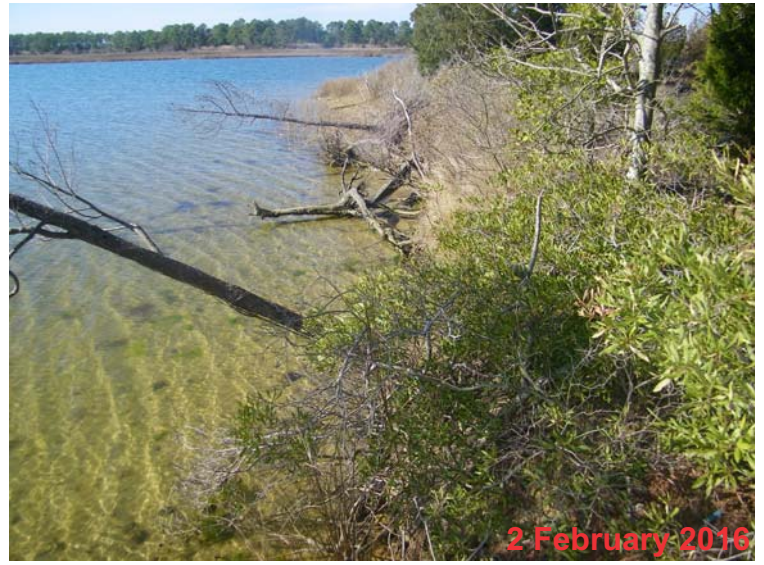
2 An eroding upland berm that was formed by the placement of material that was dredged from the canals in the 1960s. Presently, the berm is eroding leaving an exposed bank and trees along the shoreline. This is the location of a small living shoreline project that is in the permitting process. 60 feet of logs will be anchored along the shore.

A second, smaller living shoreline project is in the permitting phase (Appendix B). This project includes a total of 60 feet of log sections that will be anchored along a section of eroding shoreline on Whittaker Creek (Figure 8). This section of shoreline was converted to upland when material was placed on it during the dredging of the canals that occurred in the 1960s (Figure 3). It is now a low, exposed bank vegetated with trees and shrubs. Just north of the logs, an eroding marsh scarp will be stabilized with stacked oyster bags. Approximately 60 feet long, the oyster bags will buffer waves and help maintain the marshes edge. It is anticipated that this project will occur in March 2016 once permits are received.

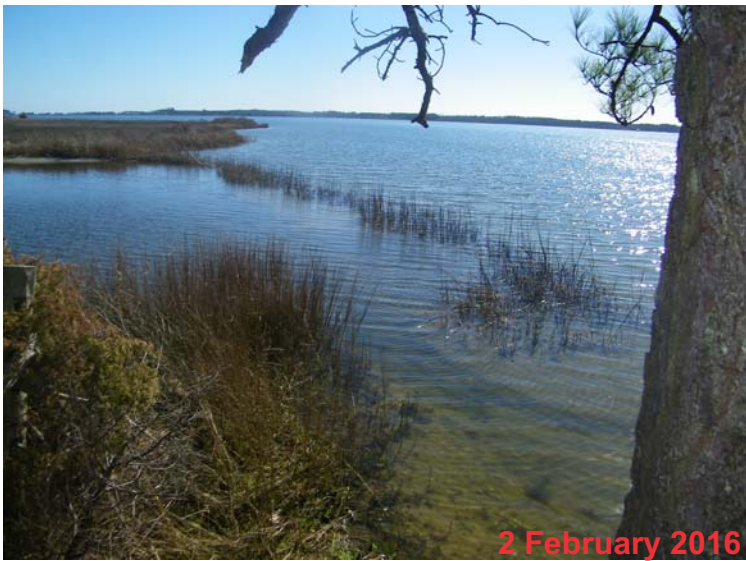
3 Looking south along Whittaker Creek. The marsh spit that fronts a small tidal creek is decaying.

South of the proposed living shoreline projects on Whittaker Creek, the shoreline is considered erosional. The marsh spit that exists at the mouth of the tidal pond is decaying (Appendix C3 and C5). Once the spit disappears, the tidal creek will be exposed to a slightly larger wave climate and could cause erosion. A duck blind

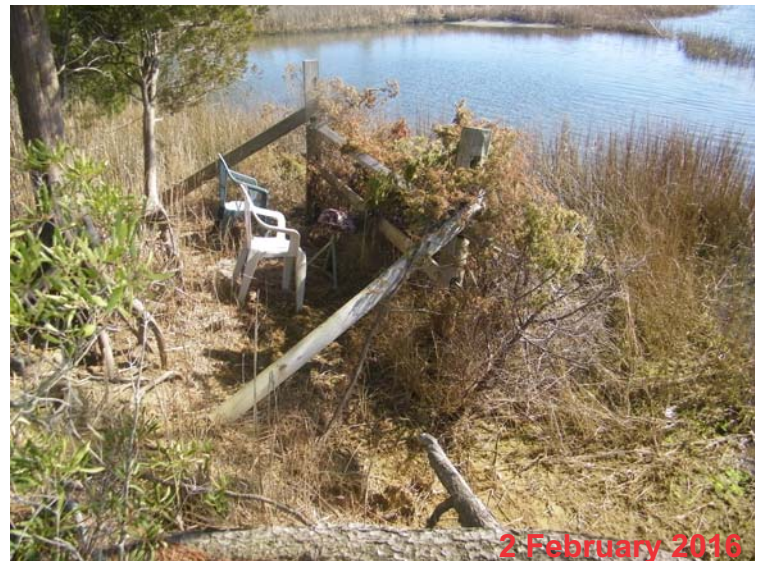
4 Looking south along Whittaker Creek. A duck blind can be rented at CPRA.

occurs along the shoreline (Appendix C4). South of the spit, the shoreline region consists of high and low marsh (Appendix C7 and C9). Utilizing oyster bags as a sill along the marsh fringe would help maintain the marsh edge.

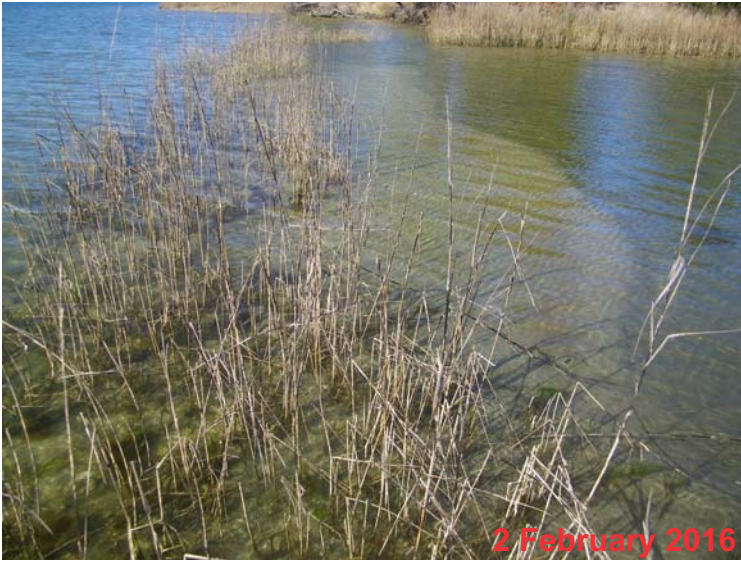
**5** Looking north along Whittaker Creek showing the marsh spit that is decaying.

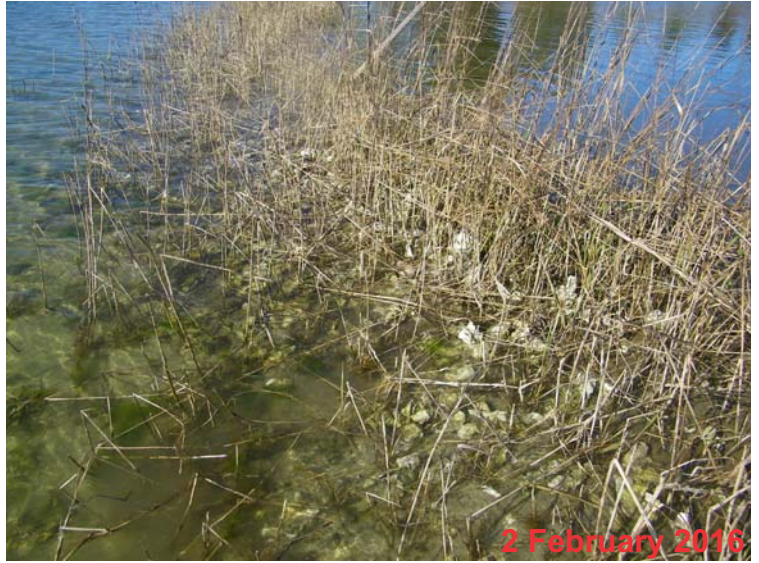
**6** Oysters are distributed throughout the marsh at CSRA.

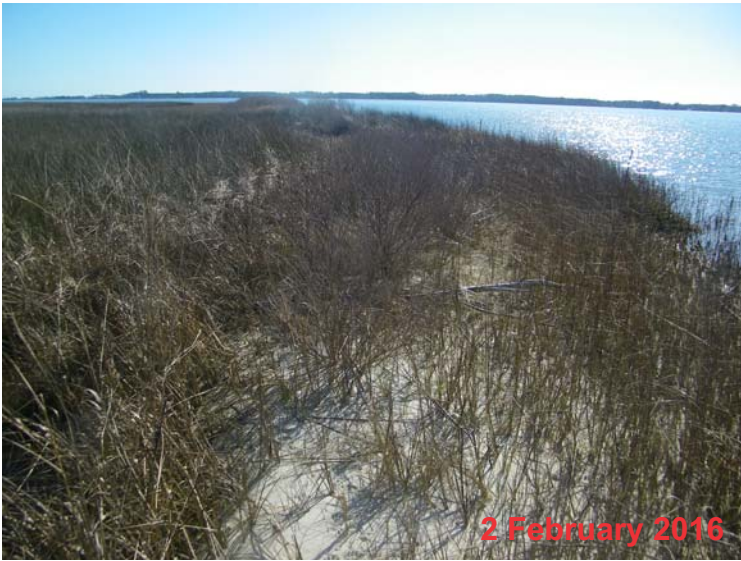
**7** Looking south along Whittaker Creek showing the wide upper marsh with sand washover and a narrow low marsh fringe.

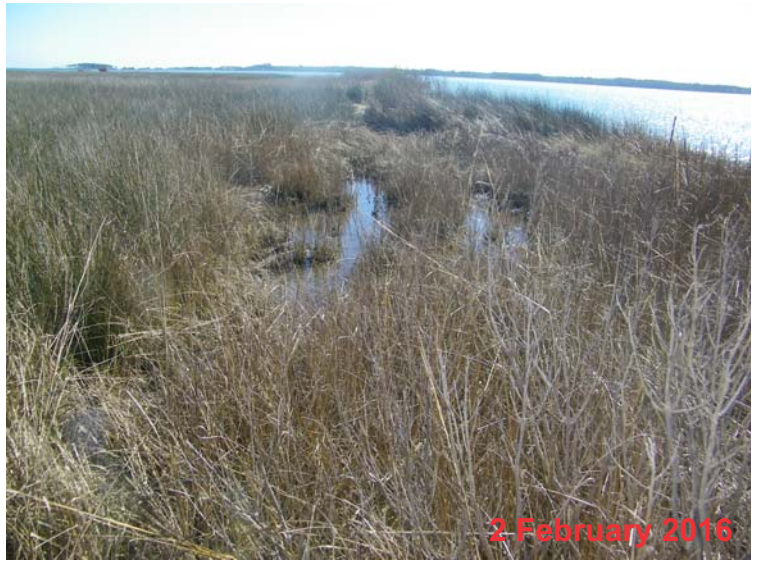
**8** Farther south along Whittaker Creek where the high marsh is changing to low marsh. Water inundates this marsh at high tide.

Farther south, the high marsh gives way to low marsh that floods at high water (Appendix C8). The low marsh of the point is rapidly eroding, particularly on its southwest facing side. While a rock sill would manage the erosion, it is not feasible to bring in the necessary rock and sand since there is no access from the land side and the nearshore is too shallow. Oyster bags, or some other type of product that is light and could be brought in via small boat, could be placed along the shoreline to try and maintain the marsh. However, the longer fetch distances at the site will mean that maintenance of the project may be required.

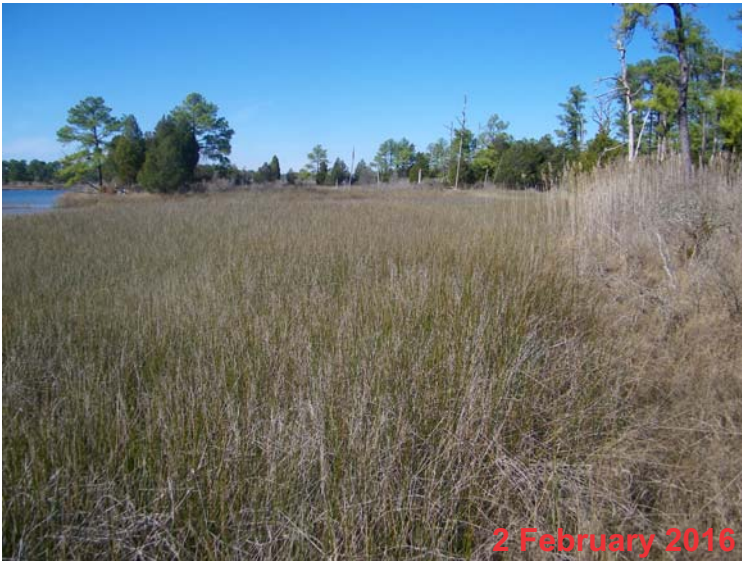
9 Wide, high marsh along Whittaker Creek.

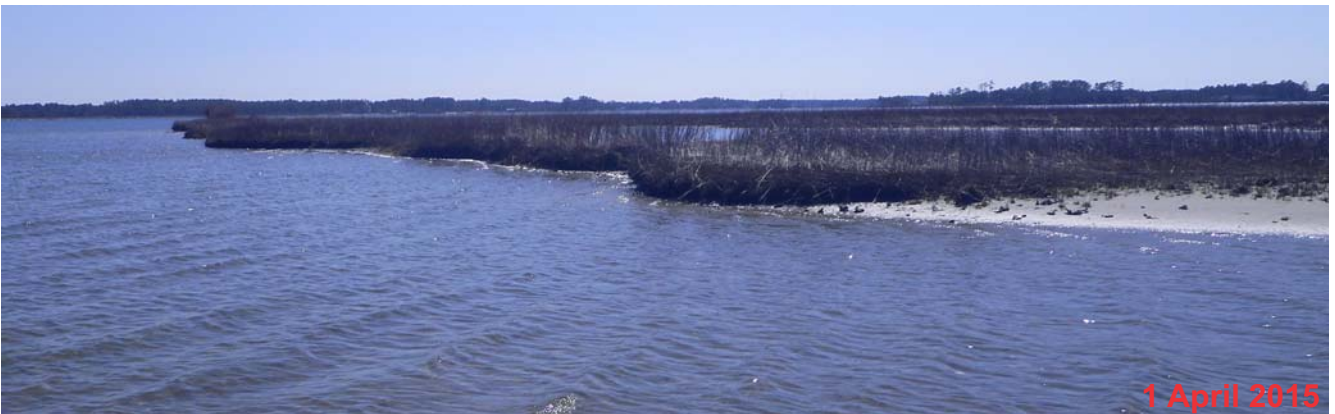
10 Eroding marsh spit along the east facing point on the Severn River. The spit is eroding quickly and has breached exposing the low marsh behind to increase wave activity.

The east facing shoreline has a spit that is eroding (Appendix C10). One section has breached and another section has no marsh but is only a sand washover (Appendix C11). An oyster bag sill could be effective in helping to maintain the spit which would protect the low marsh behind it. Placing oyster bags along the marsh edge behind the breach could help maintain the marsh before it starts being impacted by erosion.

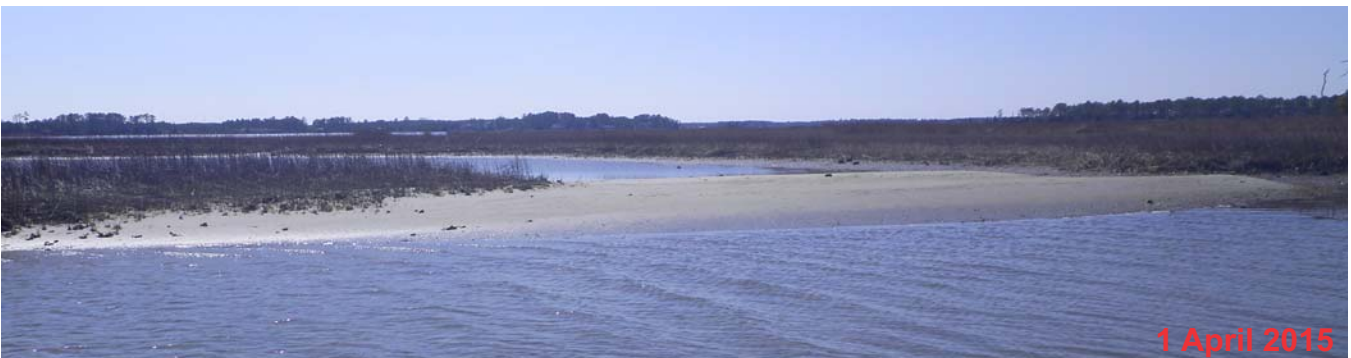
11 Eroding marsh spit along the east facing point on the Severn River. The marsh has completely disappeared on this section of the spit.

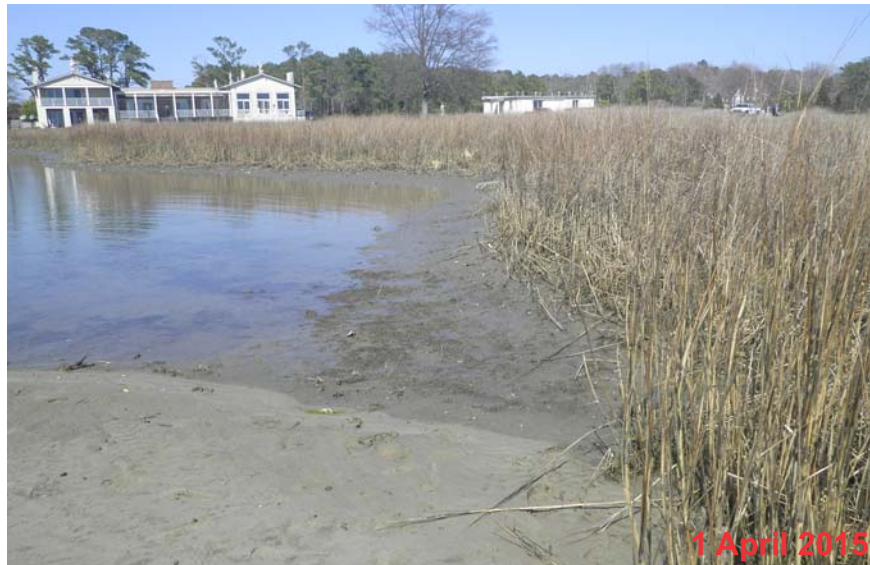
**12** Small tidal creek to the west of the main house on the Severn River. The shoreline is relatively stable in this small creek.

In the small tidal creeks on either side of the house, erosion is minimal (Appendix C12 and C13). However, placing oyster bag sills in strategic locations could reduce problems in the future by helping to maintain the marsh.

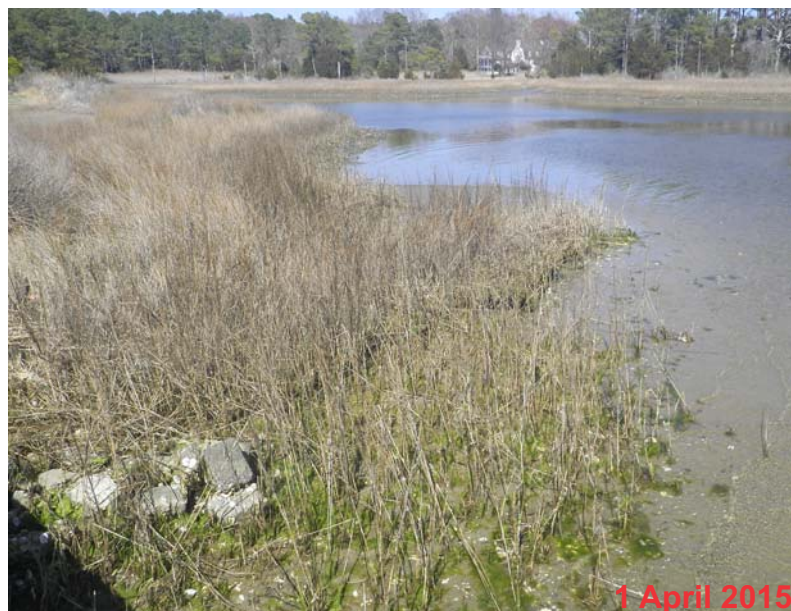
**13** Small tidal creek on the east side of the main house. This shoreline is relatively stable, but it is potentially exposed to a greater wave climate than the creek in photo 12.
