# A survey of the effectiveness of existing marsh toe protection structures in Virginia

Final Report to the Keith Campbell Foundation for the Environment, Inc.

July 2006

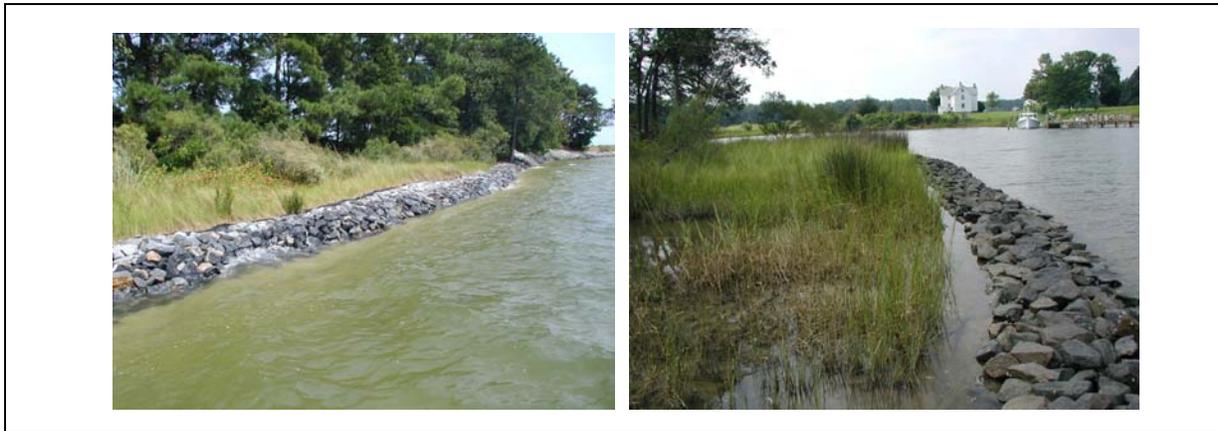
**Figure 1.** The two types of marsh revetments included in this study were “marsh toe revetments” placed directly against the edge of an eroding tidal marsh (left) and “marsh sills” offset from the edge of the marsh vegetation (right) or adjacent to non-vegetated intertidal area. Collectively, these rock revetments are referred to as “marsh revetments” for the purpose of this study.

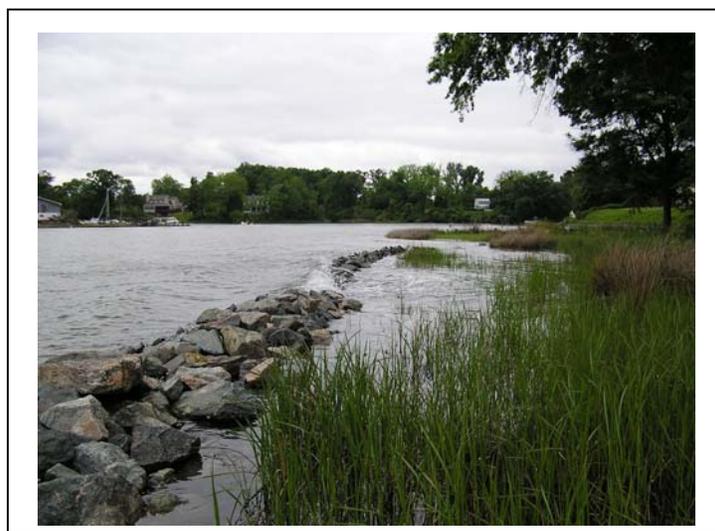
**Figure 2.** Boat wakes were observed washing over this marsh toe protection structure located in close proximity to a navigation channel. Boat wakes influence the wave climate in low energy settings.

It appears that fetch alone may not be a reliable factor to determine if a structure is necessary to support a vegetated marsh sufficient for erosion protection. Shoreline orientation and boat wakes also have an influence on determining the need for a structure, especially where the marsh is located in close proximity to a navigation channel (Figure 2).

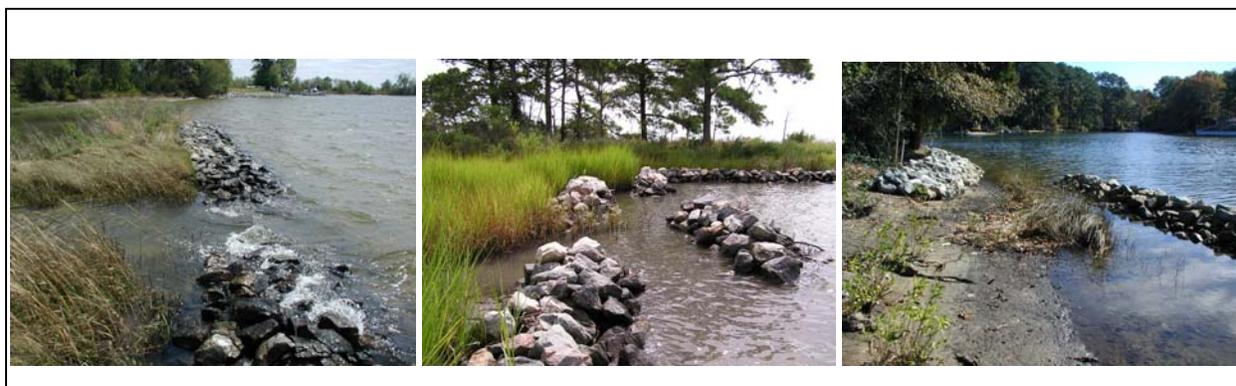
**Figure 3.** Three different types of tidal openings are illustrated, including a straight gap (left), offset gaps at a pocket marsh (center), and an end opening instead of tying into the upland bank or other erosion control structure (right).

Tidal openings were specifically included in the design of 15 out of 36 projects (Figure 3). These breaks in the revetments are important for reducing the interruption of tidal exchange, which provides nekton access to the marsh and regulates water temperatures in the marsh. Tidal openings were either straight or off-set and overlapping to prevent diffracted wave action and erosion scour at the opening. These openings were strategically placed along the length of long, continuous structures, at the tidal openings to ponds and pocket marshes or at the ends of the structures.

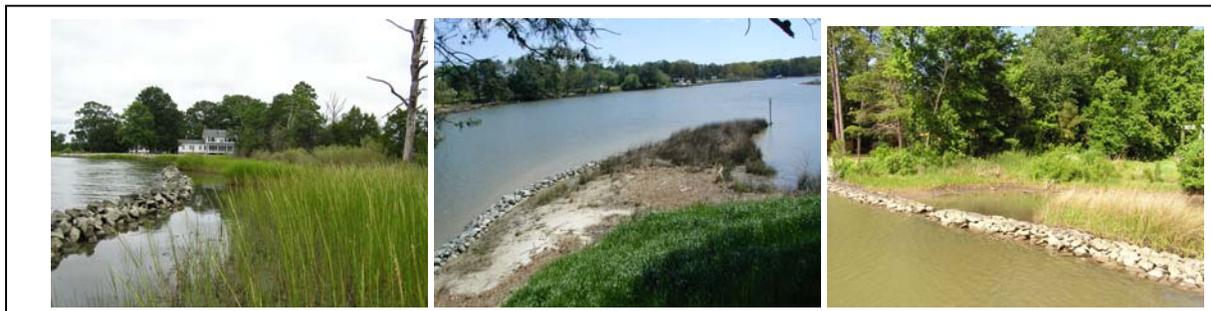
**Figure 4.** Three different geomorphic types of tidal salt marshes were the targets for erosion protection, including fringing (left), spit (center) and pocket marshes with open tidal ponds (right).

Three different geomorphic types of tidal marshes were targeted by these projects, including fringing marshes (N=18), spit marshes (N=12) and pocket marshes with tidal ponds (N=4) (Figure 4). Fringing marshes were the most common marsh type and most of these were long, continuous features greater than 100 linear feet. There was also one project located in a small tidal channel that connected a larger inland marsh with a major tributary. Only one project involved the complete creation of a tidal marsh where it did not naturally occur (Poplar Grove, MA06).

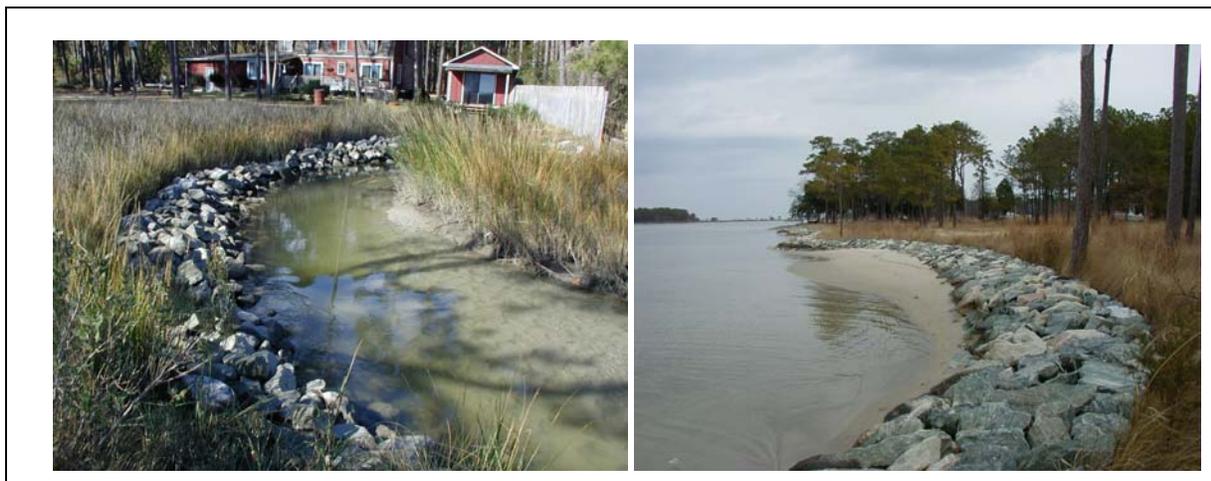
**Figure 5.** Unnecessary and inappropriate applications of marsh revetments are illustrated with these examples. The project on the left was located in a tidal channel and is excessive and unnecessary for erosion control (MA03). The project on the right was designed to perform like an upland revetment (LA07).

There were 2 cases where the marsh protection structure was considered unnecessary or inappropriate (Figure 5). If a particular shoreline erosion situation can be addressed with either no action or a non-structural solution, then a marsh revetment would be considered unnecessary. One project was considered to be unnecessary for erosion control purposes (MA03). In this case, there was no pre-existing marsh or upland erosion condition due to the protected, very low energy setting in a small tidal channel.

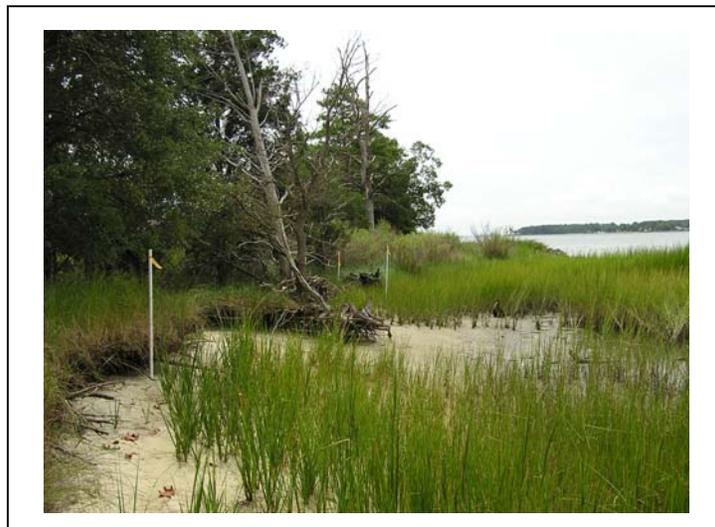
**Figure 6.** Spots of upland bank erosion were observed where the crest height of the marsh toe protection structure was less than +1 ft MHW in a medium energy setting. The white stakes indicate a proposed upland revetment (MA05). Raising the crest height of the marsh toe protection structure was encouraged instead to preserve the natural connections between the upland and wetland habitats.

Most of the structures in this study were very effective for erosion control based on reported baseline conditions and the absence of erosion indicators after the structure was installed. Most of the project sites had low banks less than 5 feet high and upland erosion was not always present before installation. Continuing upland bank erosion was observed in 5 cases at medium or high energy settings and where the revetment crest height was less than +1 ft MHW, the marsh width was less than 15 feet, and/or the upland was low and floodprone on a regular basis (Figure 6).

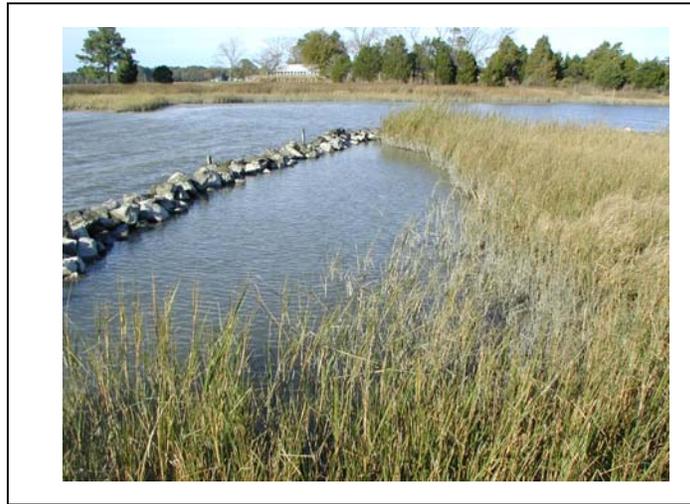
**Figure 7.** Erosion of the marsh edge continued at one section of this project where the offset distance of the marsh sill was greater than 10 feet. There was no erosion observed where the same sill was closer to the marsh edge.

sites, particularly where the off-set distance of the revetment from the marsh edge was greater than 10 feet with open water between the revetment and the marsh edge (Figure 7).

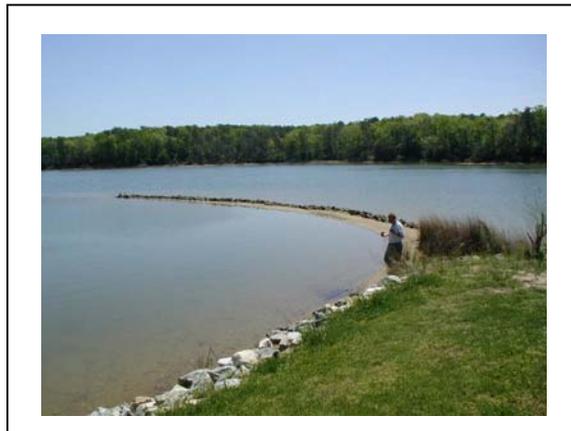
**Figure 8.** If upland revetments sever the landward end of a marsh spit, then marsh toe protection structures may not reverse the trend of “drowning” spit marshes. This is the only case where the revetment was not at all effective for erosion control (LA06).

There was only one case of a marsh sill having no apparent effect on the gradual disappearance of a spit marsh (Figure 8). This phenomenon has been observed at other spit marshes and is probably due to the combined effect of gradual sea level rise and sediment supply interruption. Spit marshes depend on sediment supply and transport to maintain suitable elevations for marsh vegetation. “Drowning” spits have been observed and reported by property owners where the adjacent upland sediment supply has been reduced by erosion stabilization projects. The additional marsh revetment structure alone is not always sufficient to reverse this trend.

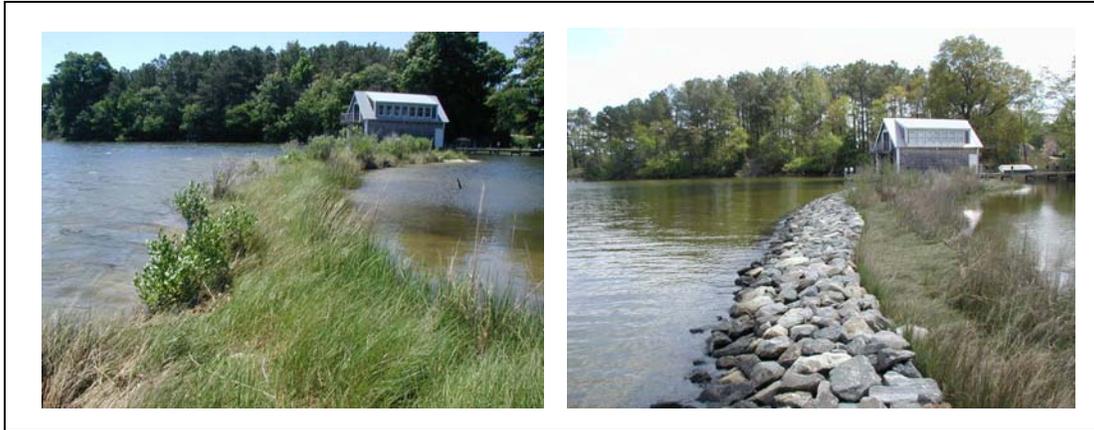
**Figure 9.** The placement of marsh toe protection structures along the entire length of marsh spits may adversely interrupt the sediment transport process that maintains suitable elevations for marsh vegetation. In this case, the revetment base width also seemed to be excessive (8 ft) compared to the width of the existing marsh (NU08).

It is also possible that the marsh toe structures interrupt sediment transport along and to the end of the spit (Figure 9). Additional research is needed to evaluate spit marshes and how to preserve these features in the landscape, especially when they are surrounded by erosion stabilization projects and increased boat wake activity.
