# Westmoreland County, Virginia Shoreline Situation Report

Prepared By:  
Comprehensive Coastal Inventory Program  
Center for Coastal Resources Management  
Virginia Institute of Marine Science, College of William and Mary  
Gloucester Point, Virginia

June, 2007

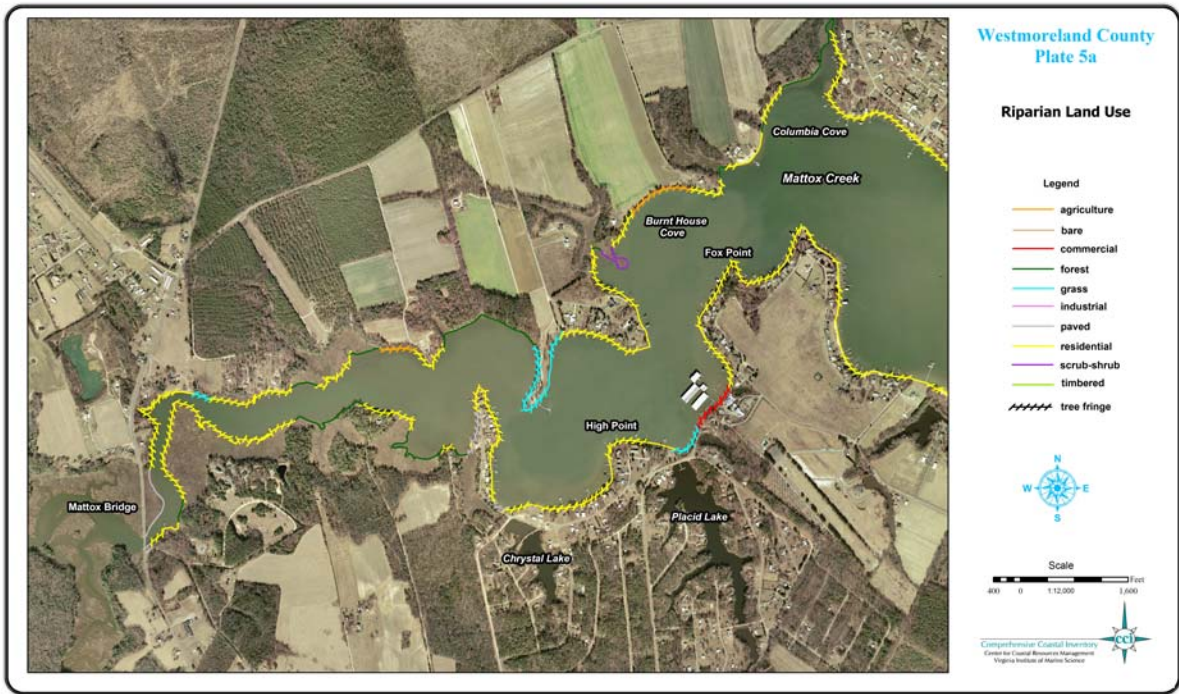
Figure 4. Sample riparian land use map for Westmoreland County

Plate A describes the riparian land use as color-coded bars along the shore. A legend keys the color to the type of land use. If the line is hatched, there is forest fringe on site. The background imagery is natural color VBMP imagery at a publication scale of 1:12,000. Users should note that the imagery is sometime rotated in order to meet the scale requirements. This means that “north” is not always to the top of the page.

Data collected for the SSR can assist with targeting efforts for designating AOCs. AOCs can be areas where riparian buffers are fragmented, and could be restored. Use Plate A to identify forested upland. Breaks in the continuity of the riparian forest can be easily observed in the line segments, and background image. Land use between the breaks relates to potential opportunity for restoring the buffer where fragmentation has occurred. Agricultural tracts which breach forest buffers are more logical targets for restoration than developed residential or commercial stretches. Agricultural areas, therefore, offer the highest opportunity for conversion. Priority sites for riparian forest restoration should target forested tracts breached by “agriculture” or “grass” land.
