Marine Corps Base, Quantico Shoreline Protection Plan

Shoreline Studies Program
Virginia Institute of Marine Science
College of William & Mary
Gloucester Point, Virginia

March 2011

Final Report

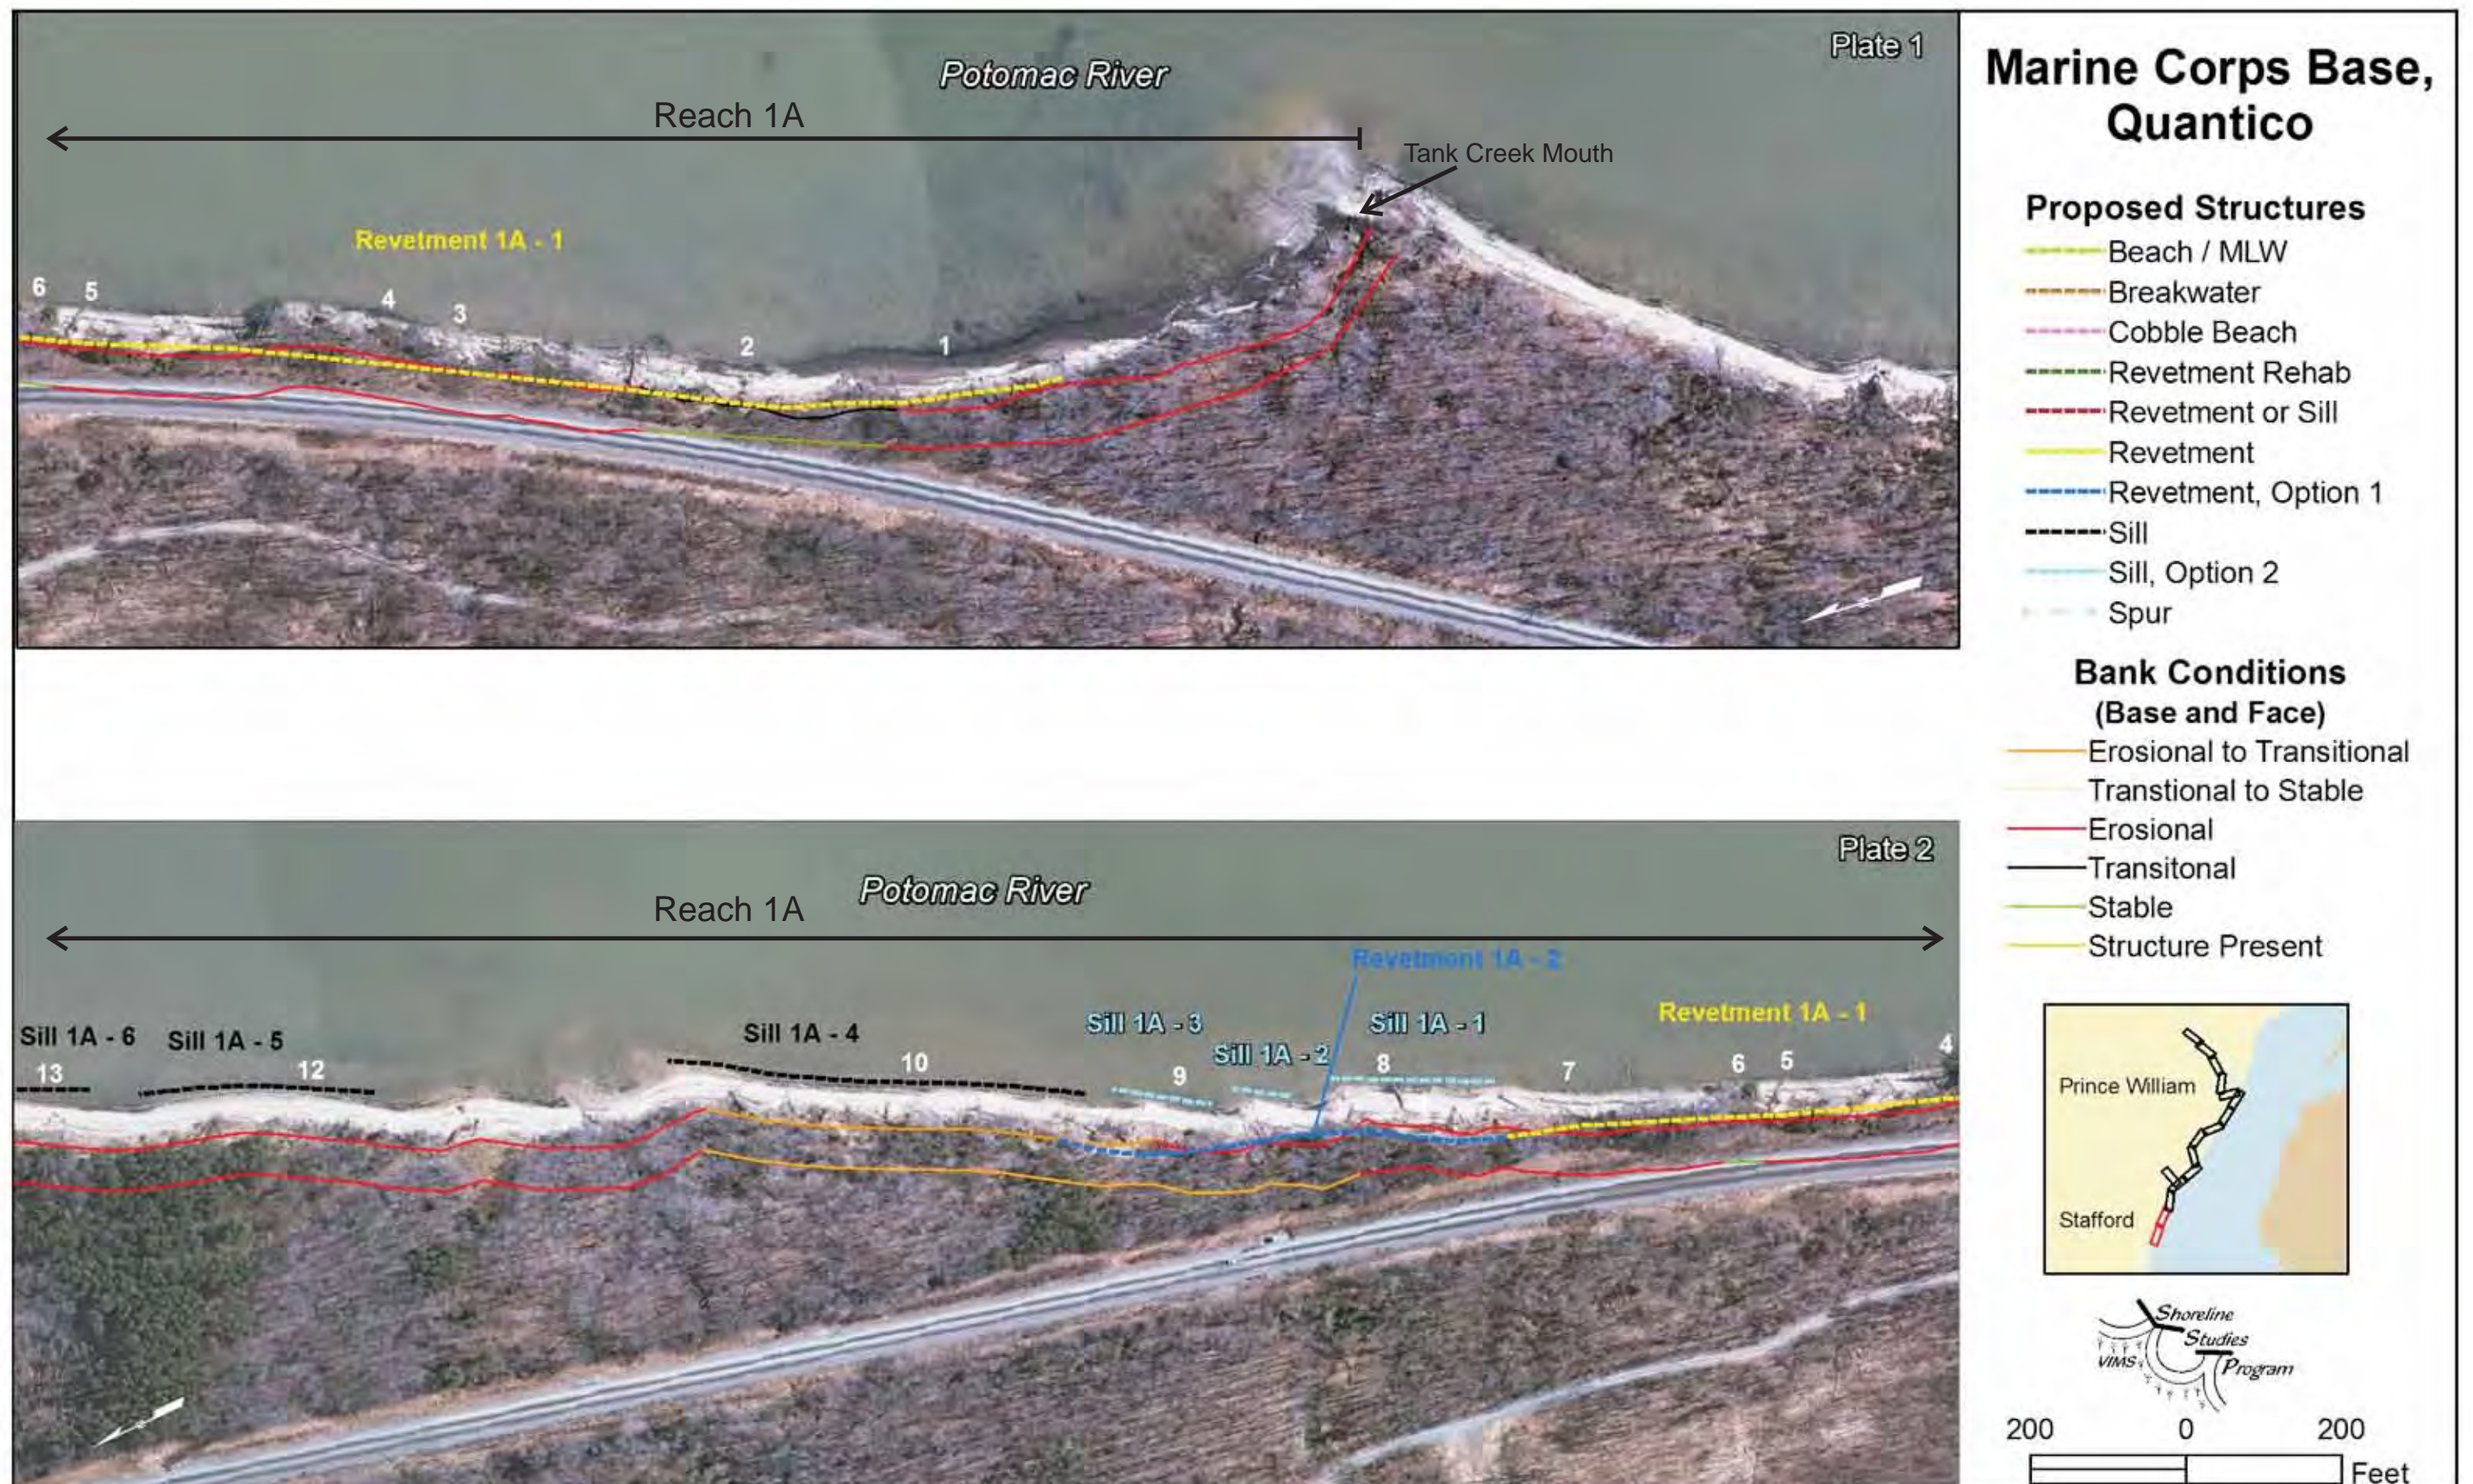
Figure 5-1. Bank conditions recommended shore management structures for Plates 1 and 2. Segment number (shown in white) is for location reference only. The recommendation name matches, in color, its representative alongshore line. Photo base VGIN 2009.

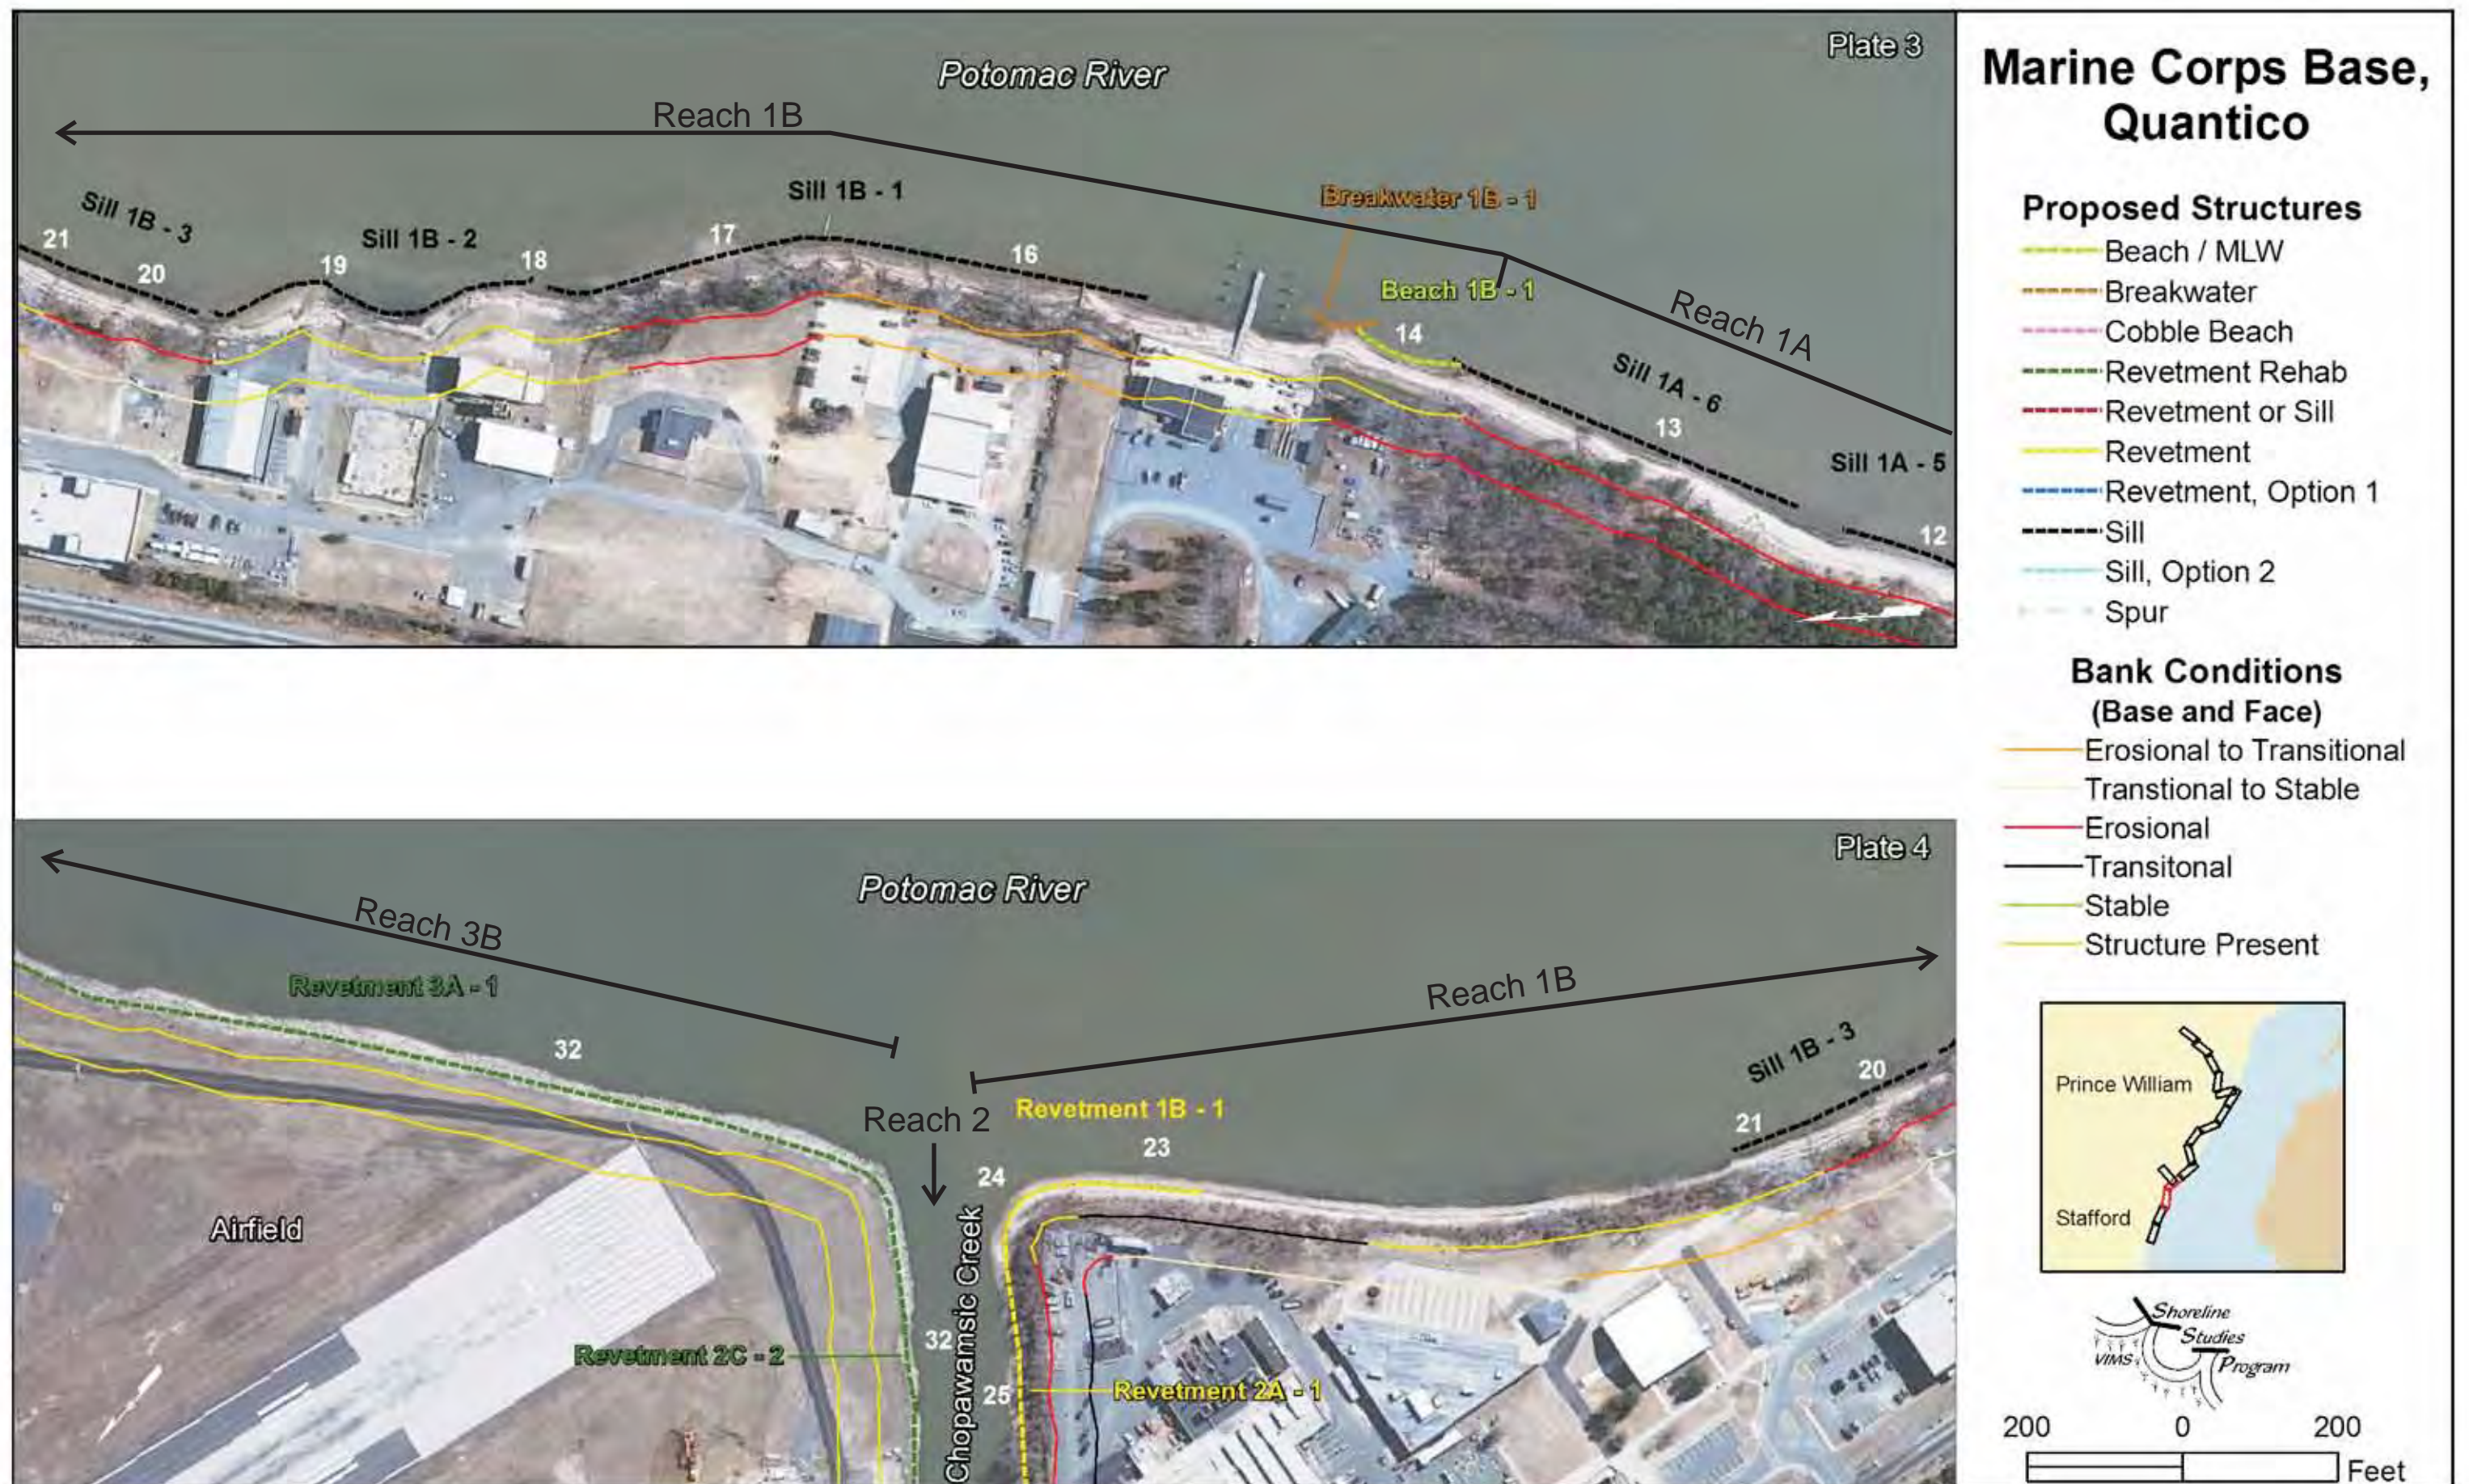
Figure 5-2. Bank conditions and recommended shore management structures for Plates 3 and 4. Segment number (shown in white) is for location reference only. The recommendation name matches, in color, its representative alongshore line. Photo base VGIN 2009.

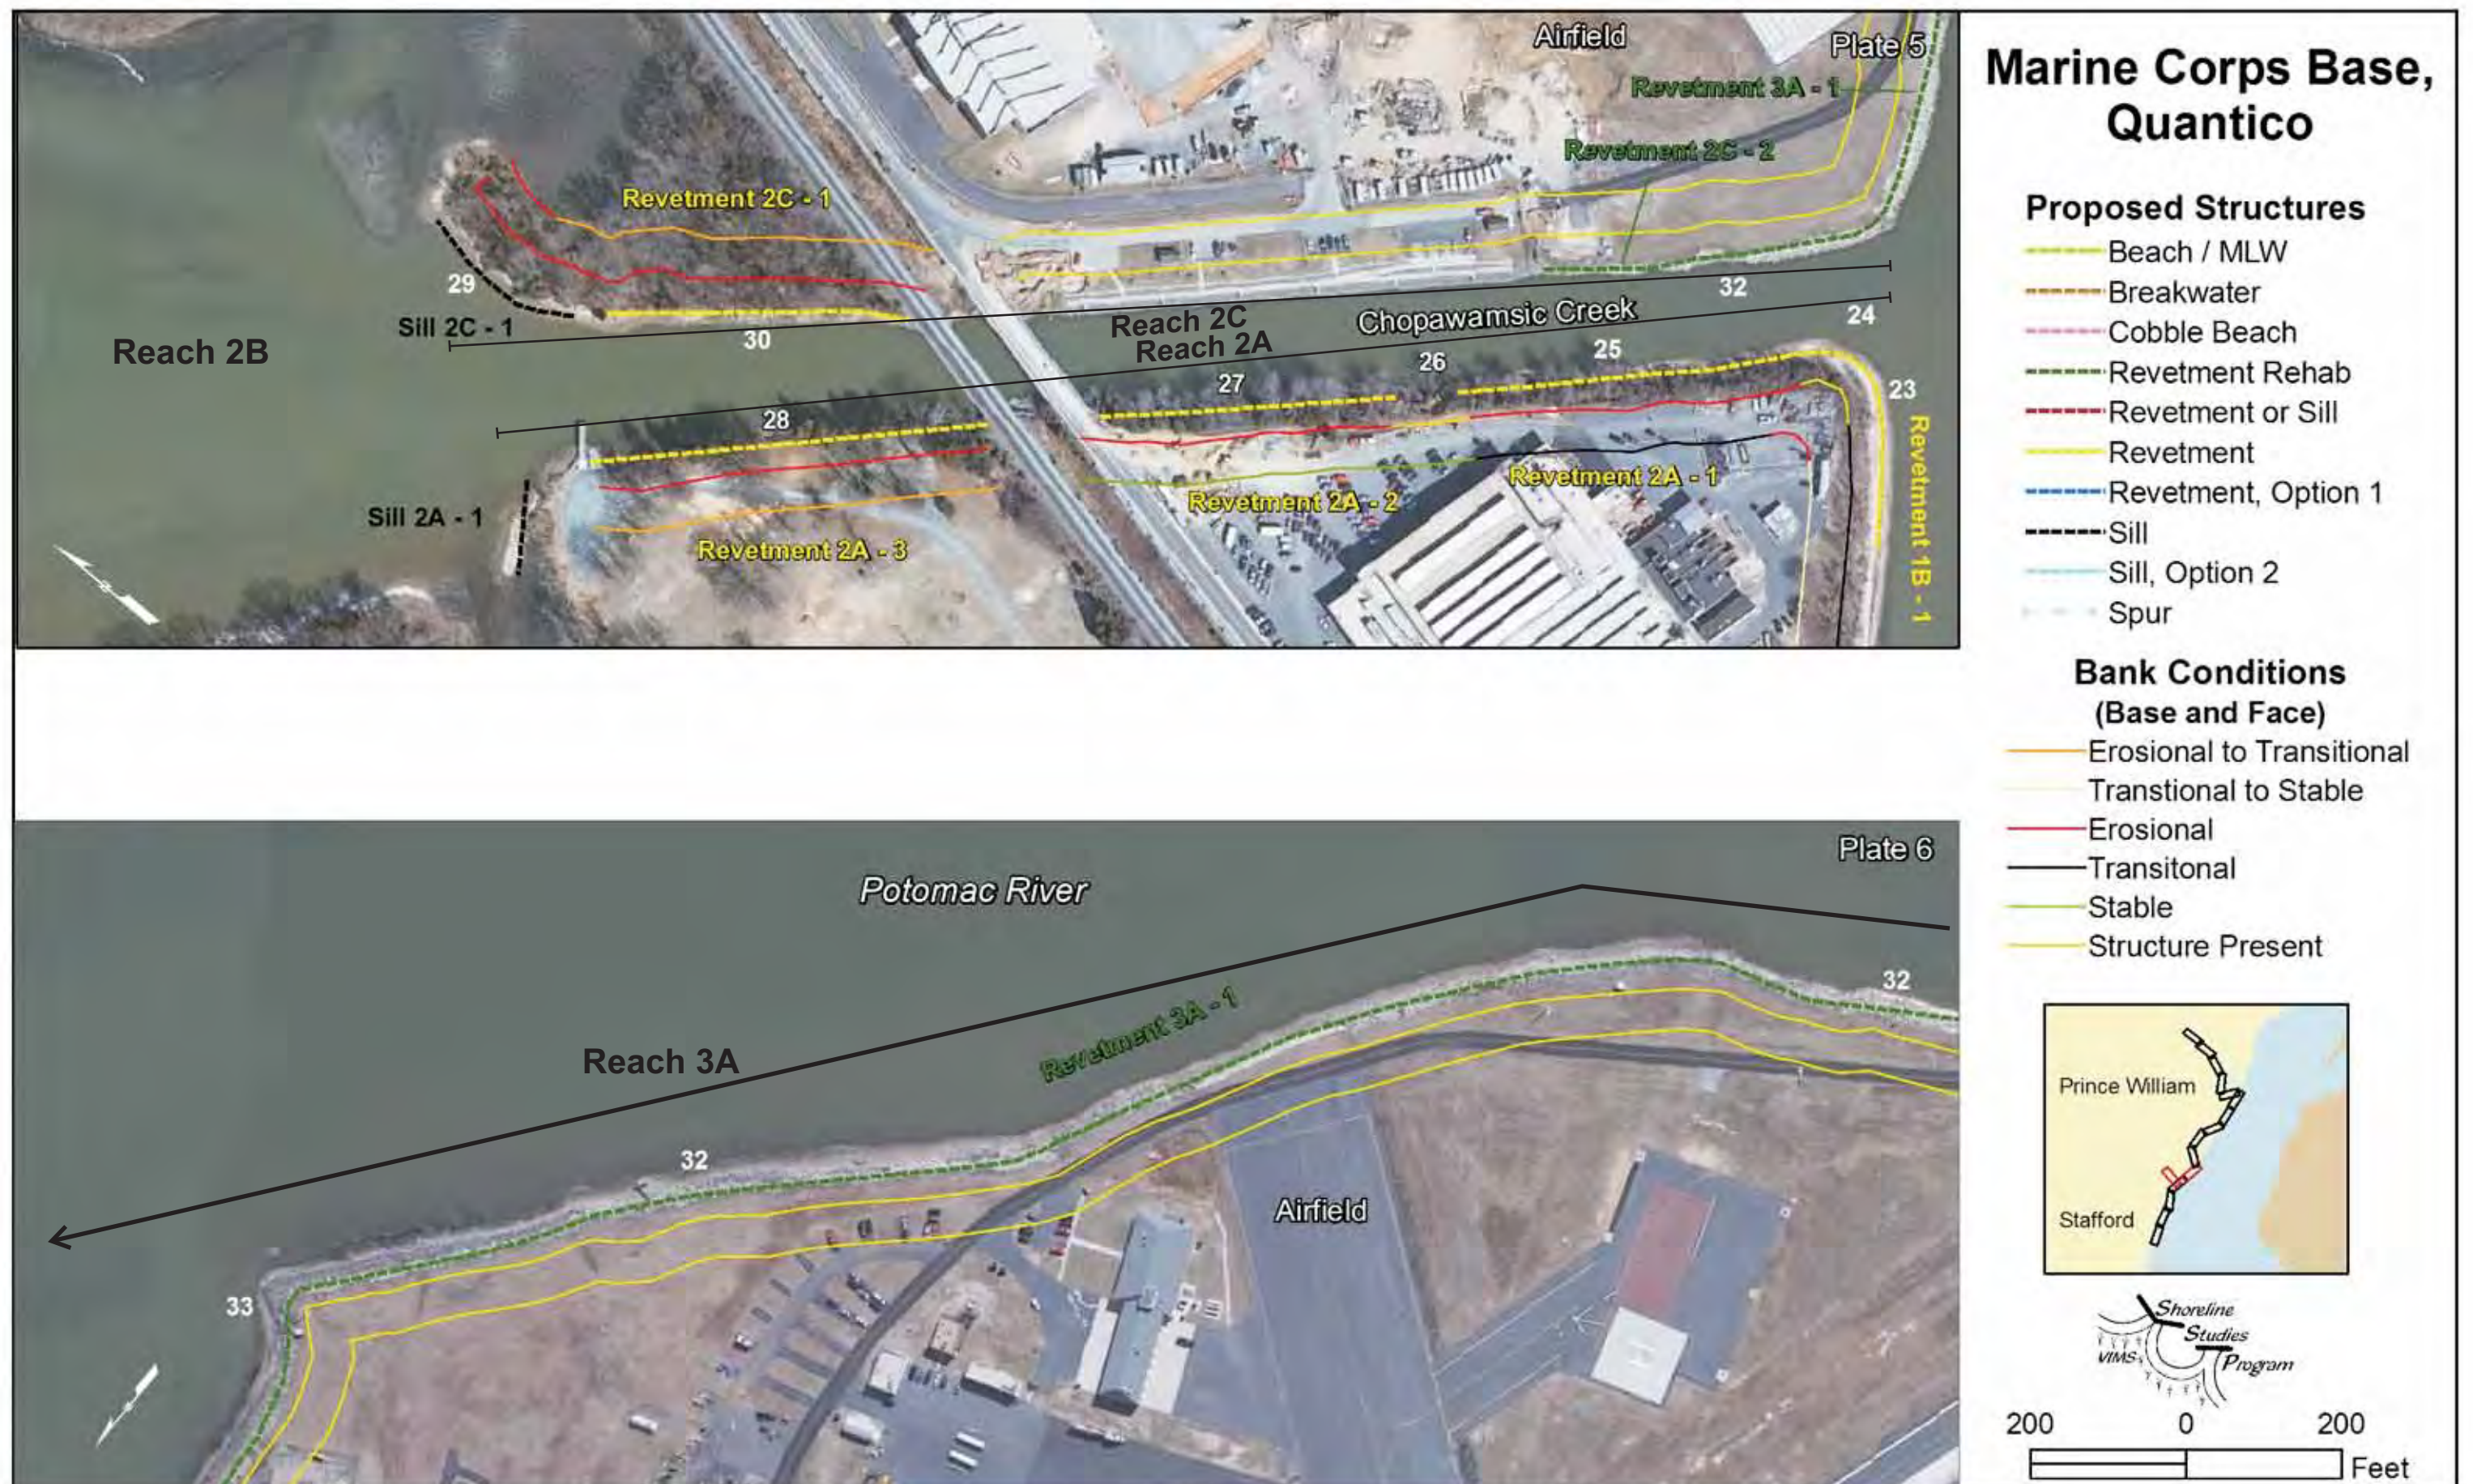
Figure 6-1. Bank conditions and recommended shore management structures for Plates 5 and 6. Segment number (shown in white) is for location reference only. The recommendation name matches, in color, its representative alongshore line. Photo base VGIN 2009.

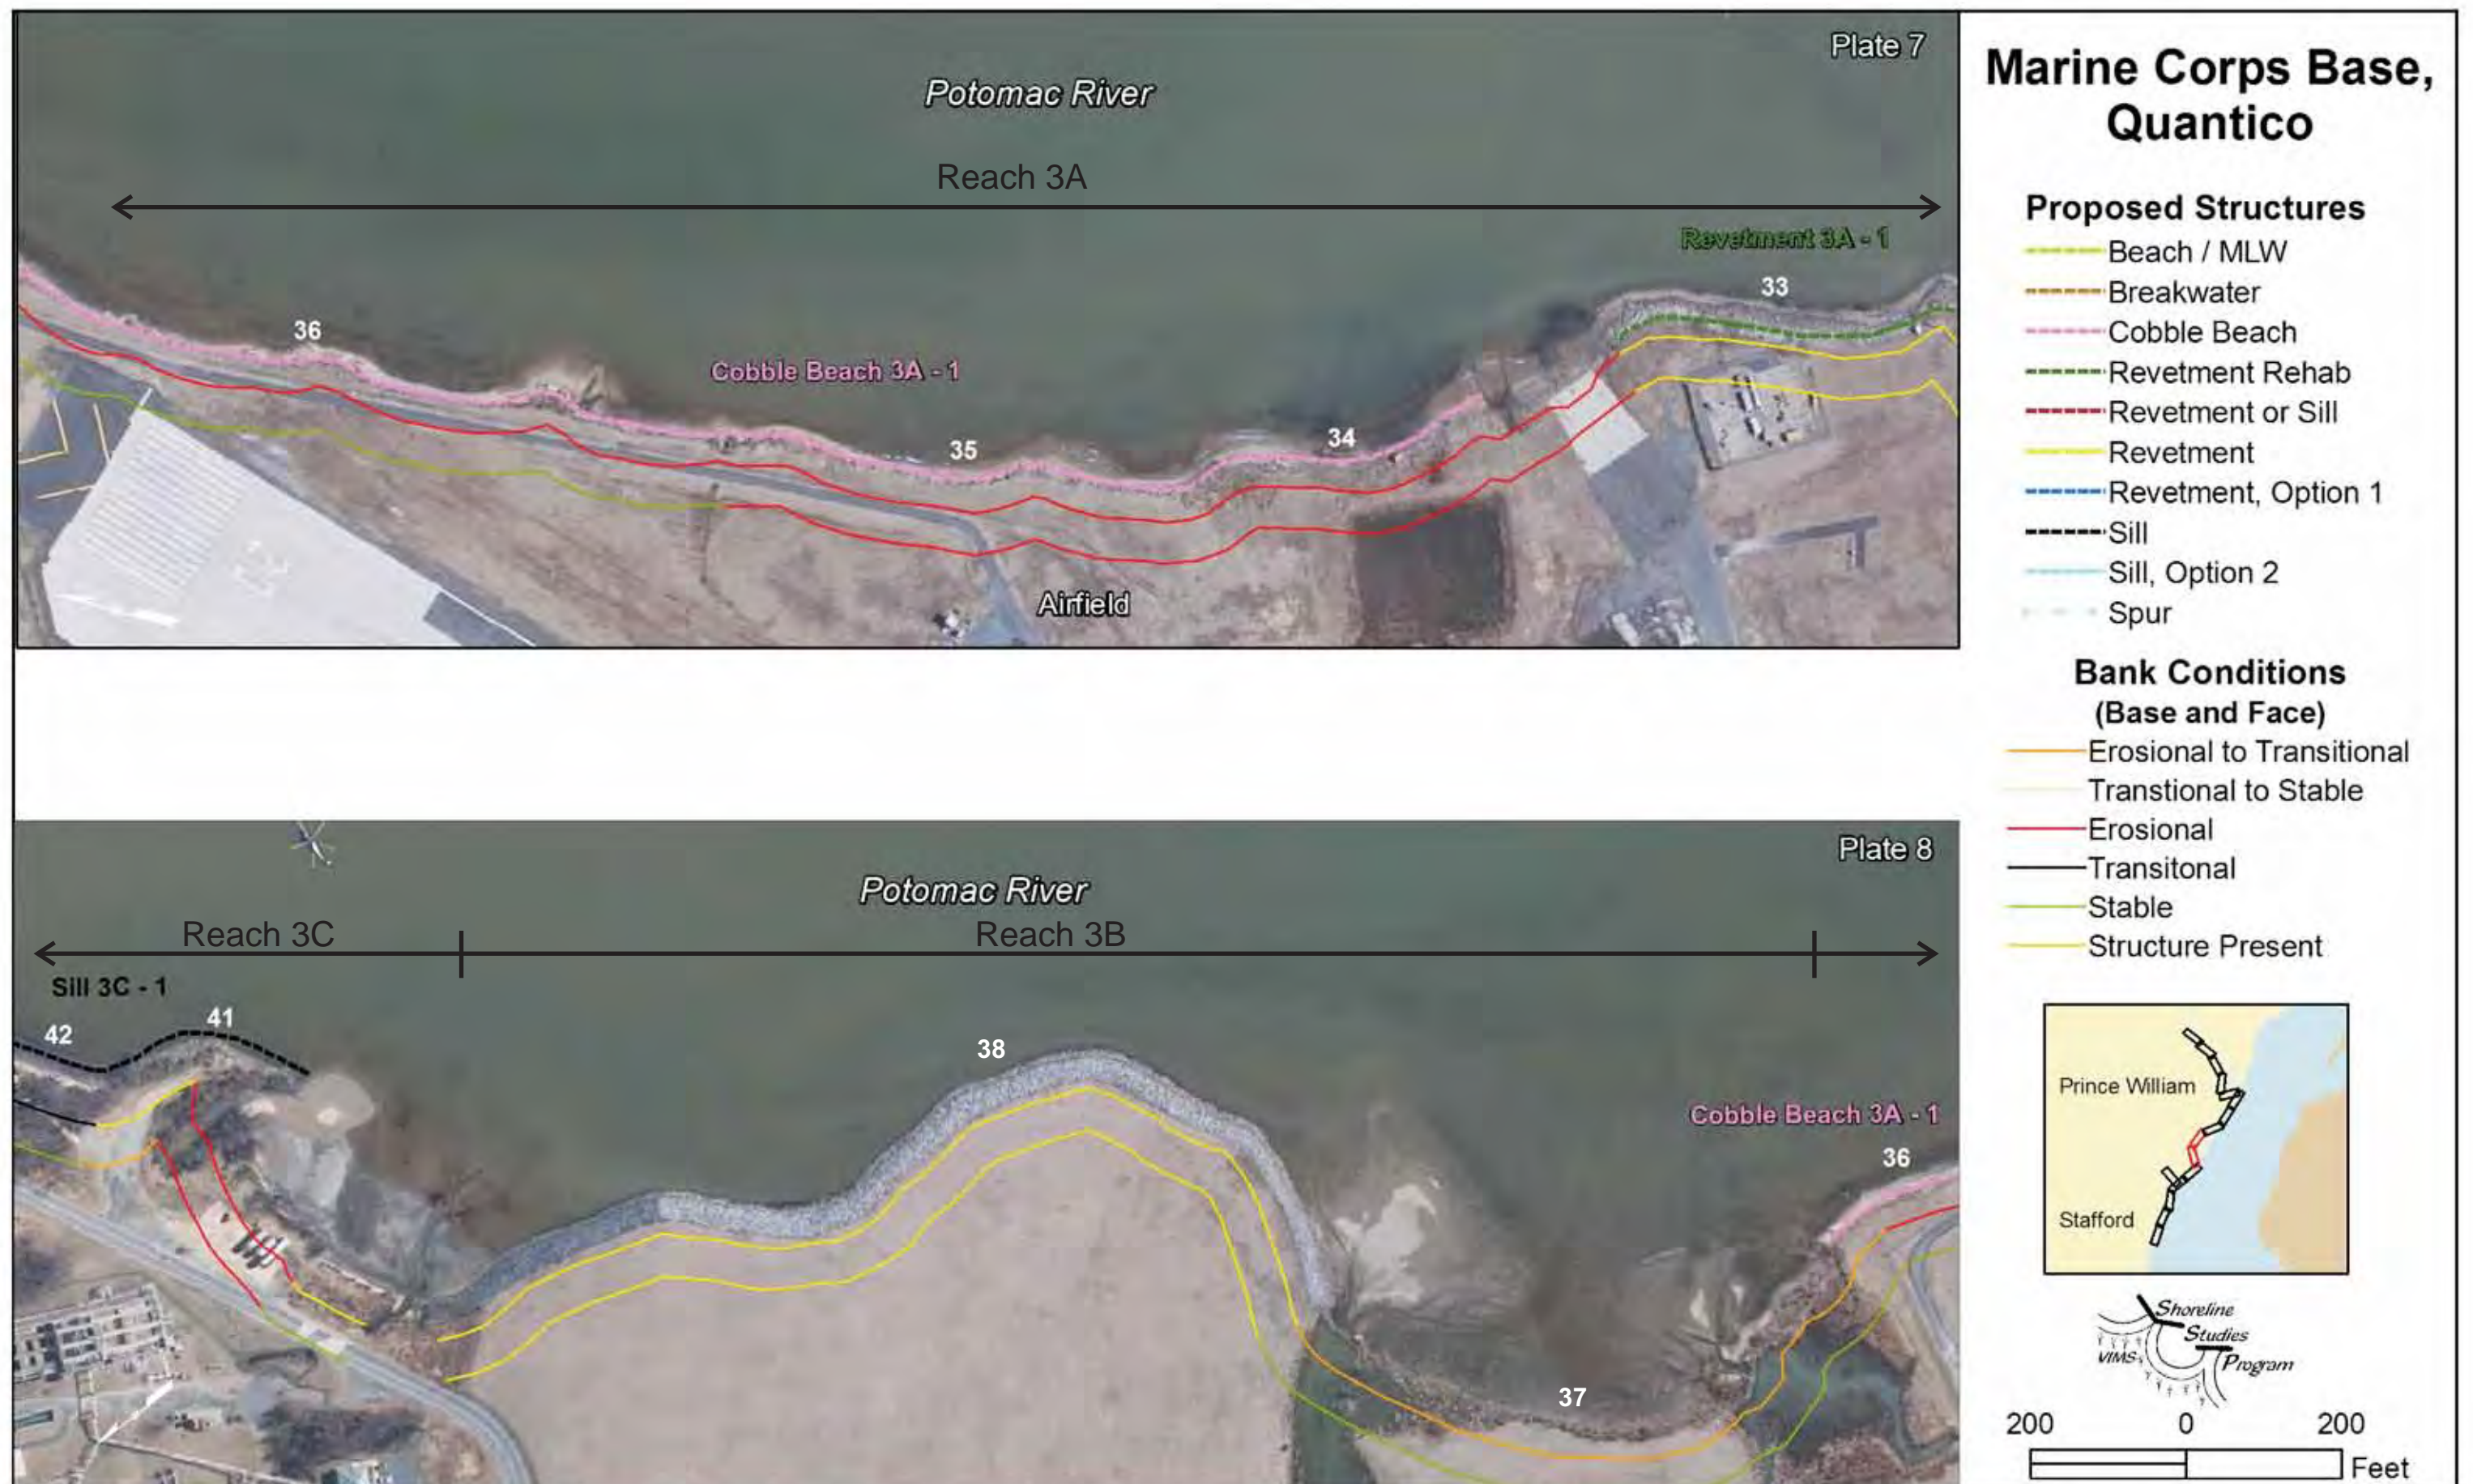
Figure 7-1. Bank conditions and recommended shore management structures for Plates 7 and 8. Segment number (shown in white) is for location reference only. The recommendation name matches, in color, its representative alongshore line. Photo base VGIN 2009.

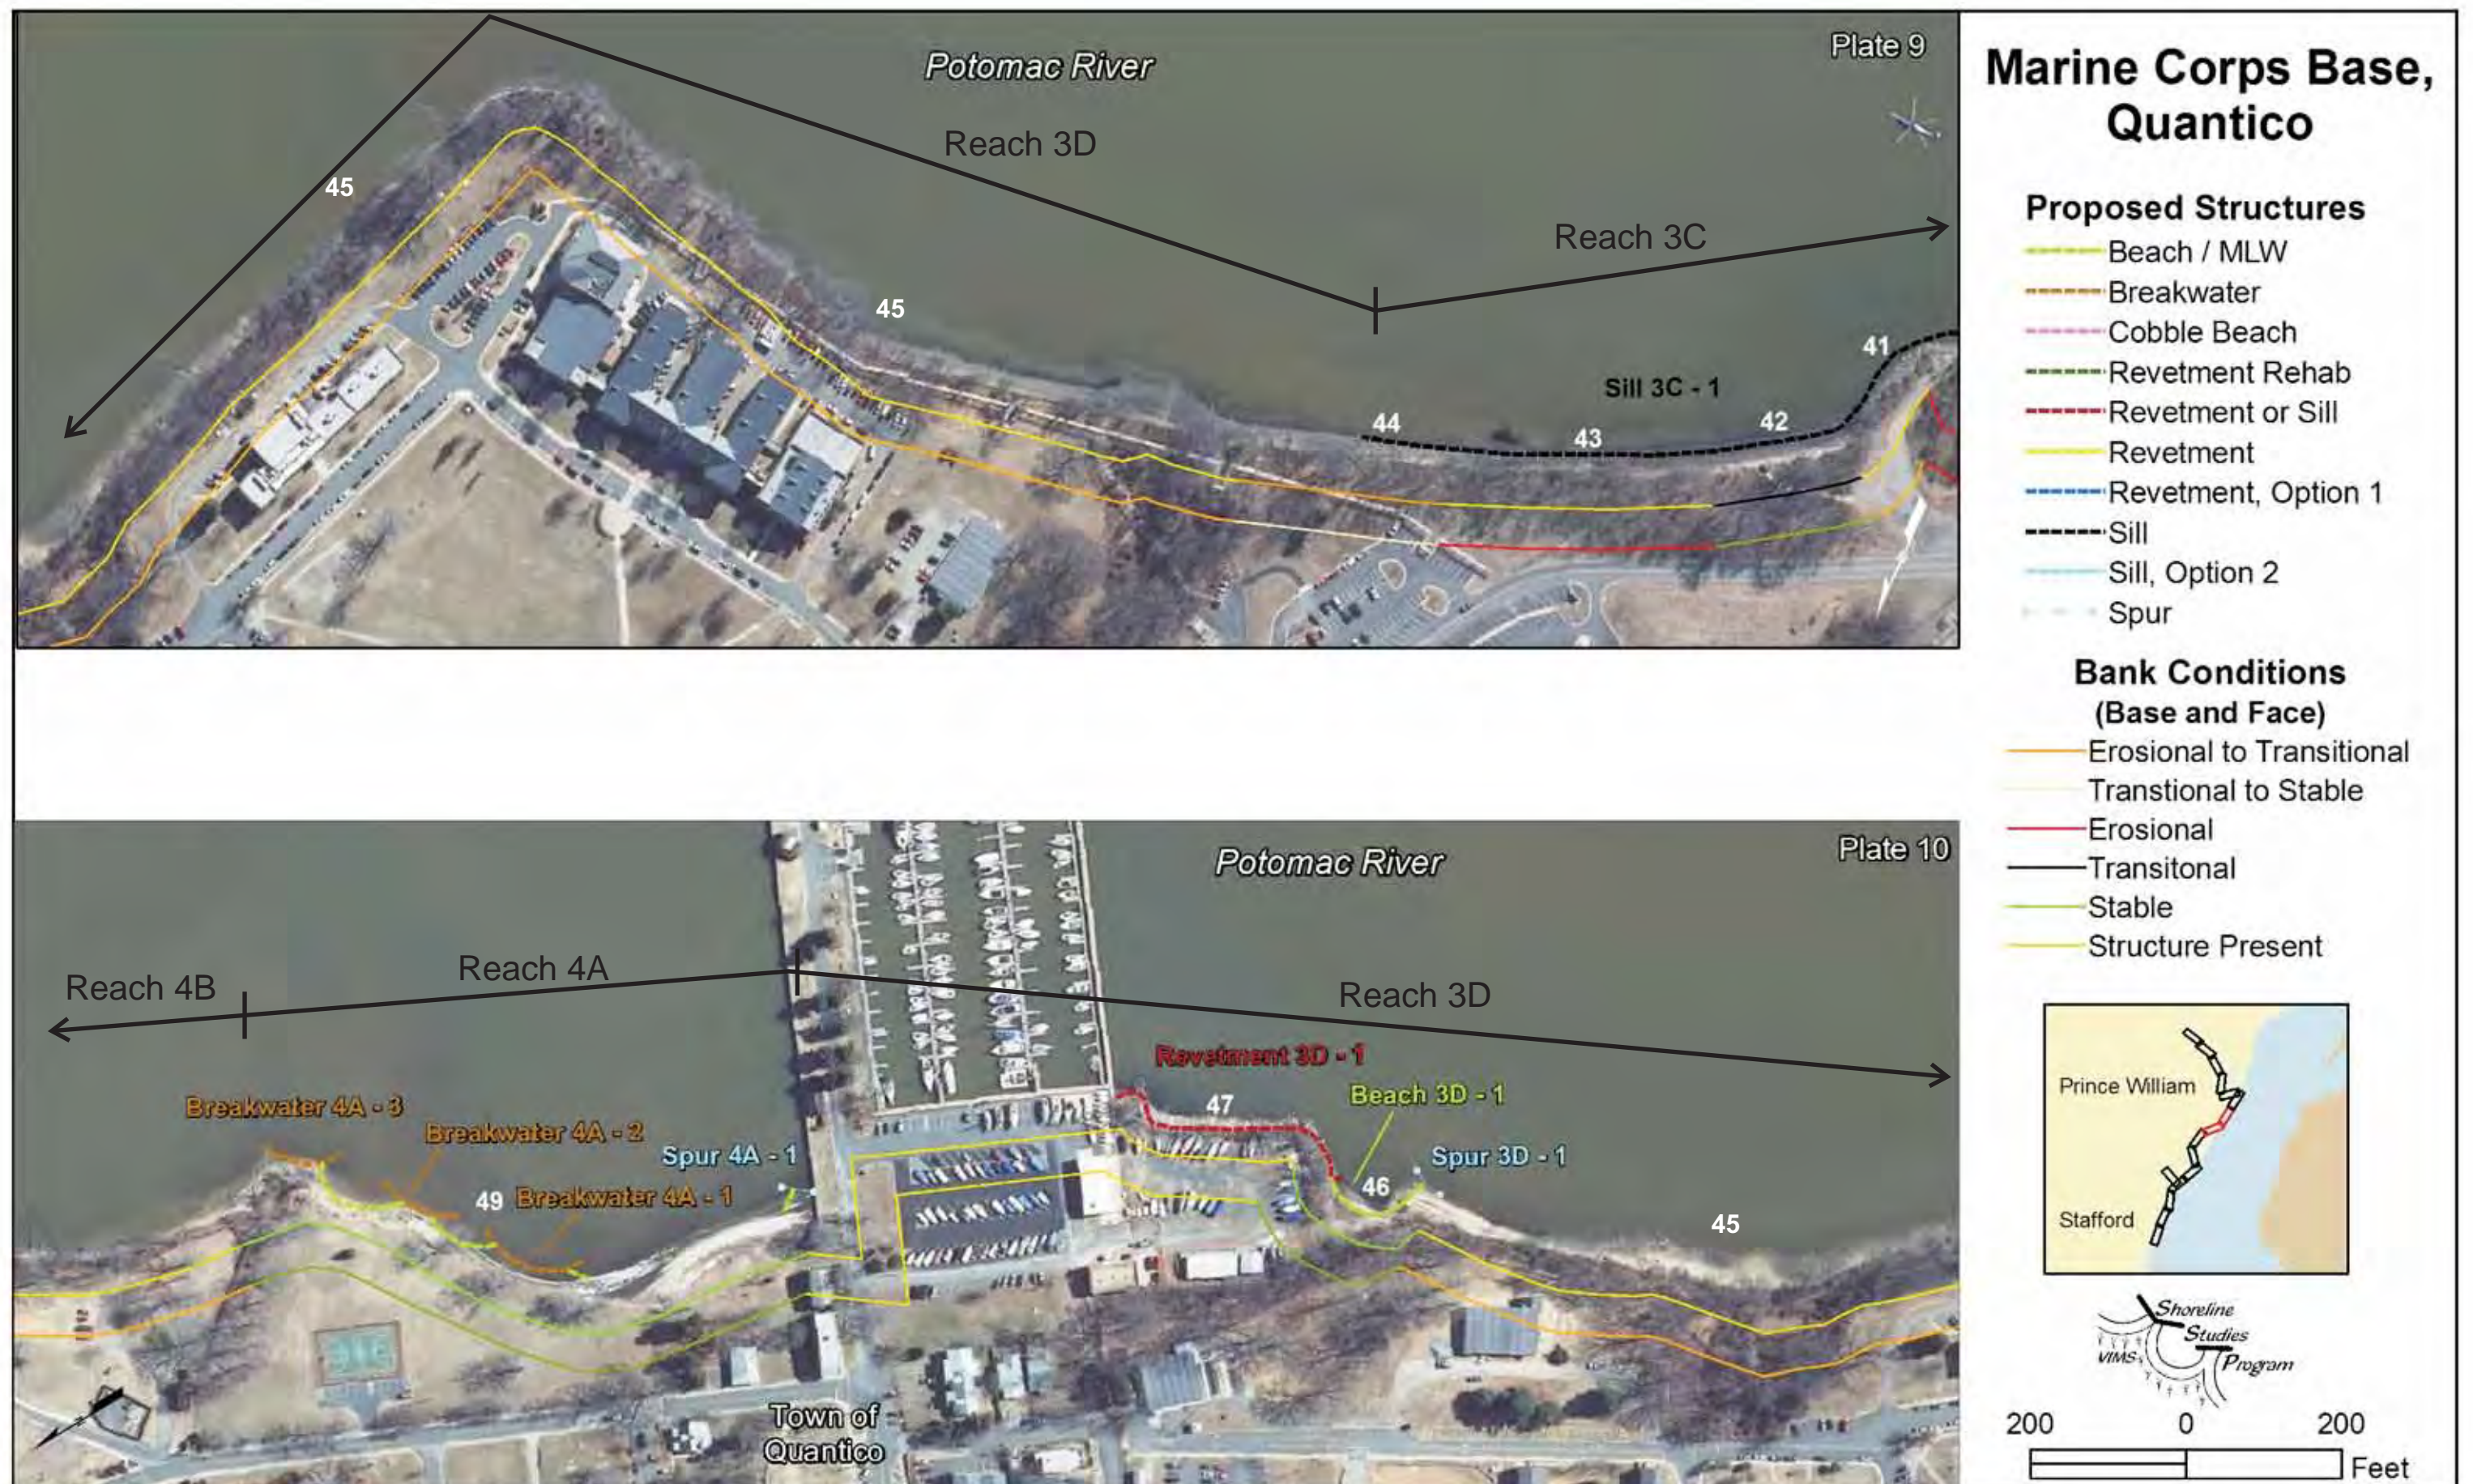
Figure 7-2. Bank conditions and recommended shore management structures for Plates 9 and 10. Segment number (shown in white) is for location reference only. The recommendation name matches, in color, its representative alongshore line. Photo base VGIN 2009.
